# Manhole Inspection Report

Date:	<b>03/27/2018</b>	Weather:		Coding:	<b>RZMACP</b>
MH#:	<b>M-407-010</b>	Owner:	<b>NA</b>	Len. Surveyed:	<b>3.7</b>
P.O.#:		Surveyor:	<b>John Kuglmaier</b>	Rim to Invert:	<b>4.2</b>
Customer:		Cert. #:	<b>U-1215-07002349</b>	Wall Material:	<b>Concrete (reinforced)</b>

Street:	<b>On Lake Side Dr. South of 10th St.</b>	Project:	<b>Hobart, IN</b>
City:	<b>Hobart, IN</b>	GPS Northing:	<b>0.0</b>
Location:		GPS Easting:	<b>0.0</b>
Drain Area:	<b>Southwest</b>	GPS Accuracy:	<b>Nearest Meter</b>
Cover Shape:	<b>Circular</b>	Evidence of Surcharge:	<b>No</b>
Cover Size:	<b>22.5</b>	Potential for Runoff:	<b>None</b>
Comments:

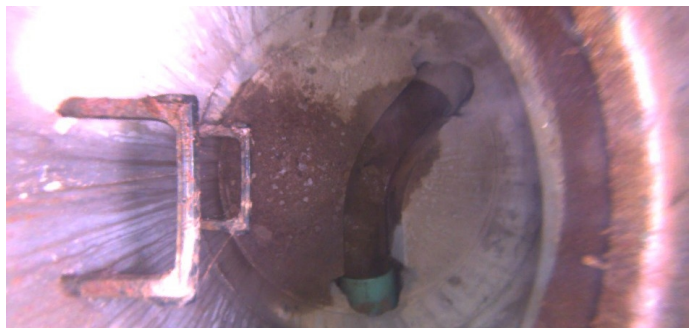
Code: **MGP**  
Description: **General Photo**

Distance (ft): **.0**  
Structural Grade: **0**  
O&M Grade: **0**  
Clock Start/From:  
Clock To:  
1st Value:  
2nd Value:  
Value Percent:  
Step: **NO**  
Remarks:

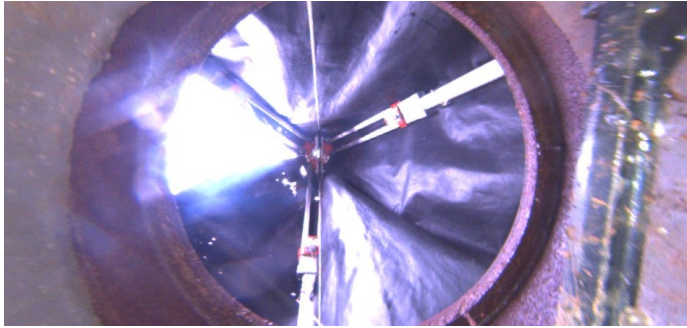
Code: **MGP**  
Description: **General Photo**

Distance (ft): **2.0**  
Structural Grade: **0**  
O&M Grade: **0**  
Clock Start/From:  
Clock To:  
1st Value:  
2nd Value:  
Value Percent:  
Step: **NO**  
Remarks:

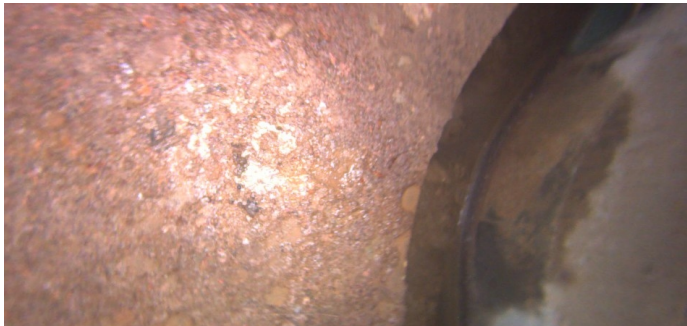
Code: **MGO**  
Description: **General Observation**

Distance (ft): **2.8**  
Structural Grade: **0**  
O&M Grade: **0**  
Clock Start/From:  
Clock To:  
1st Value:  
2nd Value:  
Value Percent:  
Step: **NO**  
Remarks: **Ins. Comp.**
