# Manhole Inspection Report

Date:	<b>03/27/2018</b>	Weather:		Coding:	<b>RZMACP</b>
MH#:	<b>M-407-012</b>	Owner:	<b>NA</b>	Len. Surveyed:	<b>6.4</b>
P.O.#:		Surveyor:	<b>John Kuglmaier</b>	Rim to Invert:	<b>8.6</b>
Customer:		Cert. #:	<b>U-1215-07002349</b>	Wall Material:	<b>Concrete (reinforced)</b>

Street:	<b>Lake Side Dr. and W 11TH PL CUL-DE</b>	Project:	<b>Hobart, IN</b>
City:	<b>Hobart, IN</b>	GPS Northing:	<b>0.0</b>
Location:		GPS Easting:	<b>0.0</b>
Drain Area:	<b>Southwest</b>	GPS Accuracy:	<b>Nearest Meter</b>
Cover Shape:	<b>Circular</b>	Evidence of Surcharge:	<b>No</b>
Cover Size:	<b>22.5</b>	Potential for Runoff:	<b>None</b>
Comments:

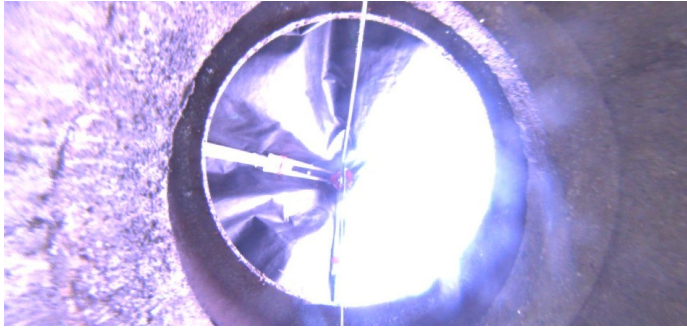
Code: **MGP**  
Description: **General Photo**

Distance (ft): **2.2**  
Structural Grade: **0**  
O&M Grade: **0**  
Clock Start/From:  
Clock To:  
1st Value:  
2nd Value:  
Value Percent:  
Step: **NO**  
Remarks:

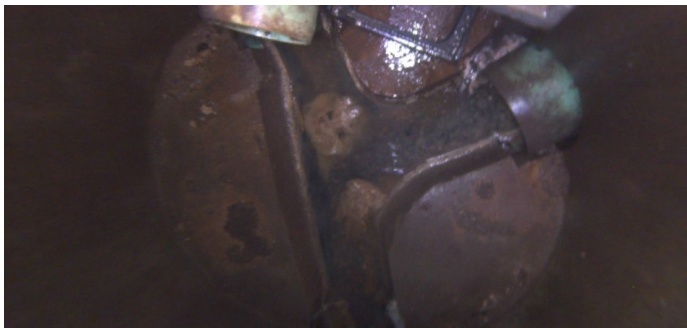
Code: **MGO**  
Description: **General Observation**

Distance (ft): **5.8**  
Structural Grade: **0**  
O&M Grade: **0**  
Clock Start/From:  
Clock To:  
1st Value:  
2nd Value:  
Value Percent:  
Step: **NO**  
Remarks: **Ins. Comp.**
