# Manhole Inspection Report

Date:	<b>03/27/2018</b>	Weather:		Coding:	<b>RZMACP</b>
MH#:	<b>M-407-013</b>	Owner:	<b>NA</b>	Len. Surveyed:	<b>8.1</b>
P.O.#:		Surveyor:	<b>John Kuglmaier</b>	Rim to Invert:	<b>8.9</b>
Customer:		Cert. #:	<b>U-1215-07002349</b>	Wall Material:	<b>Concrete (reinforced)</b>

Street:	<b>East of Lake Side Dr. South of 10th S</b>	Project:	<b>Hobart, IN</b>
City:	<b>Hobart, IN</b>	GPS Northing:	<b>0.0</b>
Location:		GPS Easting:	<b>0.0</b>
Drain Area:	<b>Southwest</b>	GPS Accuracy:	<b>Nearest Meter</b>
Cover Shape:	<b>Circular</b>	Evidence of Surcharge:	<b>No</b>
Cover Size:	<b>22.5</b>	Potential for Runoff:	<b>None</b>
Comments:

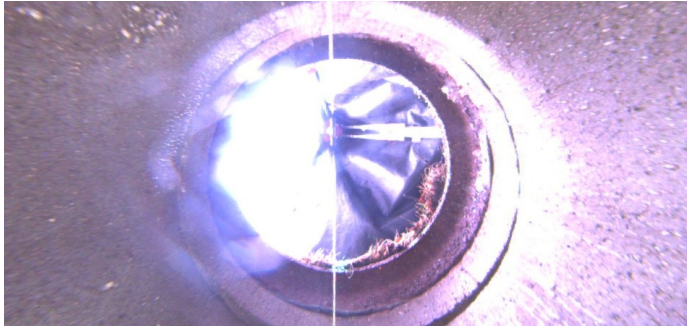
Code:	<b>MGP</b>
Description:	<b>General Photo</b>
Distance (ft):	<b>2.6</b>
Structural Grade:	<b>0</b>
O&M Grade:	<b>0</b>
Clock Start/From:	
Clock To:	
1st Value:	
2nd Value:	
Value Percent:	
Step:	<b>NO</b>
Remarks:

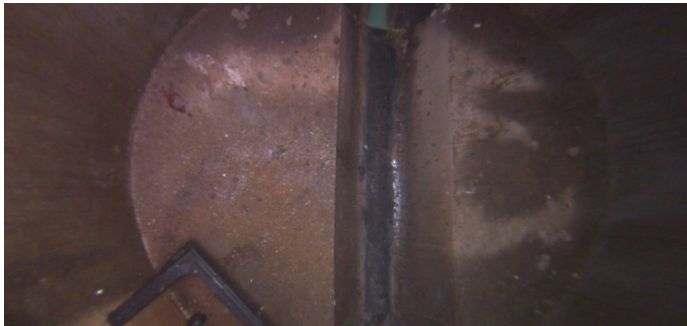
Code:	<b>MGO</b>
Description:	<b>General Observation</b>
Distance (ft):	<b>6.1</b>
Structural Grade:	<b>0</b>
O&M Grade:	<b>0</b>
Clock Start/From:	
Clock To:	
1st Value:	
2nd Value:	
Value Percent:	
Step:	<b>NO</b>
Remarks:	<b>Ins. Comp.</b>
