Manhole Inspection Report

Date:	03/23/2018	Weather:		Coding:	RZMACP
MH#:	M-408-001	Owner:	NA	Len. Surveyed:	22.0
P.O.#:		Surveyor:	John Kuglmaier	Rim to Invert:	22.2
Customer:		Cert. #:	U-1215-07002349	Wall Material:	Concrete (reinforced)

Street:	North of 61st Ave. 45' East of Clay St	Project:	Hobart, IN
City:	Hobart, IN	GPS Northing:	0.0
Location:		GPS Easting:	0.0
Drain Area:	Southwest	GPS Accuracy:	Nearest Meter
Cover Shape:	Circular	Evidence of Surcharge:	No
Cover Size:	22.5	Potential for Runoff:	None
Comments:

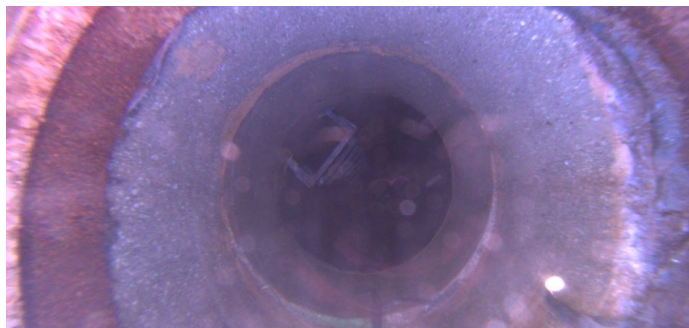
Code: **MGP**
Description: **General Photo**

Distance (ft): **.0**
Structural Grade: **0**
O&M Grade: **0**
Clock Start/From:
Clock To:
1st Value:
2nd Value:
Value Percent:
Step: **NO**
Remarks:

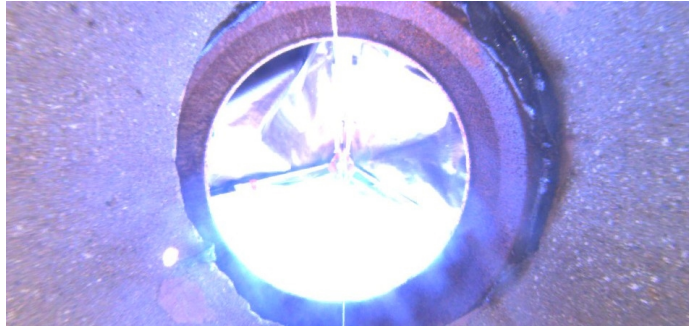
Code: **MGP**
Description: **General Photo**

Distance (ft): **2.7**
Structural Grade: **0**
O&M Grade: **0**
Clock Start/From:
Clock To:
1st Value:
2nd Value:
Value Percent:
Step: **NO**
Remarks:

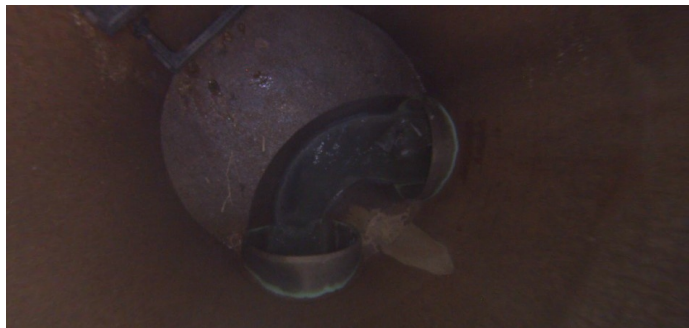
Code: **IS**
Description: **Infil Stain**

Distance (ft): **18.1**
Structural Grade: **0**
O&M Grade: **0**
Clock Start/From: **4**
Clock To:
1st Value:
2nd Value:
Value Percent:
Step: **NO**
Remarks:

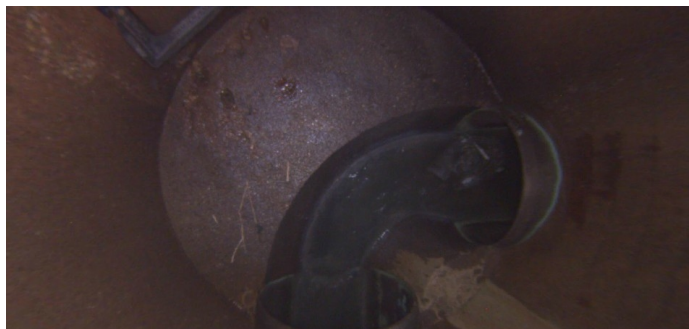
Code: **MGO**
Description: **General Observation**

Distance (ft): **19.2**
Structural Grade: **0**
O&M Grade: **0**
Clock Start/From:
Clock To:
1st Value:
2nd Value:
Value Percent:
Step: **NO**
Remarks: **Ins. Comp.**
