Manhole Inspection Report

Date:	03/23/2018	Weather:		Coding:	RZMACP
MH#:	M-408-002	Owner:	NA	Len. Surveyed:	21.8
P.O.#:		Surveyor:	John Kuglmaier	Rim to Invert:	21.8
Customer:		Cert. #:	U-1215-07002349	Wall Material:	Concrete (reinforced)

Street:	North of 61st Ave. 43' East of Clay St	Project:	Hobart, IN
City:	Hobart, IN	GPS Northing:	0.0
Location:		GPS Easting:	0.0
Drain Area:	Southwest	GPS Accuracy:	Nearest Meter
Cover Shape:	Circular	Evidence of Surcharge:	No
Cover Size:	22.5	Potential for Runoff:	None
Comments:

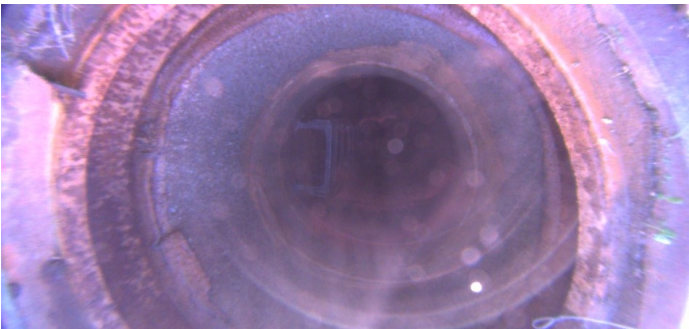
Code:
MGP

Description:
General Photo

Distance (ft):
.0

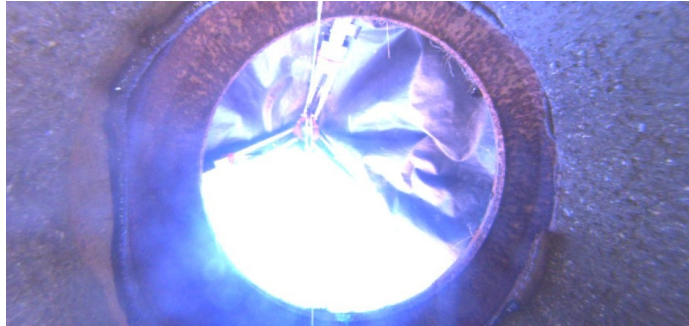
Code: **MGP**
Description: **General Photo**

Distance (ft): **2.7**
Structural Grade: **0**
O&M Grade: **0**
Clock Start/From:
Clock To:
1st Value:
2nd Value:
Value Percent:
Step: **NO**
Remarks:

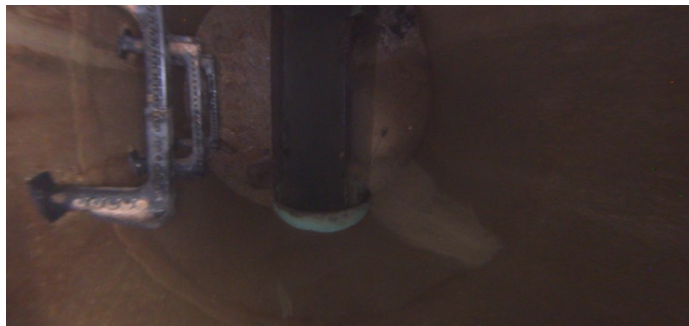
Code: **IS**
Description: **Infil Stain**

Distance (ft): **17.6**
Structural Grade: **0**
O&M Grade: **0**
Clock Start/From: **5**
Clock To:
1st Value:
2nd Value:
Value Percent:
Step: **NO**
Remarks:

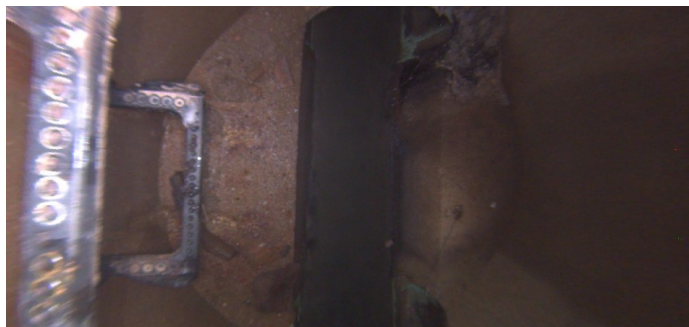
Code: **MGO**
Description: **General Observation**

Distance (ft): **19.4**
Structural Grade: **0**
O&M Grade: **0**
Clock Start/From:
Clock To:
1st Value:
2nd Value:
Value Percent:
Step: **NO**
Remarks: **Ins. Comp.**
