Manhole Inspection Report

Date:	04/12/2018	Weather:		Coding:	RZMACP
MH#:	M-503-001	Owner:	NA	Len. Surveyed:	12.2
P.O.#:		Surveyor:	John Kuglmaier	Rim to Invert:	13.2
Customer:		Cert. #:	U-1215-07002349	Wall Material:	Concrete (reinforced)

Street:	Wisconsin St. 29' North of 40th Plac	Project:	Hobart, IN
City:	Hobart, IN	GPS Northing:	2901770.882
Location:		GPS Easting:	2901770.882
Drain Area:	Northwest	GPS Accuracy:	Sub-Meter
Cover Shape:	Circular	Evidence of Surcharge:	Yes
Cover Size:	23.0	Potential for Runoff:	None
Comments:

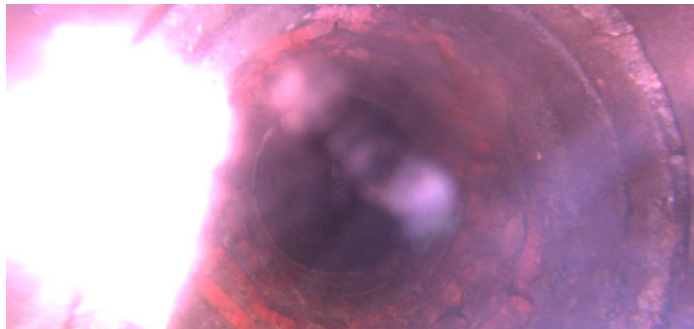
Code: **MGP**
Description: **General Photo**

Distance (ft): **.0**
Structural Grade: **0**
O&M Grade: **0**
Clock Start/From:
Clock To:
1st Value:
2nd Value:
Value Percent:
Step: **NO**
Remarks:

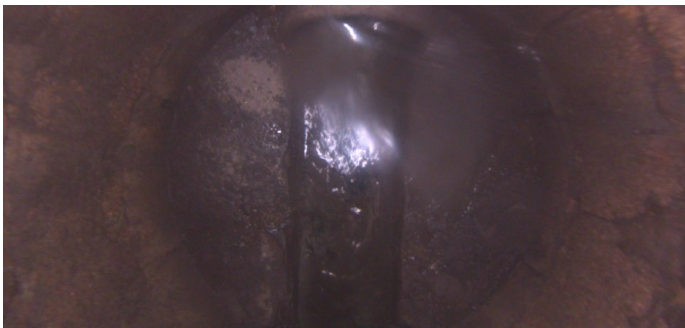
Code: **DSF**
Description: **Deposits Settled Fine**

Distance (ft): **10.4**
Structural Grade: **0**
O&M Grade: **2**
Clock Start/From: **12**
Clock To: **12**
1st Value:
2nd Value:
Value Percent: **10.000**
Step: **NO**
Remarks:

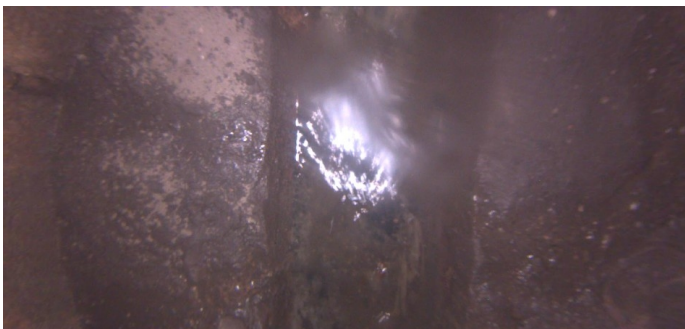
Code: **MGO**
Description: **General Observation**

Distance (ft): **11.4**
Structural Grade: **0**
O&M Grade: **0**
Clock Start/From:
Clock To:
1st Value:
2nd Value:
Value Percent:
Step: **NO**
Remarks: **Ins. Comp.**
