# Manhole Inspection Report

Date:	04/09/2018	Weather:		Coding:	RZMACP
MH#:	M-503-009	Owner:	NA	Len. Surveyed:	9.3
P.O.#:		Surveyor:	John Kuglmaier	Rim to Invert:	10.8
Customer:		Cert. #:	U-1215-07002349	Wall Material:	Concrete (reinforced)

Street:	164' West of Wisconsin St. 161' North	Project:	Hobart, IN
City:	Hobart, IN	GPS Northing:	2901613.288
Location:		GPS Easting:	2901613.288
Drain Area:	Northwest	GPS Accuracy:	Sub-Meter
Cover Shape:	Circular	Evidence of Surcharge:	Yes
Cover Size:	23.0	Potential for Runoff:	None
Comments:

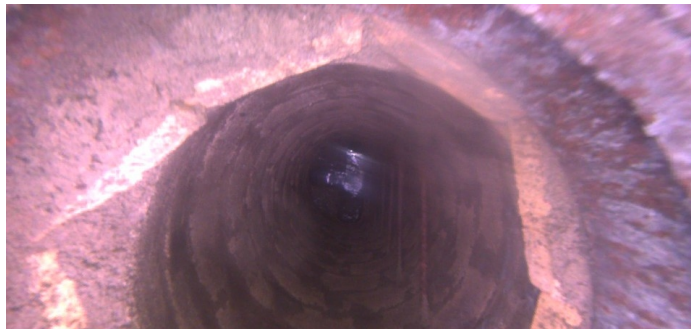
Code: **MGP**  
Description: **General Photo**

Distance (ft): **.0**  
Structural Grade: **0**  
O&M Grade: **0**  
Clock Start/From:  
Clock To:  
1st Value:  
2nd Value:  
Value Percent:  
Step: **NO**  
Remarks:

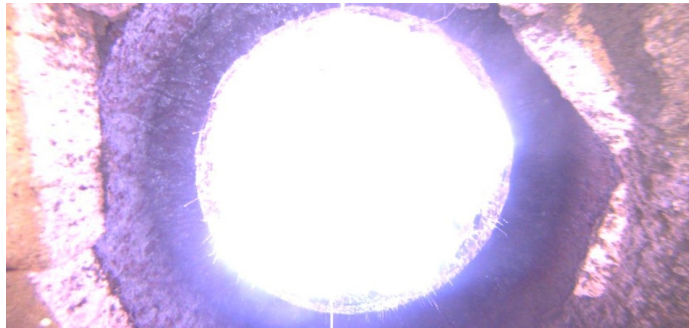
Code: **MGP**  
Description: **General Photo**

Distance (ft): **2.1**  
Structural Grade: **0**  
O&M Grade: **0**  
Clock Start/From:  
Clock To:  
1st Value:  
2nd Value:  
Value Percent:  
Step: **NO**  
Remarks:

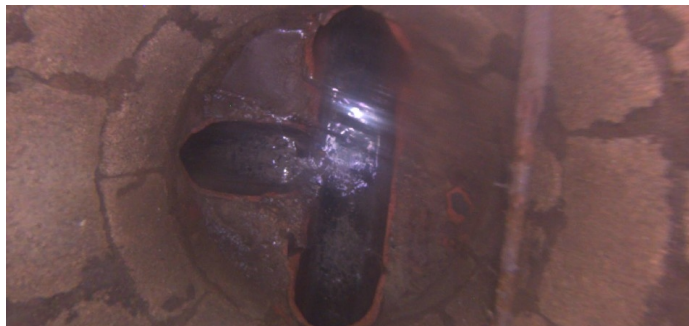
Code: **DSF**  
Description: **Deposits Settled Fine**

Distance (ft): **7.4**  
Structural Grade: **0**  
O&M Grade: **2**  
Clock Start/From: **12**  
Clock To: **12**  
1st Value:  
2nd Value:  
Value Percent: **5.000**  
Step: **NO**  
Remarks:

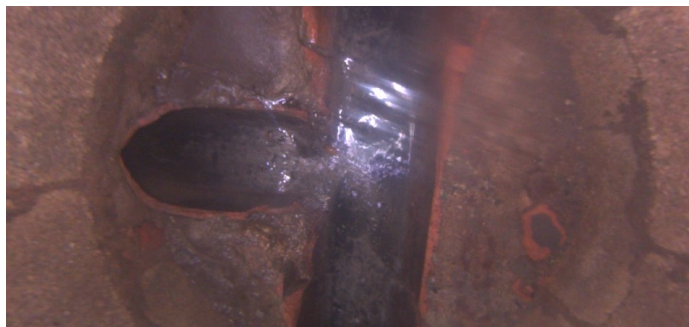
Code: **MGO**  
Description: **General Observation**

Distance (ft): **8.4**  
Structural Grade: **0**  
O&M Grade: **0**  
Clock Start/From:  
Clock To:  
1st Value:  
2nd Value:  
Value Percent:  
Step: **NO**  
Remarks: **Ins. Comp.**
