Manhole Inspection Report

Date:	04/09/2018	Weather:		Coding:	RZMACP
MH#:	M-503-013	Owner:	NA	Len. Surveyed:	6.8
P.O.#:		Surveyor:	John Kuglmaier	Rim to Invert:	8.0
Customer:		Cert. #:	U-1215-07002349	Wall Material:	Concrete (reinforced)

Street:	Virginia St. 239' South of 39th PL.	Project:	Hobart, IN
City:	Hobart, IN	GPS Northing:	2901027.78
Location:		GPS Easting:	2901027.78
Drain Area:	Northwest	GPS Accuracy:	Sub-Meter
Cover Shape:	Circular	Evidence of Surcharge:	No
Cover Size:	23.0	Potential for Runoff:	None
Comments:

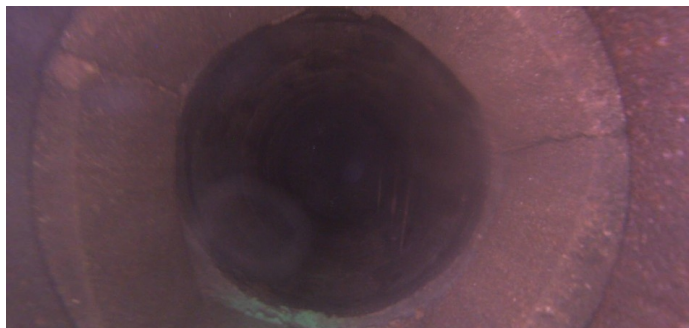
Code: **MGP**
Description: **General Photo**

Distance (ft): **.0**
Structural Grade: **0**
O&M Grade: **0**
Clock Start/From:
Clock To:
1st Value:
2nd Value:
Value Percent:
Step: **NO**
Remarks:

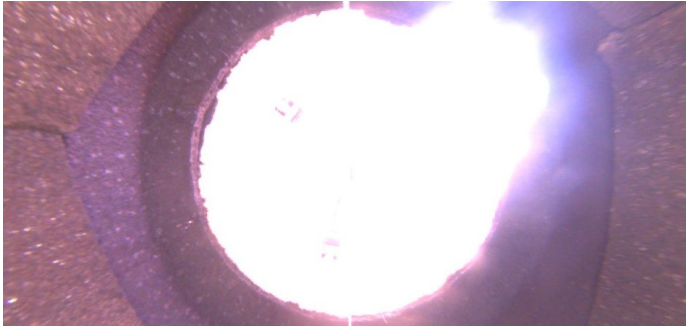
Code:	MGP
Description:	General Photo

Distance (ft):	2.1
Structural Grade:	0
O&M Grade:	0
Clock Start/From:	
Clock To:	
1st Value:	
2nd Value:	
Value Percent:	
Step:	NO
Remarks:

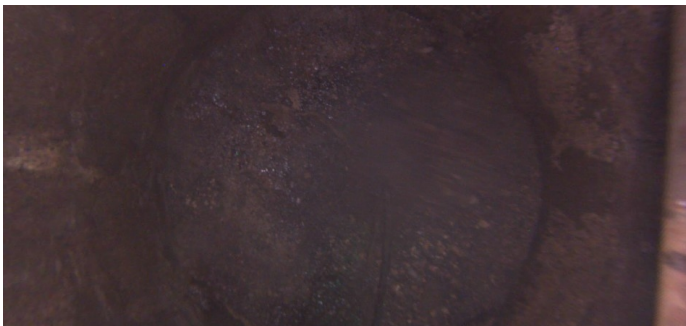
Code:	DSF
Description:	Deposits Settled Fine

Distance (ft):	5.4
Structural Grade:	0
O&M Grade:	3
Clock Start/From:	12
Clock To:	12
1st Value:	
2nd Value:	
Value Percent:	15.000
Step:	NO
Remarks:

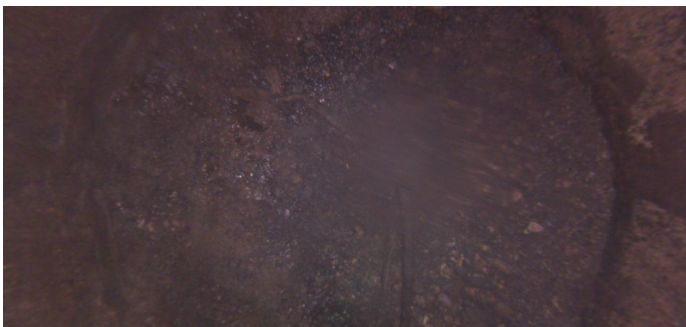
Code:	MGO
Description:	General Observation

Distance (ft):	6.0
Structural Grade:	0
O&M Grade:	0
Clock Start/From:	
Clock To:	
1st Value:	
2nd Value:	
Value Percent:	
Step:	NO
Remarks:	Ins. Comp.
