Manhole Inspection Report

Date:	04/09/2018	Weather:		Coding:	RZMACP
MH#:	M-503-016	Owner:	NA	Len. Surveyed:	8.4
P.O.#:		Surveyor:	John Kuglmaier	Rim to Invert:	9.5
Customer:		Cert. #:	U-1215-07002349	Wall Material:	Concrete (reinforced)

Street:	39th PL. 164' West of Wisconsin St.	Project:	Hobart, IN
City:	Hobart, IN	GPS Northing:	2901609.519
Location:		GPS Easting:	2901609.519
Drain Area:	Northwest	GPS Accuracy:	Sub-Meter
Cover Shape:	Circular	Evidence of Surcharge:	No
Cover Size:	23.0	Potential for Runoff:	None
Comments:

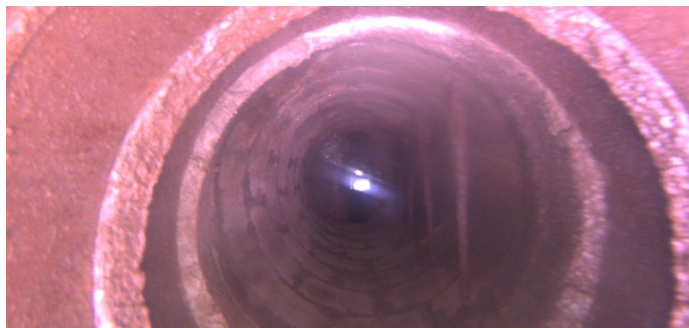
Code: **MGP**
Description: **General Photo**

Distance (ft): **.0**
Structural Grade: **0**
O&M Grade: **0**
Clock Start/From:
Clock To:
1st Value:
2nd Value:
Value Percent:
Step: **NO**
Remarks:

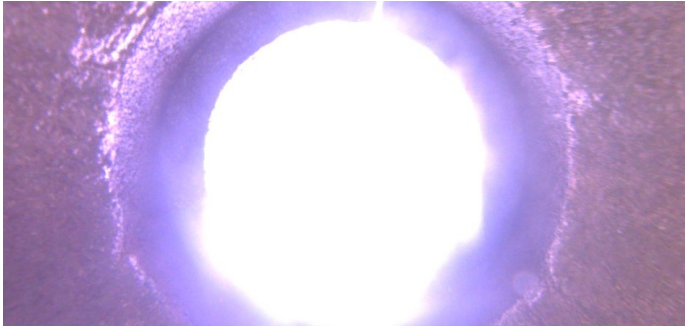
Code:	MGP
Description:	General Photo

Distance (ft):	2.8
Structural Grade:	0
O&M Grade:	0
Clock Start/From:	
Clock To:	
1st Value:	
2nd Value:	
Value Percent:	
Step:	NO
Remarks:

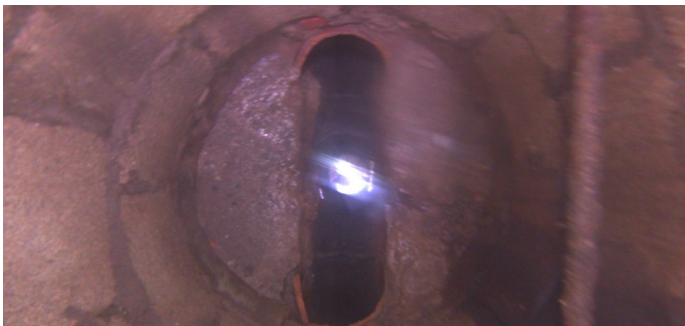
Code:	DAZ
Description:	Deposits Attached Other

Distance (ft):	5.8
Structural Grade:	0
O&M Grade:	2
Clock Start/From:	12
Clock To:	12
1st Value:	
2nd Value:	
Value Percent:	10.000
Step:	NO
Remarks:	Mixed materials

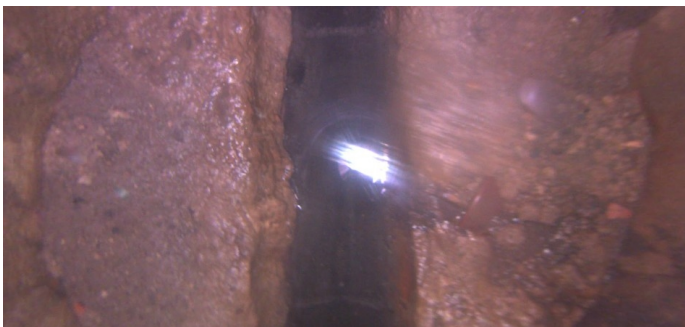
Code:	MGO
Description:	General Observation

Distance (ft):	7.1
Structural Grade:	0
O&M Grade:	0
Clock Start/From:	
Clock To:	
1st Value:	
2nd Value:	
Value Percent:	
Step:	NO
Remarks:	Ins. Comp.
