Manhole Inspection Report

Date:	04/09/2018	Weather:		Coding:	RZMACP
MH#:	M-503-018	Owner:	NA	Len. Surveyed:	5.3
P.O.#:		Surveyor:	John Kuglmaier	Rim to Invert:	6.3
Customer:		Cert. #:	U-1215-07002349	Wall Material:	Concrete (reinforced)

Street:	52' South of 39th Ave. 163' West of	Project:	Hobart, IN
City:	Hobart, IN	GPS Northing:	2901606.61
Location:		GPS Easting:	2901606.61
Drain Area:	Northwest	GPS Accuracy:	Sub-Meter
Cover Shape:	Circular	Evidence of Surcharge:	Yes
Cover Size:	23.0	Potential for Runoff:	None
Comments:

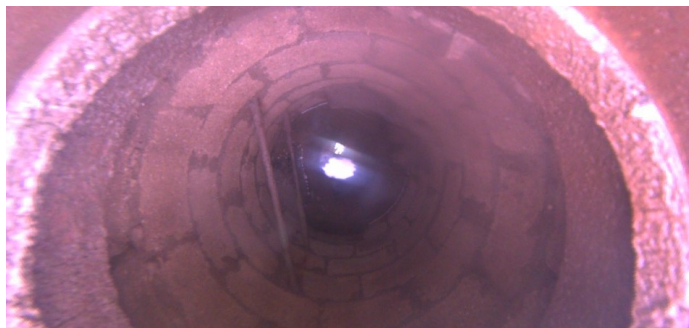
Code: **MGP**
Description: **General Photo**

Distance (ft): **.0**
Structural Grade: **0**
O&M Grade: **0**
Clock Start/From:
Clock To:
1st Value:
2nd Value:
Value Percent:
Step: **NO**
Remarks:

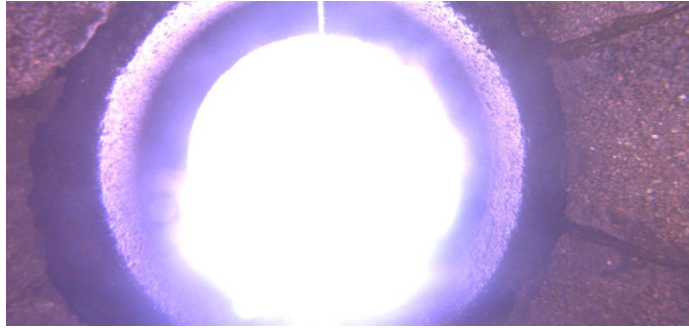
Code: **MGP**
Description: **General Photo**

Distance (ft): **2.7**
Structural Grade: **0**
O&M Grade: **0**
Clock Start/From:
Clock To:
1st Value:
2nd Value:
Value Percent:
Step: **NO**
Remarks:

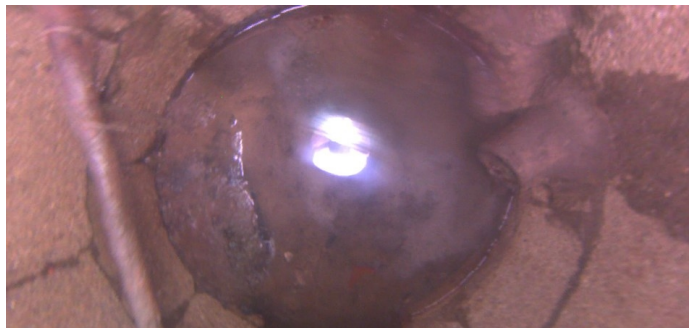
Code: **MGO**
Description: **General Observation**

Distance (ft): **3.7**
Structural Grade: **0**
O&M Grade: **0**
Clock Start/From:
Clock To:
1st Value:
2nd Value:
Value Percent:
Step: **NO**
Remarks: **Surcharge**

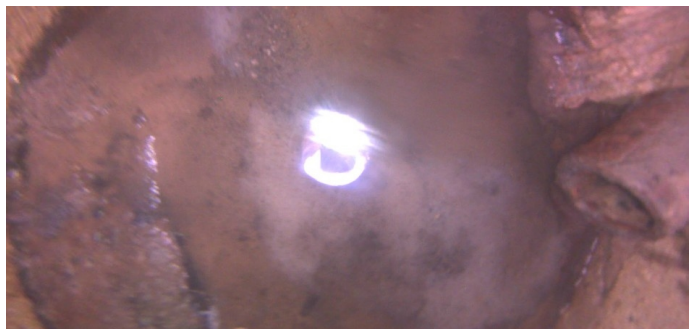
Code: **MGO**
Description: **General Observation**

Distance (ft): **4.7**
Structural Grade: **0**
O&M Grade: **0**
Clock Start/From:
Clock To:
1st Value:
2nd Value:
Value Percent:
Step: **NO**
Remarks: **Ins. Comp.**
