Manhole Inspection Report

Date:	04/09/2018	Weather:		Coding:	RZMACP
MH#:	M-503-020	Owner:	NA	Len. Surveyed:	8.9
P.O.#:		Surveyor:	John Kuglmaier	Rim to Invert:	10.0
Customer:		Cert. #:	U-1215-07002349	Wall Material:	Concrete (reinforced)

Street:	188' East of Virginia St. 165' South o	Project:	Hobart, IN
City:	Hobart, IN	GPS Northing:	2901238.56
Location:		GPS Easting:	2901238.56
Drain Area:	Northwest	GPS Accuracy:	Sub-Meter
Cover Shape:	Circular	Evidence of Surcharge:	No
Cover Size:	23.0	Potential for Runoff:	None
Comments:

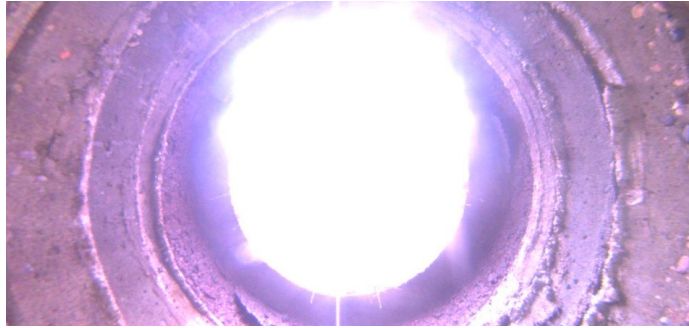
Code: **MGP**
Description: **General Photo**

Distance (ft): **2.5**
Structural Grade: **0**
O&M Grade: **0**
Clock Start/From:
Clock To:
1st Value:
2nd Value:
Value Percent:
Step: **NO**
Remarks:

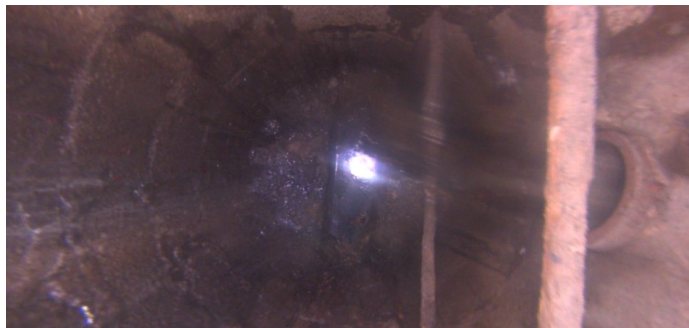
Code: **RFJ**
Description: **Roots Fine Joint**

Distance (ft): **5.4**
Structural Grade: **0**
O&M Grade: **1**
Clock Start/From: **12**
Clock To: **12**
1st Value:
2nd Value:
Value Percent:
Step: **NO**
Remarks:

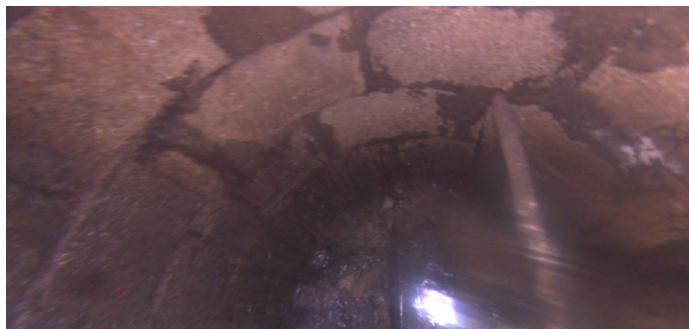
Code: **RFJ**
Description: **Roots Fine Joint**

Distance (ft): **6.0**
Structural Grade: **0**
O&M Grade: **1**
Clock Start/From: **10**
Clock To:
1st Value:
2nd Value:
Value Percent:
Step: **NO**
Remarks:

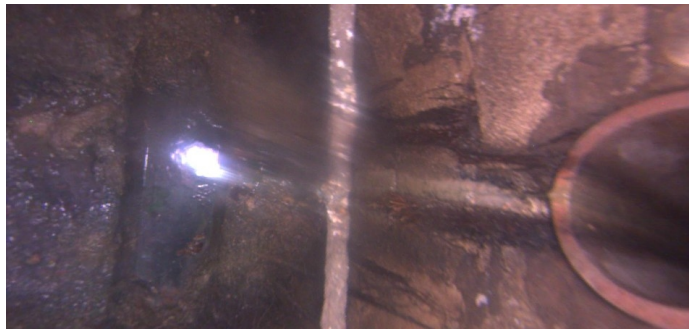
Code:	RFC
Description:	Roots Fine Connection
Distance (ft):	6.6
Structural Grade:	0
O&M Grade:	1
Clock Start/From:	3
Clock To:	
1st Value:	
2nd Value:	
Value Percent:	
Step:	NO
Remarks:

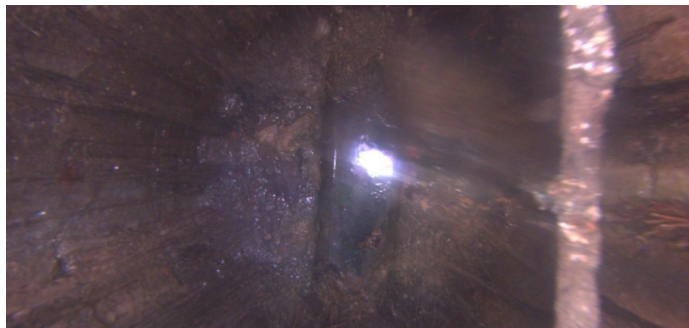
Code:	DAZ
Description:	Deposits Attached Other
Distance (ft):	6.9
Structural Grade:	0
O&M Grade:	2
Clock Start/From:	12
Clock To:	12
1st Value:	
2nd Value:	
Value Percent:	10.000
Step:	NO
Remarks:	Mixed materials

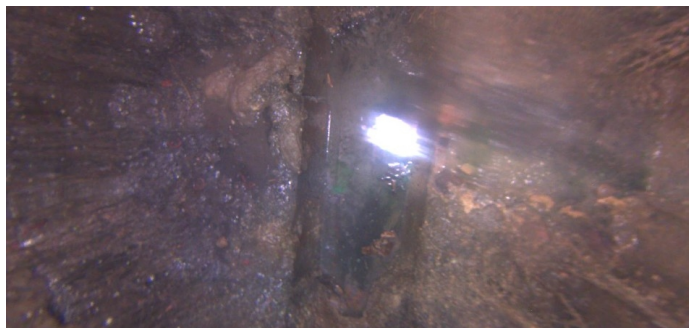
Code:	MGO
Description:	General Observation
Distance (ft):	7.9
Structural Grade:	0
O&M Grade:	0
Clock Start/From:	
Clock To:	
1st Value:	
2nd Value:	
Value Percent:	
Step:	NO
Remarks:	Ins. Comp.
