Manhole Inspection Report

Date:	04/09/2018	Weather:		Coding:	RZMACP
MH#:	M-503-022	Owner:	NA	Len. Surveyed:	7.6
P.O.#:		Surveyor:	John Kuglmaier	Rim to Invert:	8.5
Customer:		Cert. #:	U-1215-07002349	Wall Material:	Concrete (reinforced)

Street:	173' West of Virginia St. 166' South	Project:	Hobart, IN
City:	Hobart, IN	GPS Northing:	2900871.082
Location:		GPS Easting:	2900871.082
Drain Area:	Northwest	GPS Accuracy:	Sub-Meter
Cover Shape:	Circular	Evidence of Surcharge:	Yes
Cover Size:	23.0	Potential for Runoff:	None
Comments:

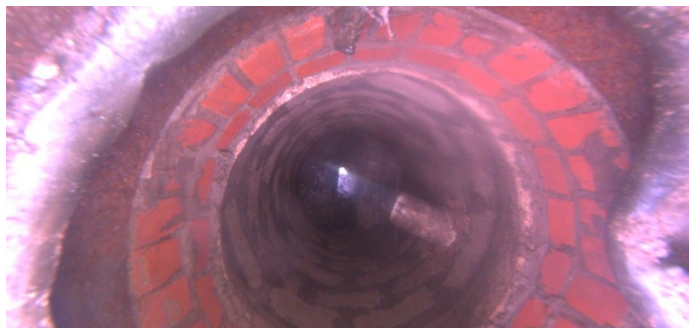
Code: **MGP**
Description: **General Photo**

Distance (ft): **.0**
Structural Grade: **0**
O&M Grade: **0**
Clock Start/From:
Clock To:
1st Value:
2nd Value:
Value Percent:
Step: **NO**
Remarks:

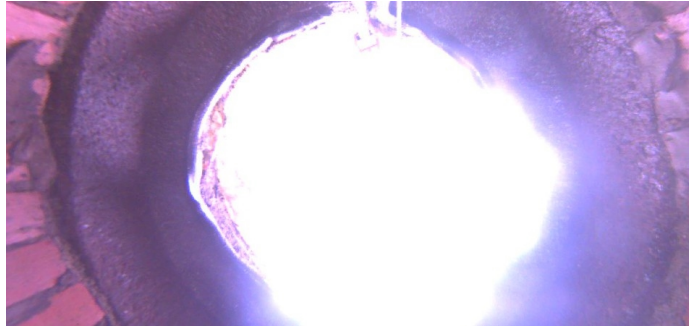
Code: **MGP**
Description: **General Photo**

Distance (ft): **1.9**
Structural Grade: **0**
O&M Grade: **0**
Clock Start/From:
Clock To:
1st Value:
2nd Value:
Value Percent:
Step: **NO**
Remarks:

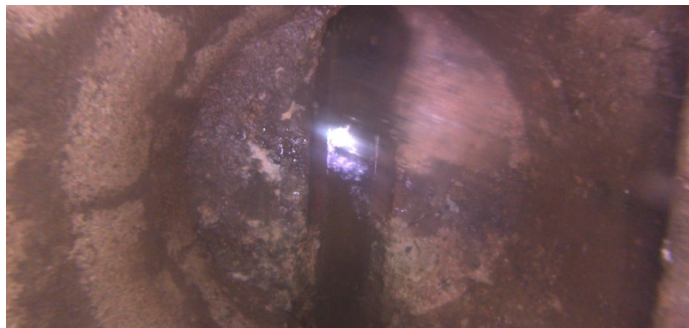
Code: **DAZ**
Description: **Deposits Attached Other**

Distance (ft): **5.5**
Structural Grade: **0**
O&M Grade: **2**
Clock Start/From: **12**
Clock To: **12**
1st Value:
2nd Value:
Value Percent: **10.000**
Step: **NO**
Remarks: **Mixed materials**

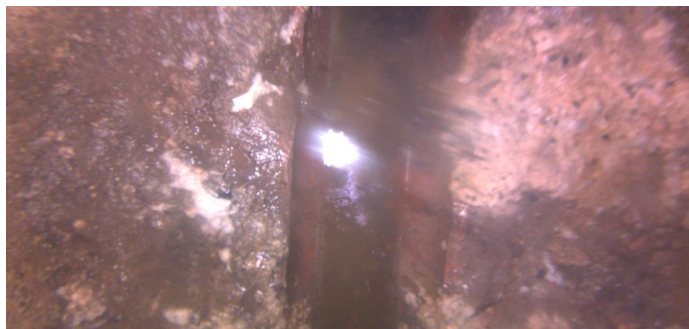
Code: **MGO**
Description: **General Observation**

Distance (ft): **6.8**
Structural Grade: **0**
O&M Grade: **0**
Clock Start/From:
Clock To:
1st Value:
2nd Value:
Value Percent:
Step: **NO**
Remarks: **Ins. Comp.**
