# Manhole Inspection Report

Date:	<b>04/10/2018</b>	Weather:		Coding:	<b>RZMACP</b>
MH#:	<b>M-503-026</b>	Owner:	<b>NA</b>	Len. Surveyed:	<b>11.0</b>
P.O.#:		Surveyor:	<b>John Kuglmaier</b>	Rim to Invert:	<b>12.6</b>
Customer:		Cert. #:	<b>U-1215-07002349</b>	Wall Material:	<b>Concrete (reinforced)</b>

Street:	<b>41st Ave. 33' West of California St.</b>	Project:	<b>Hobart, IN</b>
City:	<b>Hobart, IN</b>	GPS Northing:	<b>2901293.971</b>
Location:		GPS Easting:	<b>2901293.971</b>
Drain Area:	<b>Northwest</b>	GPS Accuracy:	<b>Sub-Meter</b>
Cover Shape:	<b>Circular</b>	Evidence of Surcharge:	<b>Yes</b>
Cover Size:	<b>23.0</b>	Potential for Runoff:	<b>None</b>
Comments:	<b>Manhole has a liner that is cured in place.</b>

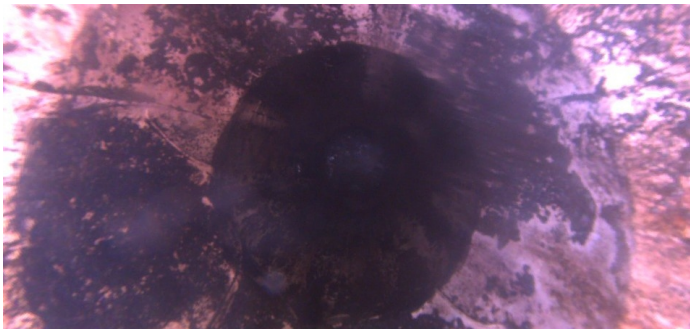
Code:

MGP

Description:

General Photo

Distance (ft):

.0

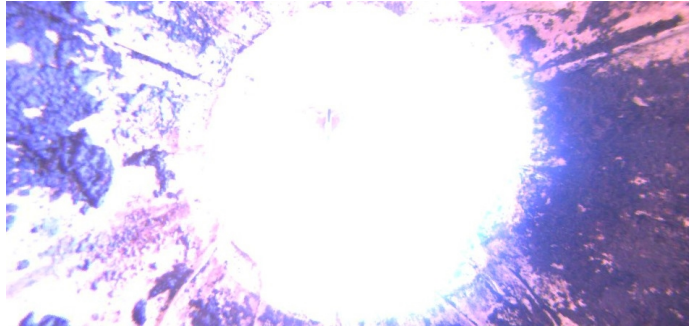
Code: **MGP**  
Description: **General Photo**

Distance (ft): **2.0**  
Structural Grade: **0**  
O&M Grade: **0**  
Clock Start/From:  
Clock To:  
1st Value:  
2nd Value:  
Value Percent:  
Step: **NO**  
Remarks:

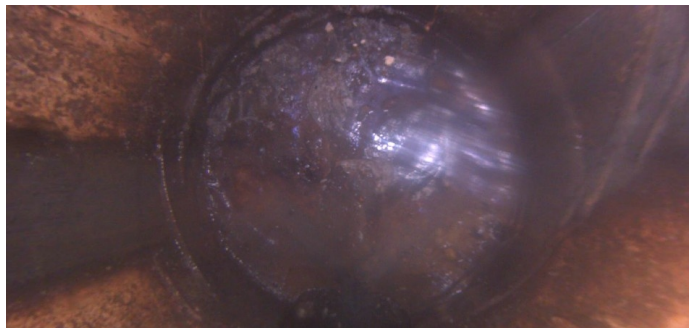
Code: **DAZ**  
Description: **Deposits Attached Other**

Distance (ft): **9.9**  
Structural Grade: **0**  
O&M Grade: **2**  
Clock Start/From: **12**  
Clock To: **12**  
1st Value:  
2nd Value:  
Value Percent: **10.000**  
Step: **NO**  
Remarks: **Mixed materials**

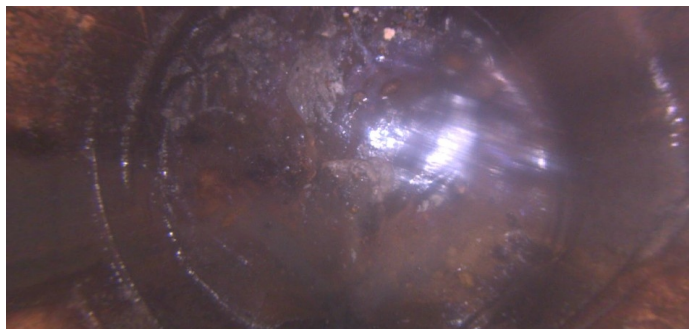
Code: **MGO**  
Description: **General Observation**

Distance (ft): **10.4**  
Structural Grade: **0**  
O&M Grade: **0**  
Clock Start/From:  
Clock To:  
1st Value:  
2nd Value:  
Value Percent:  
Step: **NO**  
Remarks: **Ins. Comp.**
