Manhole Inspection Report

Date:	04/09/2018	Weather:		Coding:	RZMACP
MH#:	M-503-027	Owner:	NA	Len. Surveyed:	6.6
P.O.#:		Surveyor:	John Kuglmaier	Rim to Invert:	7.3
Customer:		Cert. #:	U-1215-07002349	Wall Material:	Concrete (reinforced)

Street:	Intersection of 41st Ave and Virginia	Project:	Hobart, IN
City:	Hobart, IN	GPS Northing:	2900998.524
Location:		GPS Easting:	2900998.524
Drain Area:	Northwest	GPS Accuracy:	Sub-Meter
Cover Shape:	Circular	Evidence of Surcharge:	No
Cover Size:	23.0	Potential for Runoff:	None
Comments:

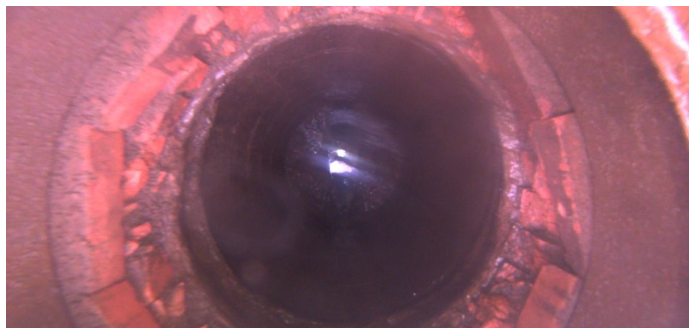
Code: **MGP**
Description: **General Photo**

Distance (ft): **.0**
Structural Grade: **0**
O&M Grade: **0**
Clock Start/From:
Clock To:
1st Value:
2nd Value:
Value Percent:
Step: **NO**
Remarks:

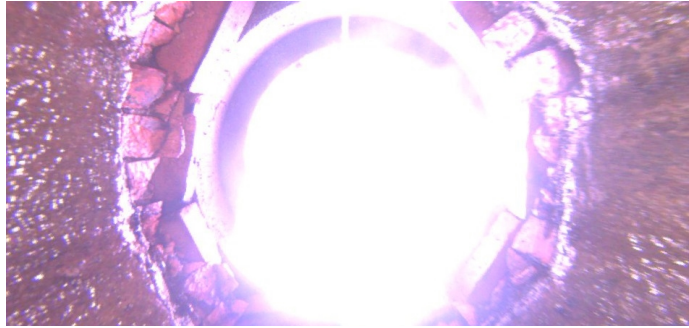
Code: **MGP**
Description: **General Photo**

Distance (ft): **2.8**
Structural Grade: **0**
O&M Grade: **0**
Clock Start/From:
Clock To:
1st Value:
2nd Value:
Value Percent:
Step: **NO**
Remarks:

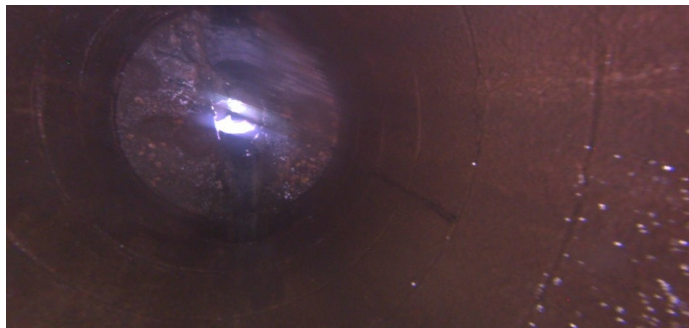
Code: **IS**
Description: **Infil Stain**

Distance (ft): **2.9**
Structural Grade: **0**
O&M Grade: **0**
Clock Start/From: **4**
Clock To:
1st Value:
2nd Value:
Value Percent:
Step: **NO**
Remarks:

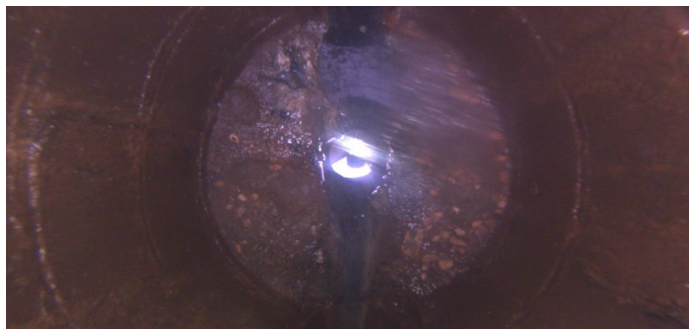
Code: **DAZ**
Description: **Deposits Attached Other**

Distance (ft): **4.5**
Structural Grade: **0**
O&M Grade: **2**
Clock Start/From: **12**
Clock To: **12**
1st Value:
2nd Value:
Value Percent: **10.000**
Step: **NO**
Remarks: **Mixed materials**

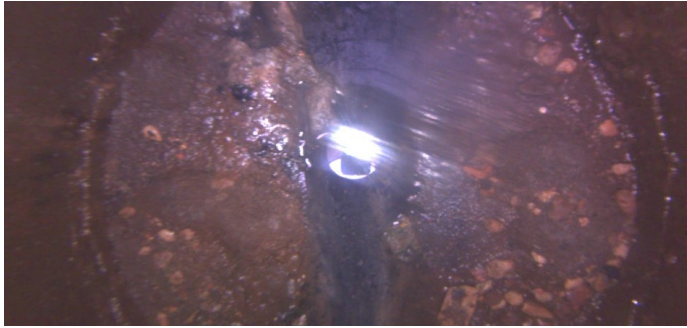
Code:	MGO
Description:	General Observation
Distance (ft):	5.7
Structural Grade:	0
O&M Grade:	0
Clock Start/From:	
Clock To:	
1st Value:	
2nd Value:	
Value Percent:	
Step:	NO
Remarks:	Ins. Comp.
