Manhole Inspection Report

Date:	04/10/2018	Weather:		Coding:	RZMACP
MH#:	M-503-031	Owner:	NA	Len. Surveyed:	4.2
P.O.#:		Surveyor:	John Kuglmaier	Rim to Invert:	5.2
Customer:		Cert. #:	U-1215-07002349	Wall Material:	Concrete (reinforced)

Street:	Intersection of 41st Ave. and Delaw	Project:	Hobart, IN
City:	Hobart, IN	GPS Northing:	2900674.741
Location:		GPS Easting:	2900674.741
Drain Area:	Northwest	GPS Accuracy:	Sub-Meter
Cover Shape:	Circular	Evidence of Surcharge:	No
Cover Size:	23.0	Potential for Runoff:	None
Comments:

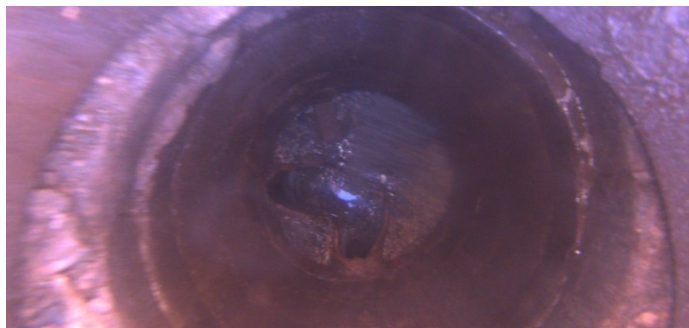
Code: **MGP**
Description: **General Photo**

Distance (ft): **.0**
Structural Grade: **0**
O&M Grade: **0**
Clock Start/From:
Clock To:
1st Value:
2nd Value:
Value Percent:
Step: **NO**
Remarks:

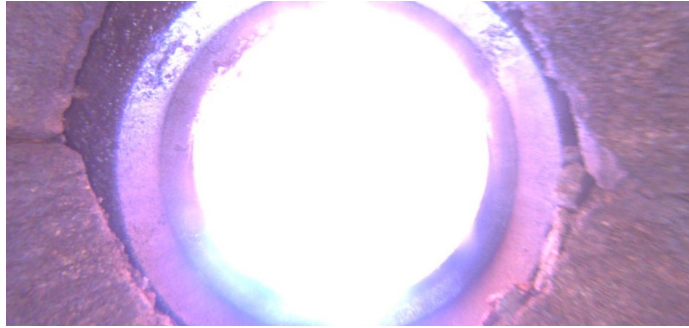
Code: **MGP**
Description: **General Photo**

Distance (ft): **2.2**
Structural Grade: **0**
O&M Grade: **0**
Clock Start/From:
Clock To:
1st Value:
2nd Value:
Value Percent:
Step: **NO**
Remarks:

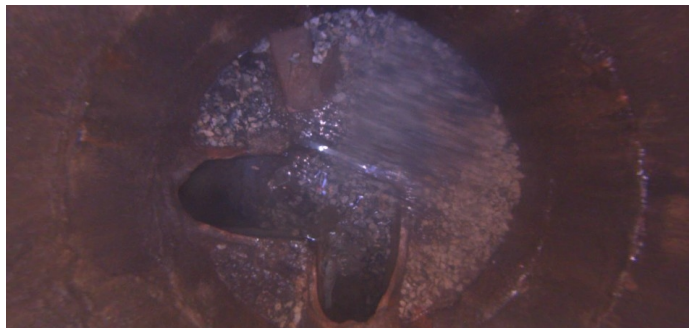
Code: **DSGV**
Description: **Deposits Settled Gravel**

Distance (ft): **2.3**
Structural Grade: **0**
O&M Grade: **2**
Clock Start/From: **12**
Clock To: **12**
1st Value:
2nd Value:
Value Percent: **10.000**
Step: **NO**
Remarks:

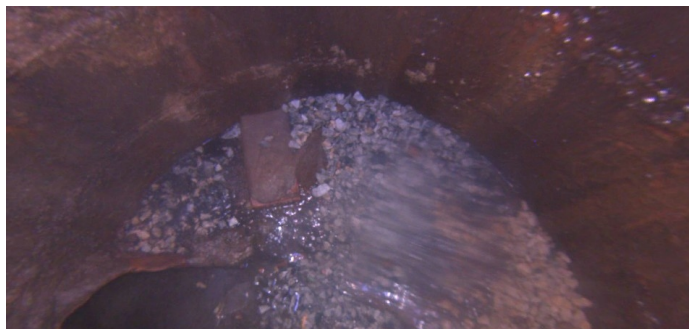
Code: **OBB**
Description: **Obstacle Brick**

Distance (ft): **3.0**
Structural Grade: **0**
O&M Grade: **2**
Clock Start/From: **11**
Clock To:
1st Value:
2nd Value:
Value Percent: **5.000**
Step: **NO**
Remarks:

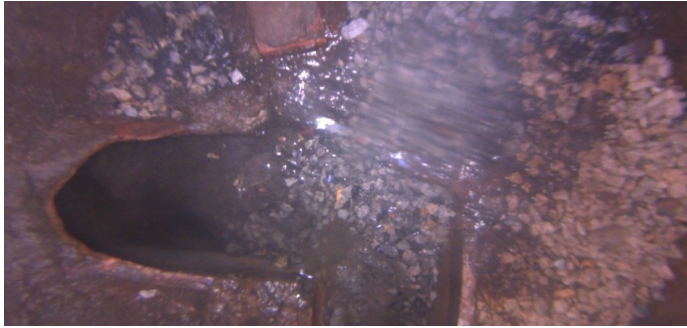
Code:	MGO
Description:	General Observation
Distance (ft):	3.5
Structural Grade:	0
O&M Grade:	0
Clock Start/From:	
Clock To:	
1st Value:	
2nd Value:	
Value Percent:	
Step:	NO
Remarks:	Ins. Comp.
