Manhole Inspection Report

Date:	04/10/2018	Weather:		Coding:	RZMACP
MH#:	M-503-033	Owner:	NA	Len. Surveyed:	3.3
P.O.#:		Surveyor:	John Kuglmaier	Rim to Invert:	4.4
Customer:		Cert. #:	U-1215-07002349	Wall Material:	Concrete (reinforced)

Street:	164' East of Colorado St. 341' South	Project:	Hobart, IN
City:	Hobart, IN	GPS Northing:	2900511.121
Location:		GPS Easting:	2900511.121
Drain Area:	Northwest	GPS Accuracy:	Sub-Meter
Cover Shape:	Circular	Evidence of Surcharge:	No
Cover Size:	23.0	Potential for Runoff:	None
Comments:

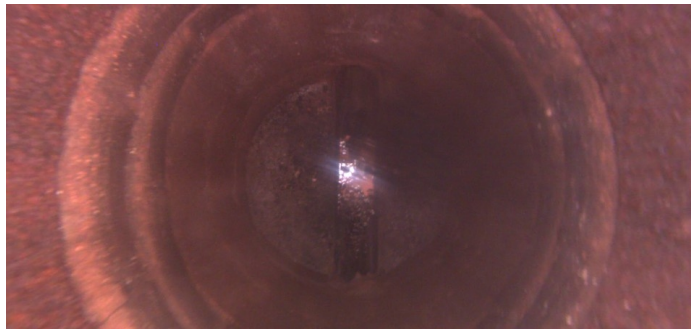
Code: **MGP**
 Description: **General Photo**

Distance (ft): **.0**
 Structural Grade: **0**
 O&M Grade: **0**
 Clock Start/From:
 Clock To:
 1st Value:
 2nd Value:
 Value Percent:
 Step: **NO**
 Remarks:

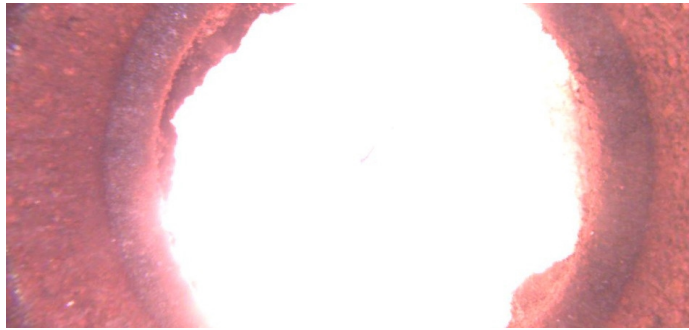
Code: **MGP**
Description: **General Photo**

Distance (ft): **1.6**
Structural Grade: **0**
O&M Grade: **0**
Clock Start/From:
Clock To:
1st Value:
2nd Value:
Value Percent:
Step: **NO**
Remarks:

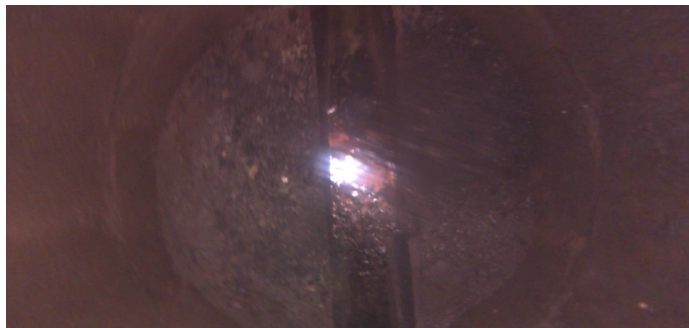
Code: **DSGV**
Description: **Deposits Settled Gravel**

Distance (ft): **1.9**
Structural Grade: **0**
O&M Grade: **2**
Clock Start/From: **12**
Clock To: **12**
1st Value:
2nd Value:
Value Percent: **10.000**
Step: **NO**
Remarks:

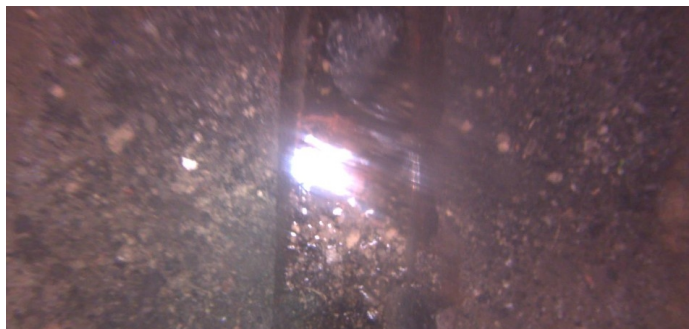
Code: **MGO**
Description: **General Observation**

Distance (ft): **3.0**
Structural Grade: **0**
O&M Grade: **0**
Clock Start/From:
Clock To:
1st Value:
2nd Value:
Value Percent:
Step: **NO**
Remarks: **Ins. Comp.**
