# Manhole Inspection Report

Date:	10/09/2022	Weather:		Coding:	RZMACP
MH#:	M-503-034	Owner:	NA	Len. Surveyed:	2.2
P.O.#:		Surveyor:	Jen Costello	Rim to Invert:	2.6
Customer:		Cert. #:	U-907-5518	Wall Material:	Brick

Street:	163' East of Colorado St. 41' South o	Project:	Hobart, IN
City:	Hobart, IN	GPS Northing:	2293782.709
Location:	Other	GPS Easting:	2900510.35
Drain Area:	Northwest	GPS Accuracy:	Sub-Meter
Cover Shape:	Circular	Evidence of Surcharge:	Yes
Cover Size:	24.0	Potential for Runoff:	None
Comments:

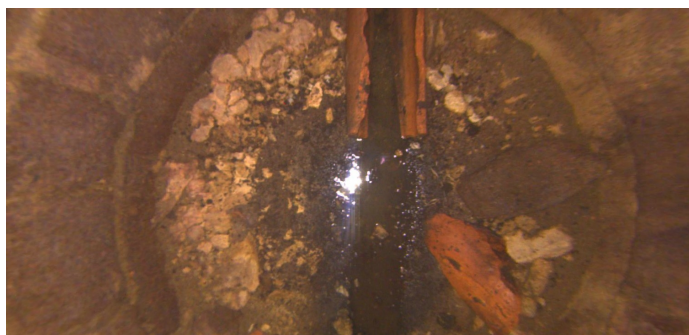
Code: **MGO**  
Description: **General Observation**

Distance (ft): **.0**  
Structural Grade: **0**  
O&M Grade: **0**  
Clock Start/From:  
Clock To:  
1st Value:  
2nd Value:  
Value Percent:  
Step: **NO**  
Remarks: **access mh**

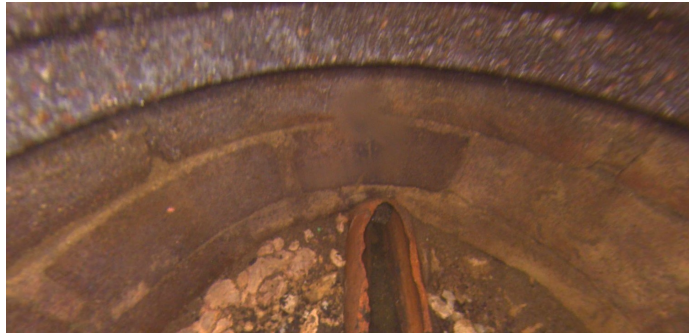
Code: **SRI**  
Description: **Surface Roughness Increased**

Distance (ft): **.0**  
Structural Grade: **1**  
O&M Grade: **0**  
Clock Start/From: **12**  
Clock To: **12**  
1st Value:  
2nd Value:  
Value Percent:  
Step: **NO**  
Remarks:

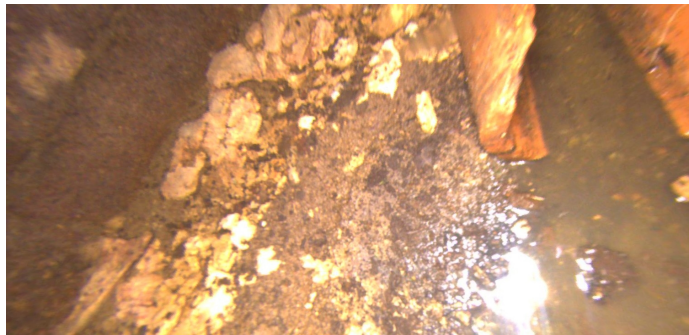
Code: **DSC**  
Description: **Deposits Settled Compacted**

Distance (ft): **1.6**  
Structural Grade: **0**  
O&M Grade: **2**  
Clock Start/From: **12**  
Clock To: **12**  
1st Value:  
2nd Value:  
Value Percent: **5.000**  
Step: **NO**  
Remarks:

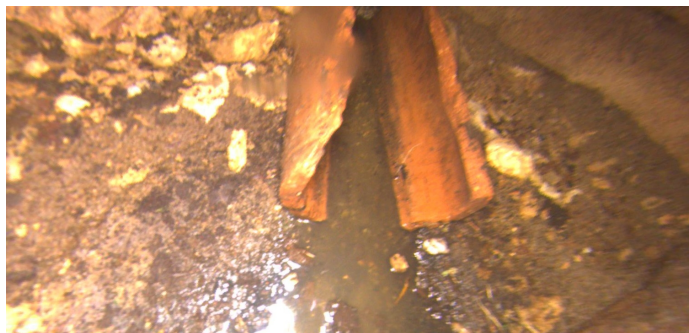
Code: **SAV**  
Description: **Surface Aggregate Visible**

Distance (ft): **1.6**  
Structural Grade: **3**  
O&M Grade: **0**  
Clock Start/From: **12**  
Clock To: **12**  
1st Value:  
2nd Value:  
Value Percent:  
Step: **NO**  
Remarks:

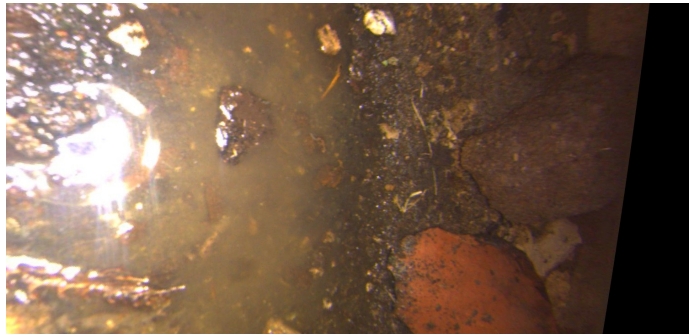
Code: **OBM**  
Description: **Obstacle Pipe Material**

Distance (ft): **1.8**  
Structural Grade: **0**  
O&M Grade: **2**  
Clock Start/From: **3**  
Clock To: **5**  
1st Value:  
2nd Value:  
Value Percent: **10.000**  
Step: **NO**  
Remarks:

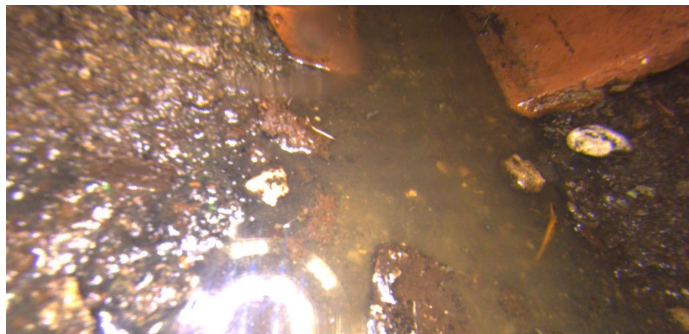
Code: **MGO**  
Description: **General Observation**

Distance (ft): **2.2**  
Structural Grade: **0**  
O&M Grade: **0**  
Clock Start/From:  
Clock To:  
1st Value:  
2nd Value:  
Value Percent:  
Step: **NO**  
Remarks: **end of survey**

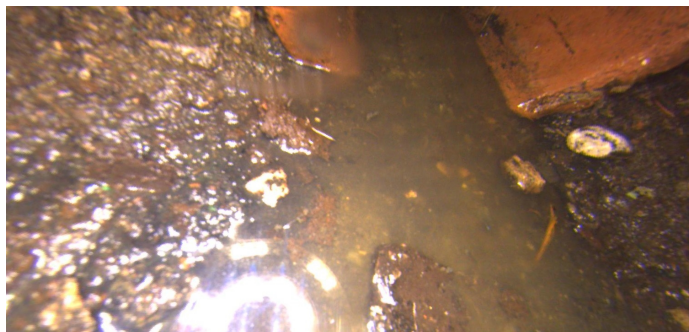
Code: **SRI**  
Description: **Surface Roughness Increased**

Distance (ft): **2.2**  
Structural Grade: **1**  
O&M Grade: **0**  
Clock Start/From: **12**  
Clock To: **12**  
1st Value:  
2nd Value:  
Value Percent:  
Step: **NO**  
Remarks:
