Manhole Inspection Report

Date:	04/10/2018	Weather:		Coding:	RZMACP
MH#:	M-503-035	Owner:	NA	Len. Surveyed:	1.9
P.O.#:		Surveyor:	John Kuglmaier	Rim to Invert:	2.7
Customer:		Cert. #:	U-1215-07002349	Wall Material:	Concrete (reinforced)

Street:	164' East of Cavender St. 271' North	Project:	Hobart, IN
City:	Hobart, IN	GPS Northing:	0.0
Location:		GPS Easting:	0.0
Drain Area:	Northwest	GPS Accuracy:	Nearest Meter
Cover Shape:	Circular	Evidence of Surcharge:	No
Cover Size:	23.0	Potential for Runoff:	None
Comments:

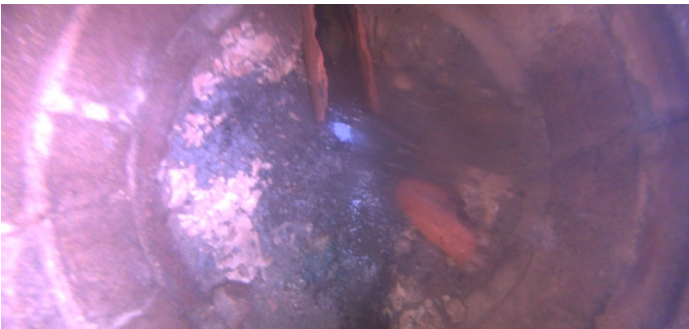
Code: **MGP**
 Description: **General Photo**

Distance (ft): **.0**
 Structural Grade: **0**
 O&M Grade: **0**
 Clock Start/From:
 Clock To:
 1st Value:
 2nd Value:
 Value Percent:
 Step: **NO**
 Remarks:

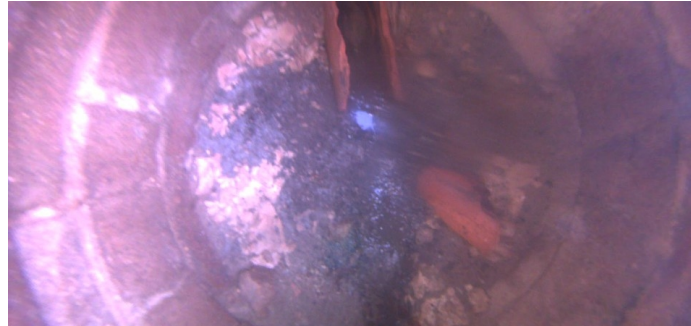
Code:	DAZ
Description:	Deposits Attached Other
Distance (ft):	.0
Structural Grade:	0
O&M Grade:	2
Clock Start/From:	12
Clock To:	12
1st Value:	
2nd Value:	
Value Percent:	5.000
Step:	NO
Remarks:	Mixed materials

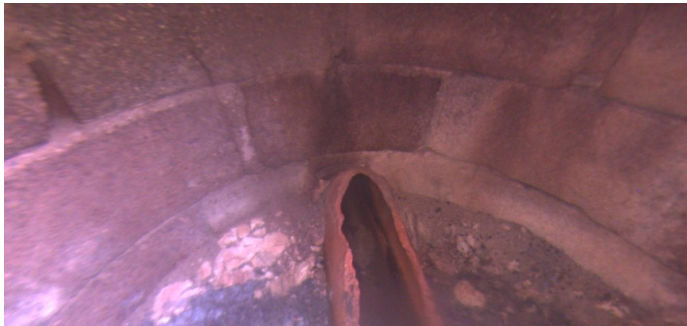
Code:	IS
Description:	Infil Stain
Distance (ft):	1.0
Structural Grade:	0
O&M Grade:	0
Clock Start/From:	12
Clock To:	
1st Value:	
2nd Value:	
Value Percent:	
Step:	NO
Remarks:

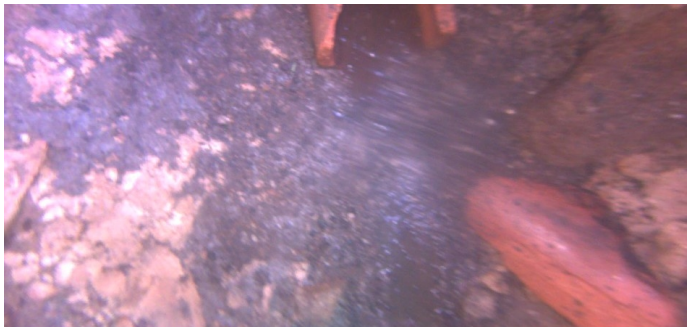
Code:	MGO
Description:	General Observation
Distance (ft):	1.5
Structural Grade:	0
O&M Grade:	0
Clock Start/From:	
Clock To:	
1st Value:	
2nd Value:	
Value Percent:	
Step:	NO
Remarks:	Ins. Comp.
