# Manhole Inspection Report

Date:	10/09/2022	Weather:		Coding:	RZMACP
MH#:	M-503-036	Owner:	NA	Len. Surveyed:	9.0
P.O.#:		Surveyor:	Jen Costello	Rim to Invert:	10.0
Customer:		Cert. #:	U-907-5518	Wall Material:	Concrete (cast in place)

Street:	161' East of Cavender St. 208' South	Project:	Hobart, IN
City:	Hobart, IN	GPS Northing:	2293623.22
Location:	Other	GPS Easting:	2900194.744
Drain Area:	Northwest	GPS Accuracy:	Sub-Meter
Cover Shape:	Circular	Evidence of Surcharge:	Yes
Cover Size:	24.0	Potential for Runoff:	None
Comments:

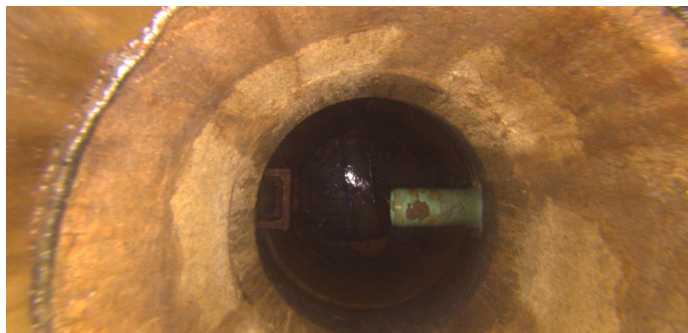
Code: **MGO**  
Description: **General Observation**

Distance (ft): **.0**  
Structural Grade: **0**  
O&M Grade: **0**  
Clock Start/From:  
Clock To:  
1st Value:  
2nd Value:  
Value Percent:  
Step: **NO**  
Remarks: **access mh**

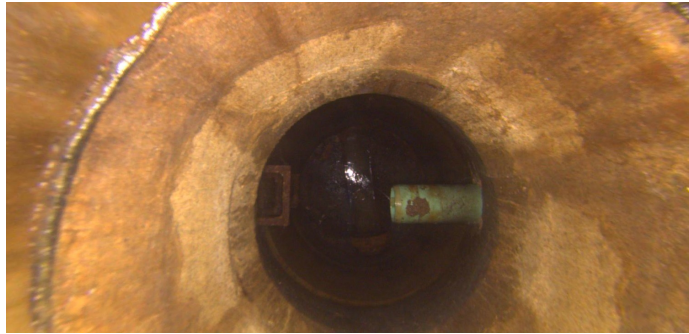
Code: **SRI**  
Description: **Surface Roughness Increased**

Distance (ft): **.0**  
Structural Grade: **1**  
O&M Grade: **0**  
Clock Start/From: **12**  
Clock To: **12**  
1st Value:  
2nd Value:  
Value Percent:  
Step: **NO**  
Remarks:

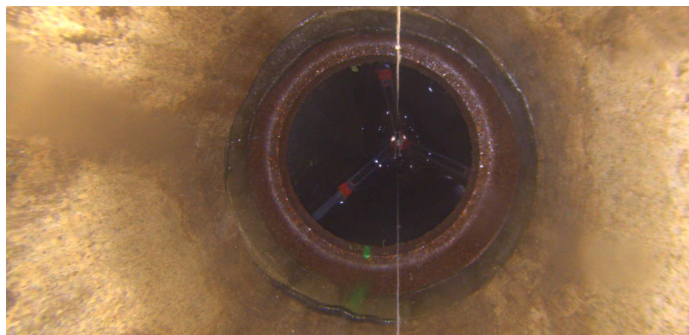
Code: **MGO**  
Description: **General Observation**

Distance (ft): **2.8**  
Structural Grade: **0**  
O&M Grade: **0**  
Clock Start/From:  
Clock To:  
1st Value:  
2nd Value:  
Value Percent:  
Step: **NO**  
Remarks: **underside of frame**

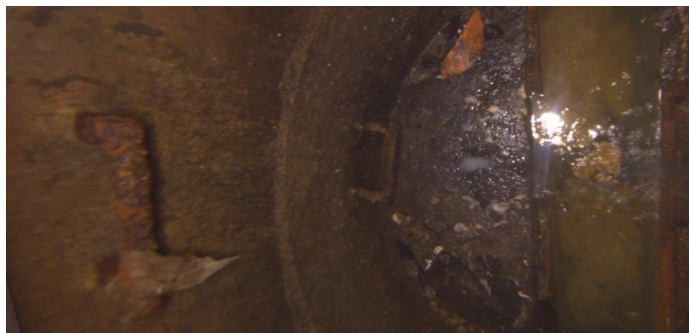
Code: **DAR**  
Description: **Deposits Attached Ragging**

Distance (ft): **6.3**  
Structural Grade: **0**  
O&M Grade: **2**  
Clock Start/From: **9**  
Clock To:  
1st Value:  
2nd Value:  
Value Percent: **5.000**  
Step: **YES**  
Remarks:

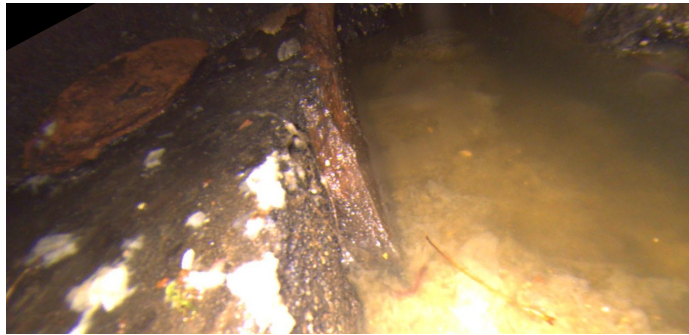
Code: **OBM**  
Description: **Obstacle Pipe Material**

Distance (ft): **9.0**  
Structural Grade: **0**  
O&M Grade: **2**  
Clock Start/From: **10**  
Clock To:  
1st Value:  
2nd Value:  
Value Percent: **5.000**  
Step: **NO**  
Remarks:

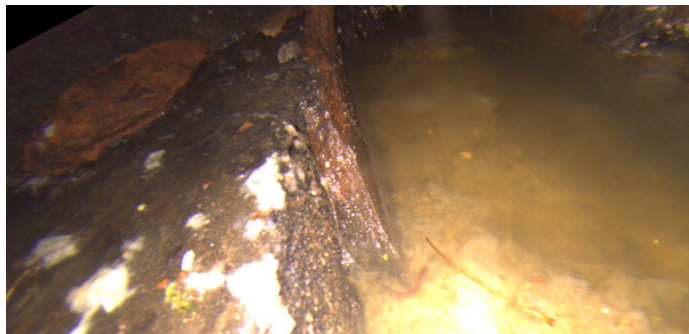
Code: **B**  
Description: **Broken**

Distance (ft): **9.0**  
Structural Grade: **5**  
O&M Grade: **0**  
Clock Start/From: **7**  
Clock To: **9**  
1st Value:  
2nd Value:  
Value Percent:  
Step: **NO**  
Remarks:

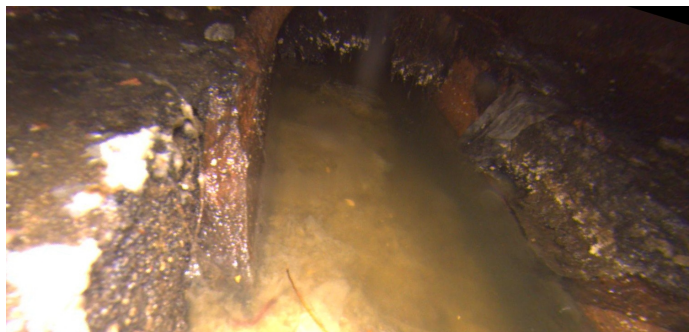
Code: **SRI**  
Description: **Surface Roughness Increased**

Distance (ft): **9.0**  
Structural Grade: **1**  
O&M Grade: **0**  
Clock Start/From: **12**  
Clock To: **12**  
1st Value:  
2nd Value:  
Value Percent:  
Step: **NO**  
Remarks:

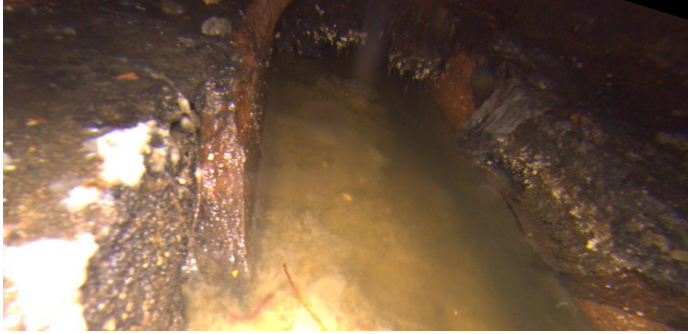
Code:	<b>MGO</b>
Description:	<b>General Observation</b>
Distance (ft):	<b>9.0</b>
Structural Grade:	<b>0</b>
O&M Grade:	<b>0</b>
Clock Start/From:	
Clock To:	
1st Value:	
2nd Value:	
Value Percent:	
Step:	<b>NO</b>
Remarks:	<b>end of survey</b>
