Manhole Inspection Report

Date:	04/11/2018	Weather:		Coding:	RZMACP
MH#:	M-503-041	Owner:	NA	Len. Surveyed:	8.3
P.O.#:		Surveyor:	John Kuglmaier	Rim to Invert:	9.9
Customer:		Cert. #:	U-1215-07002349	Wall Material:	Concrete (reinforced)

Street:	Pennsylvania St. 155' West of Caven	Project:	Hobart, IN
City:	Hobart, IN	GPS Northing:	2899861.901
Location:		GPS Easting:	2899861.901
Drain Area:	Northwest	GPS Accuracy:	Sub-Meter
Cover Shape:	Circular	Evidence of Surcharge:	Yes
Cover Size:	23.0	Potential for Runoff:	None
Comments:

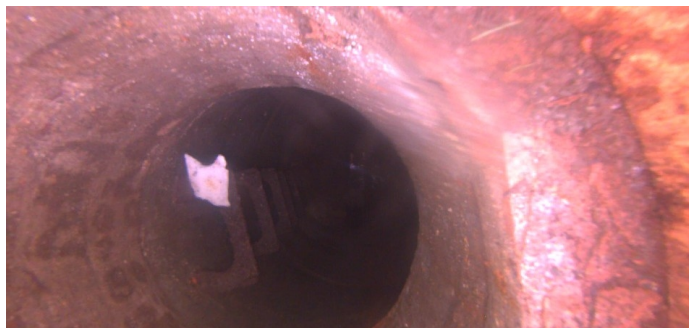
Code: **MGP**
Description: **General Photo**

Distance (ft): **.0**
Structural Grade: **0**
O&M Grade: **0**
Clock Start/From:
Clock To:
1st Value:
2nd Value:
Value Percent:
Step: **NO**
Remarks:

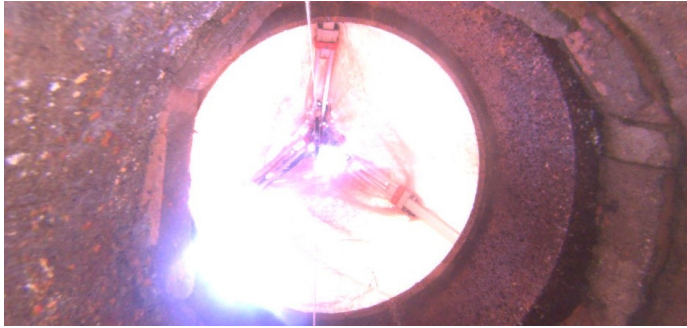
Code: **MGP**
Description: **General Photo**

Distance (ft): **1.8**
Structural Grade: **0**
O&M Grade: **0**
Clock Start/From:
Clock To:
1st Value:
2nd Value:
Value Percent:
Step: **NO**
Remarks:

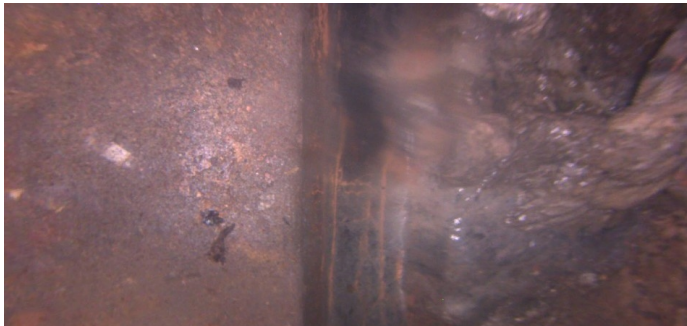
Code: **MGO**
Description: **General Observation**

Distance (ft): **8.0**
Structural Grade: **0**
O&M Grade: **0**
Clock Start/From:
Clock To:
1st Value:
2nd Value:
Value Percent:
Step: **NO**
Remarks: **Ins. Comp.**
