Manhole Inspection Report

Date:	04/10/2018	Weather:		Coding:	RZMACP
MH#:	M-503-042	Owner:	NA	Len. Surveyed:	7.5
P.O.#:		Surveyor:	John Kuglmaier	Rim to Invert:	10.0
Customer:		Cert. #:	U-1215-07002349	Wall Material:	Concrete (reinforced)

Street:	162' East of Guyer St. 160' North of	Project:	Hobart, IN
City:	Hobart, IN	GPS Northing:	2899853.65
Location:		GPS Easting:	2899853.65
Drain Area:	Northwest	GPS Accuracy:	Sub-Meter
Cover Shape:	Circular	Evidence of Surcharge:	Yes
Cover Size:	23.0	Potential for Runoff:	None
Comments:

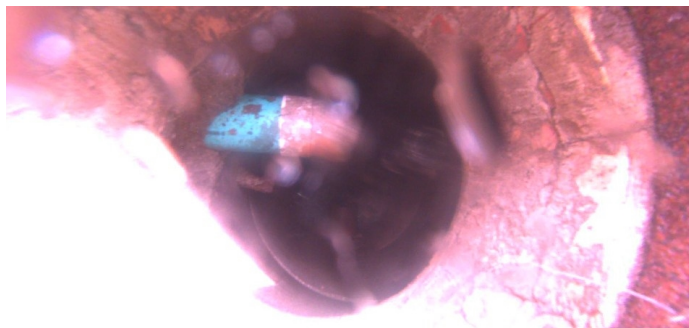
Code: **MGP**
Description: **General Photo**

Distance (ft): **.0**
Structural Grade: **0**
O&M Grade: **0**
Clock Start/From:
Clock To:
1st Value:
2nd Value:
Value Percent:
Step: **NO**
Remarks:

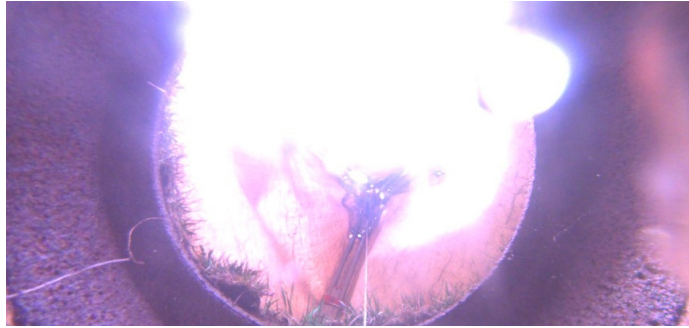
Code: **MGP**
Description: **General Photo**

Distance (ft): **1.7**
Structural Grade: **0**
O&M Grade: **0**
Clock Start/From:
Clock To:
1st Value:
2nd Value:
Value Percent:
Step: **NO**
Remarks:

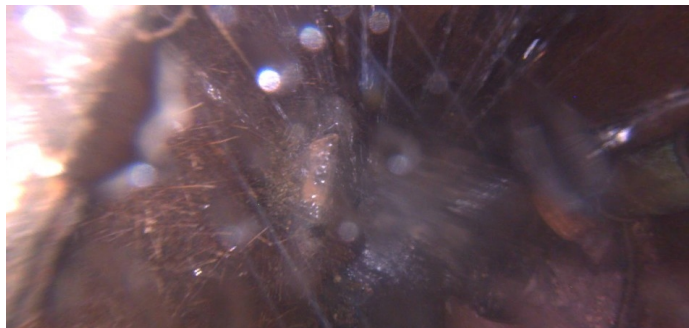
Code: **RMJ**
Description: **Roots Medium Joint**

Distance (ft): **6.1**
Structural Grade: **0**
O&M Grade: **3**
Clock Start/From: **8**
Clock To: **11**
1st Value:
2nd Value:
Value Percent: **35.000**
Step: **NO**
Remarks:

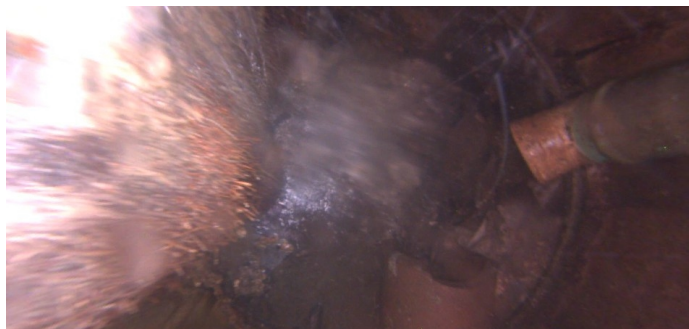
Code: **MGO**
Description: **General Observation**

Distance (ft): **7.2**
Structural Grade: **0**
O&M Grade: **0**
Clock Start/From:
Clock To:
1st Value:
2nd Value:
Value Percent:
Step: **NO**
Remarks: **Ins. Comp.**
