Manhole Inspection Report

Date:	04/09/2018	Weather:		Coding:	RZMACP
MH#:	M-503-046	Owner:	NA	Len. Surveyed:	6.5
P.O.#:		Surveyor:	John Kuglmaier	Rim to Invert:	8.0
Customer:		Cert. #:	U-1215-07002349	Wall Material:	Concrete (reinforced)

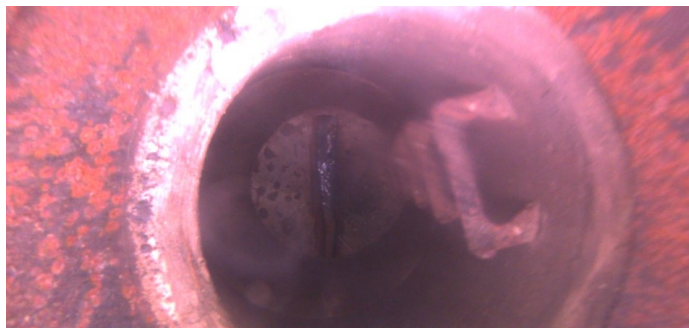
Code: **MGP**
Description: **General Photo**

Distance (ft): **.0**
Structural Grade: **0**
O&M Grade: **0**
Clock Start/From:
Clock To:
1st Value:
2nd Value:
Value Percent:
Step: **NO**
Remarks:

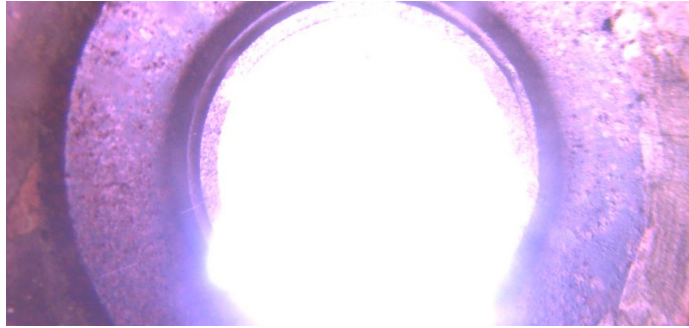
Code:	MGP
Description:	General Photo
Distance (ft):	2.0
Structural Grade:	0
O&M Grade:	0
Clock Start/From:	
Clock To:	
1st Value:	
2nd Value:	
Value Percent:	
Step:	NO
Remarks:

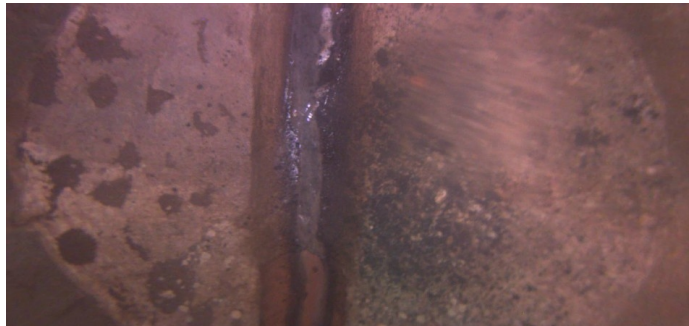
Code:	MGO
Description:	General Observation
Distance (ft):	5.5
Structural Grade:	0
O&M Grade:	0
Clock Start/From:	
Clock To:	
1st Value:	
2nd Value:	
Value Percent:	
Step:	NO
Remarks:	Ins. Comp.
