# Manhole Inspection Report

Date:	04/09/2018	Weather:		Coding:	RZMACP
MH#:	M-503-047	Owner:	NA	Len. Surveyed:	5.7
P.O.#:		Surveyor:	John Kuglmaier	Rim to Invert:	7.0
Customer:		Cert. #:	U-1215-07002349	Wall Material:	Concrete (reinforced)

Street:	65' East of Virginia St. 170' South of	Project:	Hobart, IN
City:	Hobart, IN	GPS Northing:	0.0
Location:		GPS Easting:	0.0
Drain Area:	Northwest	GPS Accuracy:	Nearest Meter
Cover Shape:	Circular	Evidence of Surcharge:	No
Cover Size:	23.0	Potential for Runoff:	None
Comments:

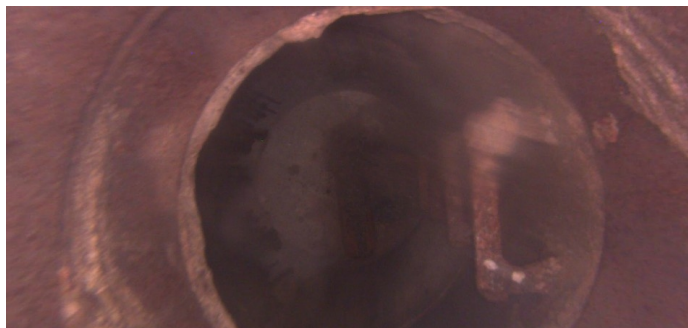
Code: **MGP**  
Description: **General Photo**

Distance (ft): **.0**  
Structural Grade: **0**  
O&M Grade: **0**  
Clock Start/From:  
Clock To:  
1st Value:  
2nd Value:  
Value Percent:  
Step: **NO**  
Remarks:

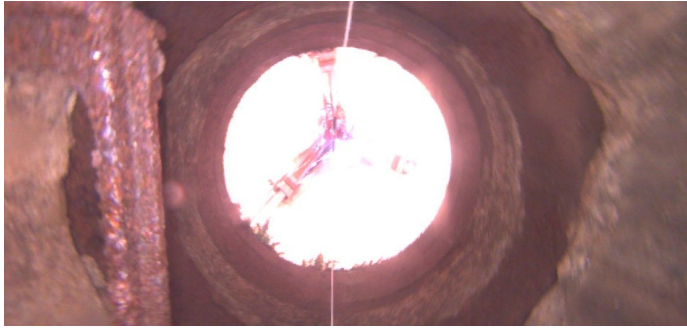
Code: **MGP**  
Description: **General Photo**

Distance (ft): **2.5**  
Structural Grade: **0**  
O&M Grade: **0**  
Clock Start/From:  
Clock To:  
1st Value:  
2nd Value:  
Value Percent:  
Step: **NO**  
Remarks:

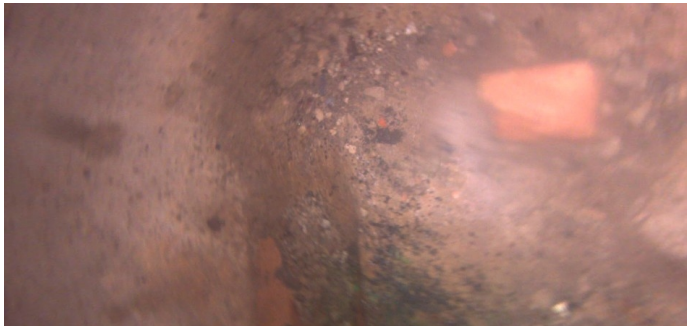
Code: **MGO**  
Description: **General Observation**

Distance (ft): **5.0**  
Structural Grade: **0**  
O&M Grade: **0**  
Clock Start/From:  
Clock To:  
1st Value:  
2nd Value:  
Value Percent:  
Step: **NO**  
Remarks: **Ins. Comp.**
