Manhole Inspection Report

Date:	04/09/2018	Weather:		Coding:	RZMACP
MH#:	M-503-047	Owner:	NA	Len. Surveyed:	6.7
P.O.#:		Surveyor:	John Kuglmaier	Rim to Invert:	8.0
Customer:		Cert. #:	U-1215-07002349	Wall Material:	Concrete (reinforced)

Street:	65' East of Virginia St. 170' South of	Project:	Hobart, IN
City:	Hobart, IN	GPS Northing:	0.0
Location:		GPS Easting:	0.0
Drain Area:	Northwest	GPS Accuracy:	Nearest Meter
Cover Shape:	Circular	Evidence of Surcharge:	No
Cover Size:	23.0	Potential for Runoff:	None
Comments:

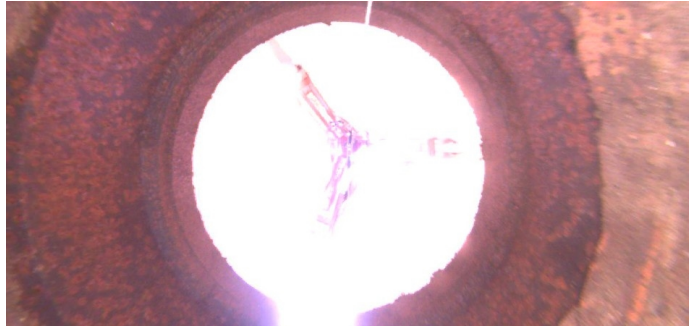
Code: **MGP**
Description: **General Photo**

Distance (ft): **2.0**
Structural Grade: **0**
O&M Grade: **0**
Clock Start/From:
Clock To:
1st Value:
2nd Value:
Value Percent:
Step: **NO**
Remarks:

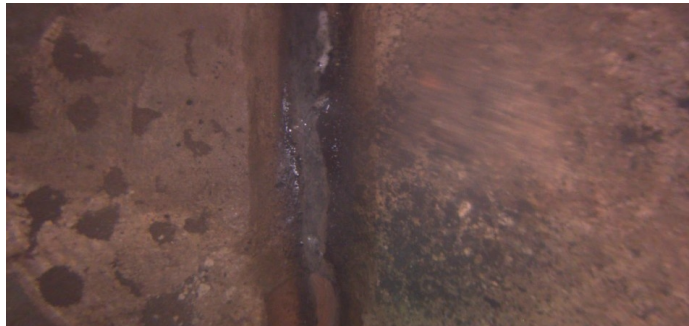
Code: **MGO**
Description: **General Observation**

Distance (ft): **5.7**
Structural Grade: **0**
O&M Grade: **0**
Clock Start/From:
Clock To:
1st Value:
2nd Value:
Value Percent:
Step: **NO**
Remarks: **Ins. Comp.**
