Manhole Inspection Report

Date:	04/08/2018	Weather:		Coding:	RZMACP
MH#:	M-503-054	Owner:	NA	Len. Surveyed:	9.9
P.O.#:		Surveyor:	John Kuglmaier	Rim to Invert:	11.7
Customer:		Cert. #:	U-1215-07002349	Wall Material:	Concrete (reinforced)

Street:	Guyer St. 165' North of 38th PL.	Project:	Hobart, IN
City:	Hobart, IN	GPS Northing:	2899689.585
Location:		GPS Easting:	2899689.585
Drain Area:	Northwest	GPS Accuracy:	Sub-Meter
Cover Shape:	Circular	Evidence of Surcharge:	Yes
Cover Size:	23.0	Potential for Runoff:	None
Comments:

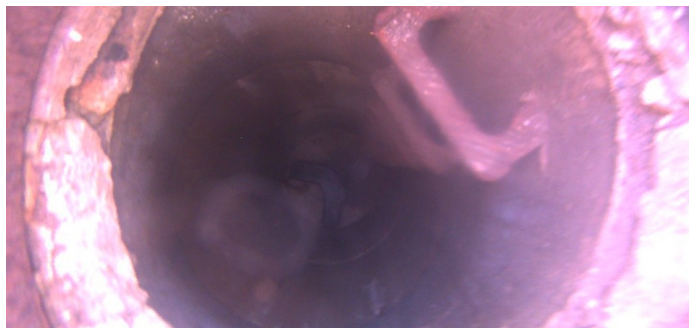
Code: **MGP**
Description: **General Photo**

Distance (ft): **.0**
Structural Grade: **0**
O&M Grade: **0**
Clock Start/From:
Clock To:
1st Value:
2nd Value:
Value Percent:
Step: **NO**
Remarks:

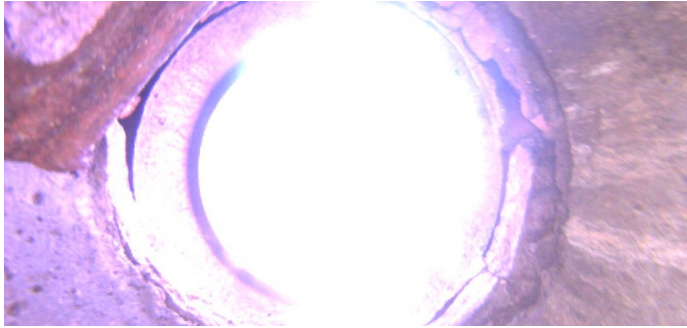
Code: **MGP**
Description: **General Photo**

Distance (ft): **2.2**
Structural Grade: **0**
O&M Grade: **0**
Clock Start/From:
Clock To:
1st Value:
2nd Value:
Value Percent:
Step: **NO**
Remarks:

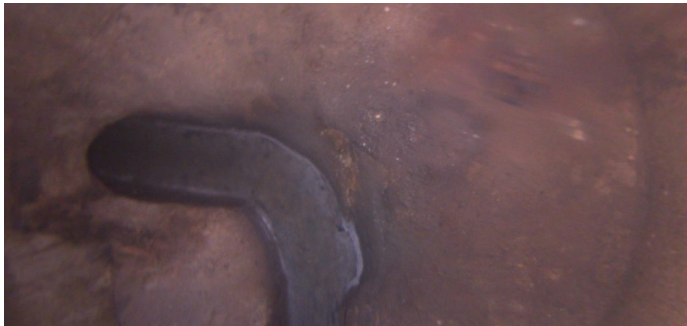
Code: **MGO**
Description: **General Observation**

Distance (ft): **9.3**
Structural Grade: **0**
O&M Grade: **0**
Clock Start/From:
Clock To:
1st Value:
2nd Value:
Value Percent:
Step: **NO**
Remarks: **Ins. Comp.**
