# Manhole Inspection Report

Date:	<b>04/08/2018</b>	Weather:		Coding:	<b>RZMACP</b>
MH#:	<b>M-503-056</b>	Owner:	<b>NA</b>	Len. Surveyed:	<b>10.5</b>
P.O.#:		Surveyor:	<b>John Kuglmaier</b>	Rim to Invert:	<b>12.4</b>
Customer:		Cert. #:	<b>U-1215-07002349</b>	Wall Material:	<b>Concrete (reinforced)</b>

Street:	<b>233' West of Colorado St.</b>	Project:	<b>Hobart, IN</b>
City:	<b>Hobart, IN</b>	GPS Northing:	<b>2900215.14</b>
Location:		GPS Easting:	<b>2900215.14</b>
Drain Area:	<b>Northwest</b>	GPS Accuracy:	<b>Sub-Meter</b>
Cover Shape:	<b>Circular</b>	Evidence of Surcharge:	<b>No</b>
Cover Size:	<b>23.0</b>	Potential for Runoff:	<b>None</b>
Comments:

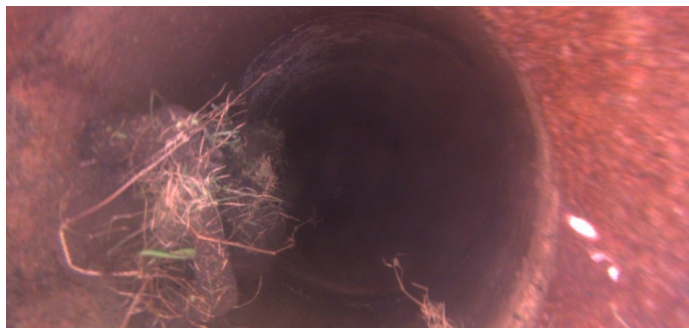
Code: **MGP**  
 Description: **General Photo**

Distance (ft): **.0**  
 Structural Grade: **0**  
 O&M Grade: **0**  
 Clock Start/From:  
 Clock To:  
 1st Value:  
 2nd Value:  
 Value Percent:  
 Step: **NO**  
 Remarks:

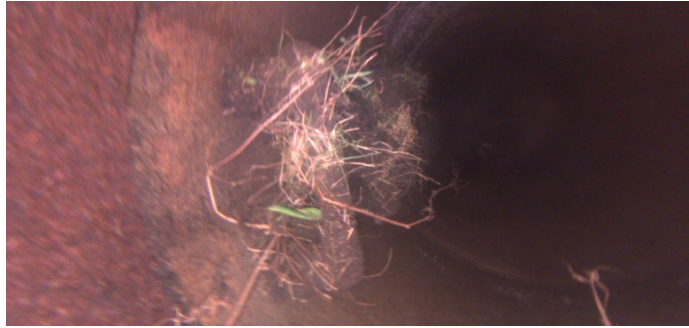
Code:	<b>DAZ</b>
Description:	<b>Deposits Attached Other</b>
Distance (ft):	<b>.5</b>
Structural Grade:	<b>0</b>
O&M Grade:	<b>2</b>
Clock Start/From:	<b>7</b>
Clock To:	<b>9</b>
1st Value:	
2nd Value:	
Value Percent:	<b>5.000</b>
Step:	<b>YES</b>
Remarks:	<b>Mixed materials</b>

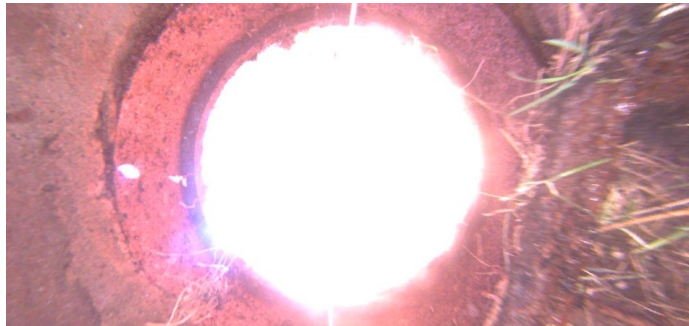
Code:	<b>MGP</b>
Description:	<b>General Photo</b>
Distance (ft):	<b>2.3</b>
Structural Grade:	<b>0</b>
O&M Grade:	<b>0</b>
Clock Start/From:	
Clock To:	
1st Value:	
2nd Value:	
Value Percent:	
Step:	<b>NO</b>
Remarks:

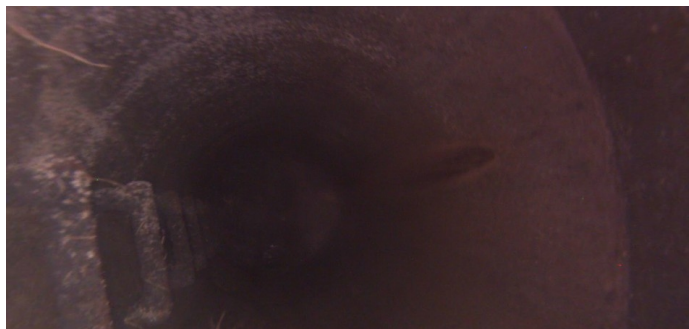
Code:	<b>IS</b>
Description:	<b>Infil Stain</b>
Distance (ft):	<b>2.9</b>
Structural Grade:	<b>0</b>
O&M Grade:	<b>0</b>
Clock Start/From:	<b>3</b>
Clock To:	
1st Value:	
2nd Value:	
Value Percent:	
Step:	<b>NO</b>
Remarks:

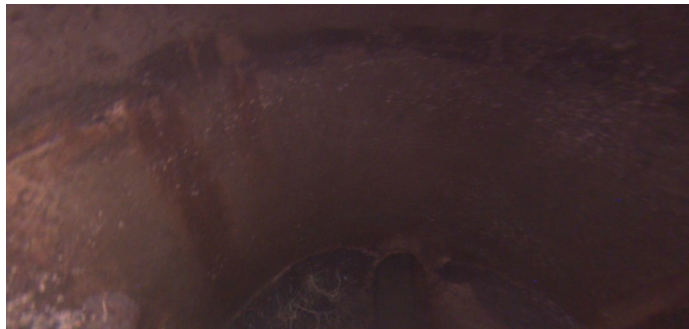
Code: **IS**  
Description: **Infil Stain**

Distance (ft): **8.3**  
Structural Grade: **0**  
O&M Grade: **0**  
Clock Start/From: **10**  
Clock To:  
1st Value:  
2nd Value:  
Value Percent:  
Step: **NO**  
Remarks:

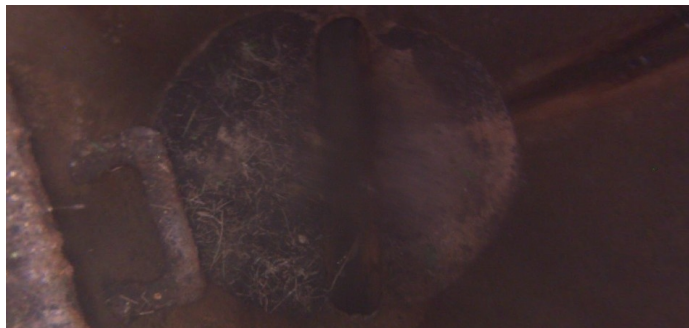
Code: **DAZ**  
Description: **Deposits Attached Other**

Distance (ft): **8.5**  
Structural Grade: **0**  
O&M Grade: **2**  
Clock Start/From: **6**  
Clock To: **12**  
1st Value:  
2nd Value:  
Value Percent: **5.000**  
Step: **NO**  
Remarks: **Mixed materials**

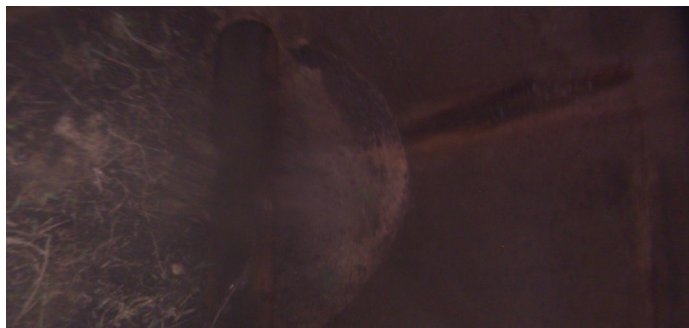
Code: **IS**  
Description: **Infil Stain**

Distance (ft): **8.7**  
Structural Grade: **0**  
O&M Grade: **0**  
Clock Start/From: **2**  
Clock To:  
1st Value:  
2nd Value:  
Value Percent:  
Step: **NO**  
Remarks:

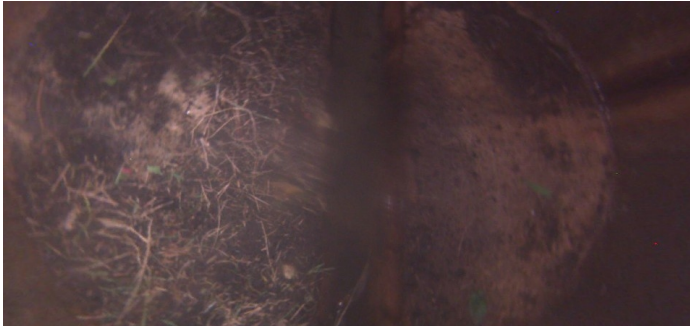
Code:	<b>MGO</b>
Description:	<b>General Observation</b>
Distance (ft):	<b>9.8</b>
Structural Grade:	<b>0</b>
O&M Grade:	<b>0</b>
Clock Start/From:	
Clock To:	
1st Value:	
2nd Value:	
Value Percent:	
Step:	<b>NO</b>
Remarks:	<b>Ins. Comp.</b>
