Manhole Inspection Report

| MH#: | M-503-057 | Owner: | NA | Len. Surveyed: | 10.9 |

| Street: | Colorado St. 170' South of 38th Ave. | Project: | Hobart, IN |

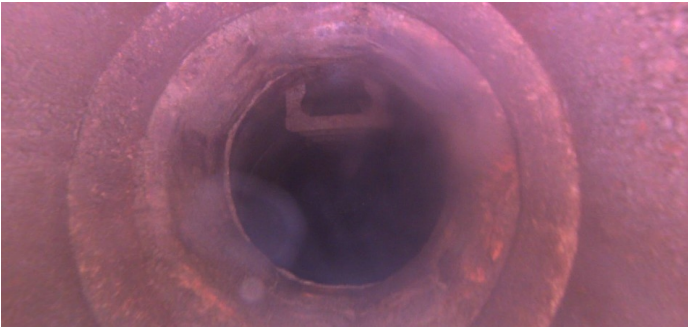
Code:

MGP

Description:

General Photo

Distance (ft):

.0

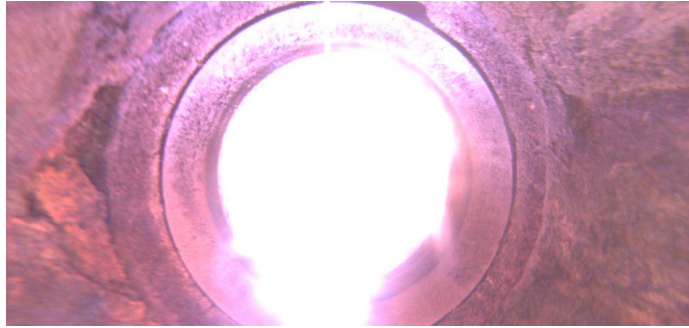
Code: **MGP**
Description: **General Photo**

Distance (ft): **2.6**
Structural Grade: **0**
O&M Grade: **0**
Clock Start/From:
Clock To:
1st Value:
2nd Value:
Value Percent:
Step: **NO**
Remarks:

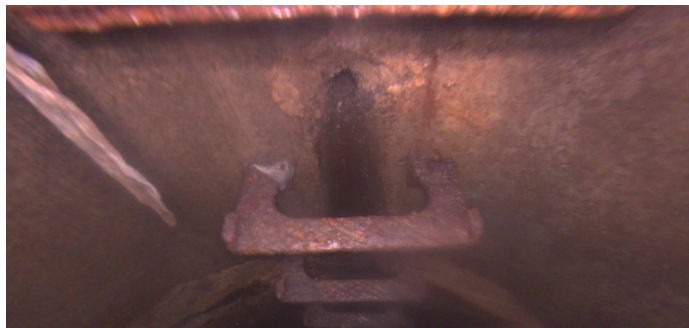
Code: **IS**
Description: **Infil Stain**

Distance (ft): **5.6**
Structural Grade: **0**
O&M Grade: **0**
Clock Start/From: **12**
Clock To:
1st Value:
2nd Value:
Value Percent:
Step: **NO**
Remarks:

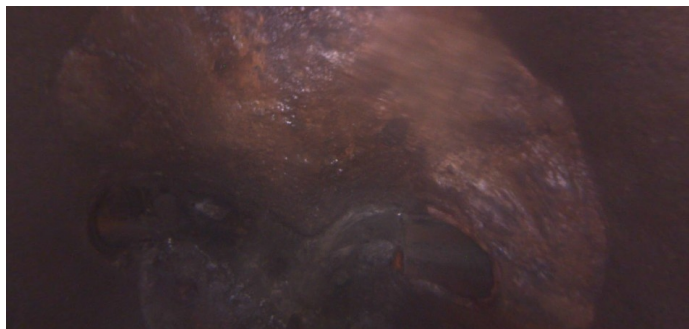
Code: **MGO**
Description: **General Observation**

Distance (ft): **9.8**
Structural Grade: **0**
O&M Grade: **0**
Clock Start/From:
Clock To:
1st Value:
2nd Value:
Value Percent:
Step: **NO**
Remarks: **Ins. Comp.**
