Manhole Inspection Report

Date:	04/08/2018	Weather:		Coding:	RZMACP
MH#:	M-503-058	Owner:	NA	Len. Surveyed:	8.3
P.O.#:		Surveyor:	John Kuglmaier	Rim to Invert:	9.6
Customer:		Cert. #:	U-1215-07002349	Wall Material:	Concrete (reinforced)

Street:	287' West of Virginia St. 166' South	Project:	Hobart, IN
City:	Hobart, IN	GPS Northing:	2900751.182
Location:		GPS Easting:	2900751.182
Drain Area:	Northwest	GPS Accuracy:	Sub-Meter
Cover Shape:	Circular	Evidence of Surcharge:	No
Cover Size:	23.0	Potential for Runoff:	None
Comments:

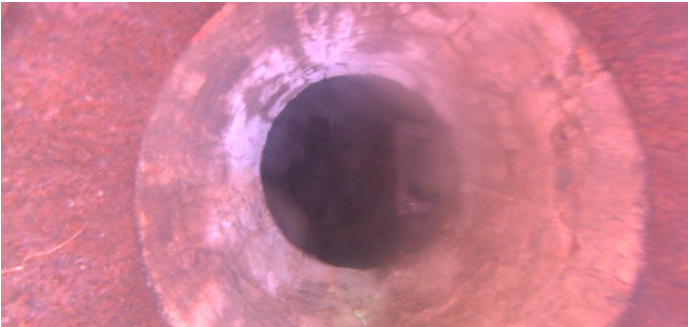
Code:

MGP

Description:

General Photo

Distance (ft):

.0

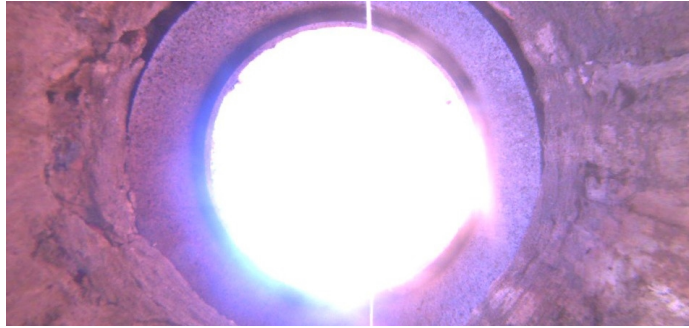
Code:	MGP
Description:	General Photo
Distance (ft):	2.3
Structural Grade:	0
O&M Grade:	0
Clock Start/From:	
Clock To:	
1st Value:	
2nd Value:	
Value Percent:	
Step:	NO
Remarks:

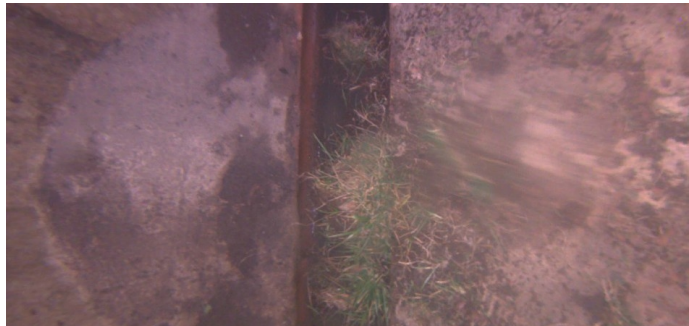
Code:	MGO
Description:	General Observation
Distance (ft):	7.5
Structural Grade:	0
O&M Grade:	0
Clock Start/From:	
Clock To:	
1st Value:	
2nd Value:	
Value Percent:	
Step:	NO
Remarks:	Ins. Comp.
