Manhole Inspection Report

Date:	03/30/2018	Weather:		Coding:	RZMACP
MH#:	M-503-062	Owner:	NA	Len. Surveyed:	8.6
P.O.#:		Surveyor:	John Kuglmaier	Rim to Invert:	9.5
Customer:		Cert. #:	U-1215-07002349	Wall Material:	Concrete (reinforced)

Street:	38th Ave. 163' West of Wisconsin St.	Project:	Hobart, IN
City:	Hobart, IN	GPS Northing:	0.0
Location:		GPS Easting:	0.0
Drain Area:	Northwest	GPS Accuracy:	Nearest Meter
Cover Shape:	Circular	Evidence of Surcharge:	No
Cover Size:	23.0	Potential for Runoff:	None
Comments:

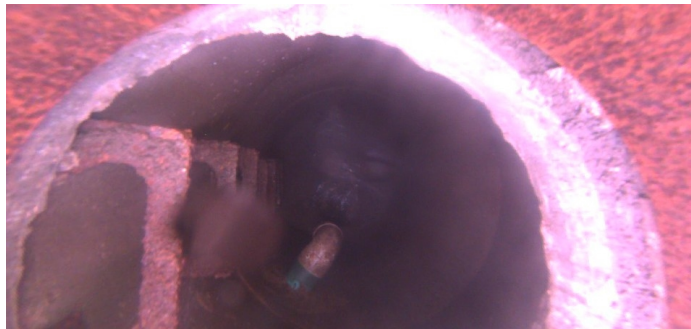
Code: **MGP**
Description: **General Photo**

Distance (ft): **.0**
Structural Grade: **0**
O&M Grade: **0**
Clock Start/From:
Clock To:
1st Value:
2nd Value:
Value Percent:
Step: **NO**
Remarks:

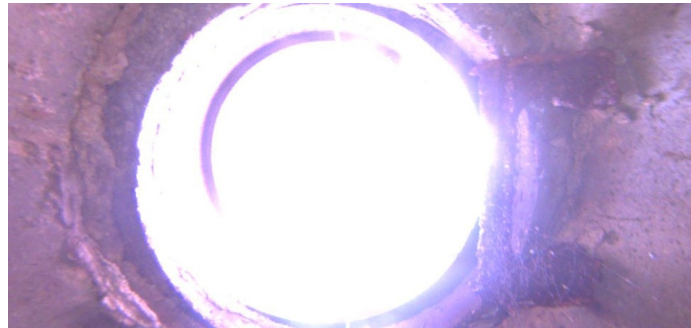
Code: **MGP**
Description: **General Photo**

Distance (ft): **2.5**
Structural Grade: **0**
O&M Grade: **0**
Clock Start/From:
Clock To:
1st Value:
2nd Value:
Value Percent:
Step: **NO**
Remarks:

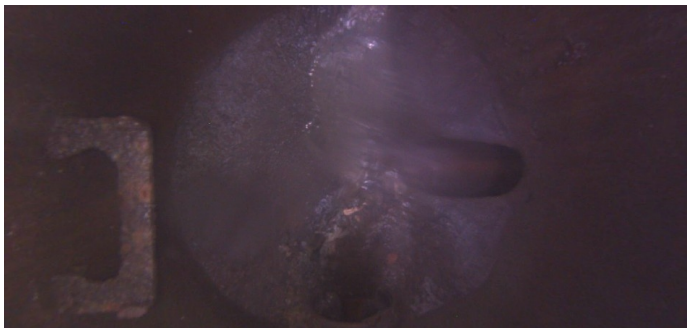
Code: **DSF**
Description: **Deposits Settled Fine**

Distance (ft): **5.5**
Structural Grade: **0**
O&M Grade: **2**
Clock Start/From: **12**
Clock To: **12**
1st Value:
2nd Value:
Value Percent: **10.000**
Step: **NO**
Remarks:

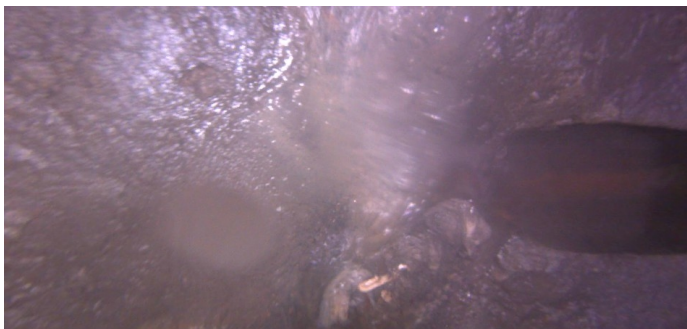
Code: **MGO**
Description: **General Observation**

Distance (ft): **7.6**
Structural Grade: **0**
O&M Grade: **0**
Clock Start/From:
Clock To:
1st Value:
2nd Value:
Value Percent:
Step: **NO**
Remarks: **Ins. Comp.**
