# Manhole Inspection Report

Date:	<b>03/30/2018</b>	Weather:		Coding:	<b>RZMACP</b>
MH#:	<b>M-503-064</b>	Owner:	<b>NA</b>	Len. Surveyed:	<b>14.1</b>
P.O.#:		Surveyor:	<b>John Kuglmaier</b>	Rim to Invert:	<b>9.5</b>
Customer:		Cert. #:	<b>U-1215-07002349</b>	Wall Material:	<b>Concrete (reinforced)</b>

Street:	<b>Intersection of 38th Ave. and Wisco</b>	Project:	<b>Hobart, IN</b>
City:	<b>Hobart, IN</b>	GPS Northing:	<b>0.0</b>
Location:		GPS Easting:	<b>0.0</b>
Drain Area:	<b>Northwest</b>	GPS Accuracy:	<b>Nearest Meter</b>
Cover Shape:	<b>Circular</b>	Evidence of Surcharge:	<b>Yes</b>
Cover Size:	<b>23.0</b>	Potential for Runoff:	<b>None</b>
Comments:

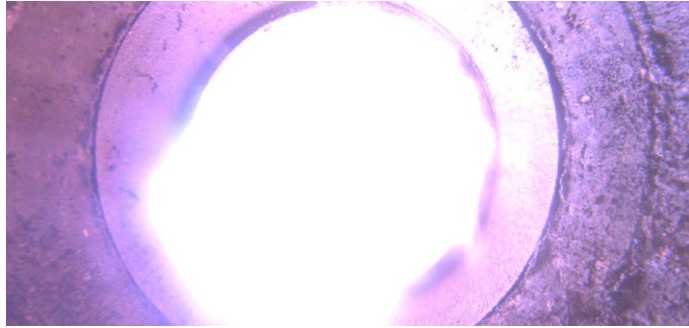
Code: **MGP**  
Description: **General Photo**

Distance (ft): **2.1**  
Structural Grade: **0**  
O&M Grade: **0**  
Clock Start/From:  
Clock To:  
1st Value:  
2nd Value:  
Value Percent:  
Step: **NO**  
Remarks:

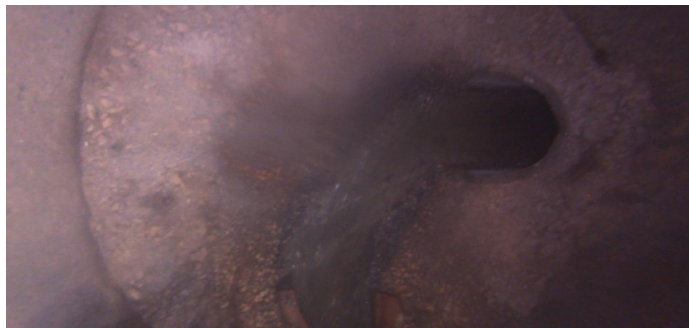
Code: **MGO**  
Description: **General Observation**

Distance (ft): **13.4**  
Structural Grade: **0**  
O&M Grade: **0**  
Clock Start/From:  
Clock To:  
1st Value:  
2nd Value:  
Value Percent:  
Step: **NO**  
Remarks: **Ins. Comp.**
