Manhole Inspection Report

Date:	04/12/2018	Weather:		Coding:	RZMACP
MH#:	M-503-067	Owner:	NA	Len. Surveyed:	8.5
P.O.#:		Surveyor:	John Kuglmaier	Rim to Invert:	10.5
Customer:		Cert. #:	U-1215-07002349	Wall Material:	Concrete (reinforced)

Street:	37th Ave. East of Wisconsin St.	Project:	Hobart, IN
City:	Hobart, IN	GPS Northing:	2901727.778
Location:		GPS Easting:	2901727.778
Drain Area:	Northwest	GPS Accuracy:	Sub-Meter
Cover Shape:	Circular	Evidence of Surcharge:	Yes
Cover Size:	23.0	Potential for Runoff:	None
Comments:

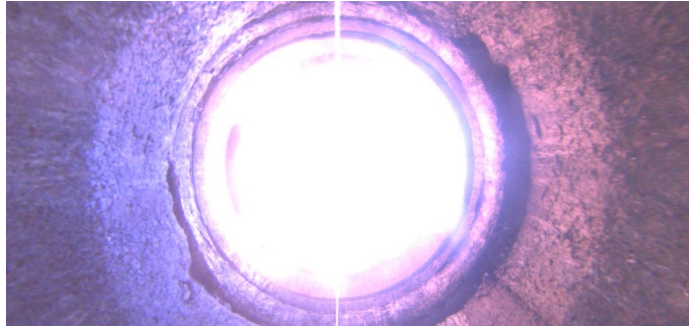
Code:	MGP
Description:	General Photo

Distance (ft):	.0
Structural Grade:	0
O&M Grade:	0
Clock Start/From:	
Clock To:	
1st Value:	
2nd Value:	
Value Percent:	
Step:	NO
Remarks:

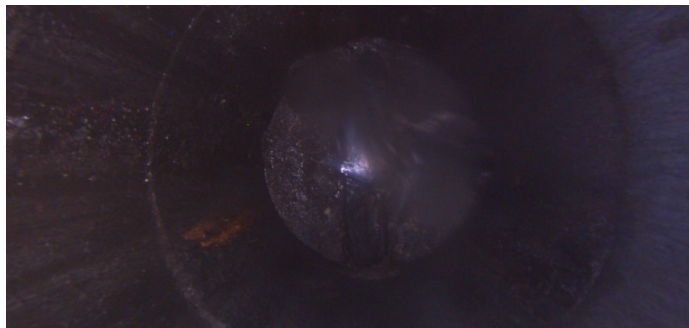
Code: **MGP**
Description: **General Photo**

Distance (ft): **3.0**
Structural Grade: **0**
O&M Grade: **0**
Clock Start/From:
Clock To:
1st Value:
2nd Value:
Value Percent:
Step: **NO**
Remarks:

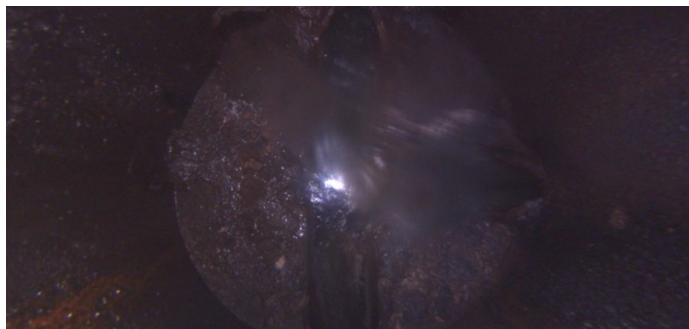
Code: **IS**
Description: **Infil Stain**

Distance (ft): **4.8**
Structural Grade: **0**
O&M Grade: **0**
Clock Start/From: **8**
Clock To:
1st Value:
2nd Value:
Value Percent:
Step: **NO**
Remarks:

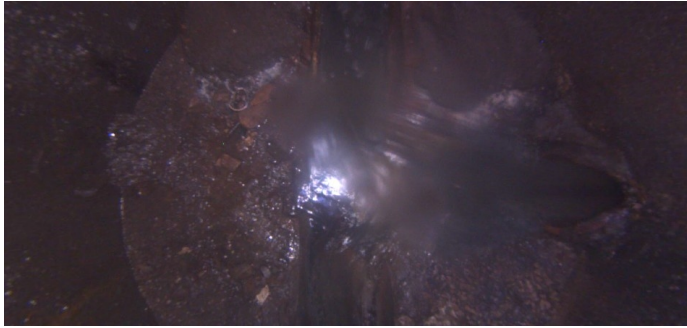
Code: **DAZ**
Description: **Deposits Attached Other**

Distance (ft): **6.5**
Structural Grade: **0**
O&M Grade: **2**
Clock Start/From: **12**
Clock To: **12**
1st Value:
2nd Value:
Value Percent: **10.000**
Step: **NO**
Remarks: **Mixed materials**
