Manhole Inspection Report

Date:	03/30/2018	Weather:		Coding:	RZMACP
MH#:	M-503-069	Owner:	NA	Len. Surveyed:	5.1
P.O.#:		Surveyor:	John Kuglmaier	Rim to Invert:	5.8
Customer:		Cert. #:	U-1215-07002349	Wall Material:	Concrete (reinforced)

Street:	159' North of 37th Ave. 198' West of	Project:	Hobart, IN
City:	Hobart, IN	GPS Northing:	0.0
Location:		GPS Easting:	0.0
Drain Area:	Northwest	GPS Accuracy:	Nearest Meter
Cover Shape:	Circular	Evidence of Surcharge:	Yes
Cover Size:	23.0	Potential for Runoff:	None
Comments:

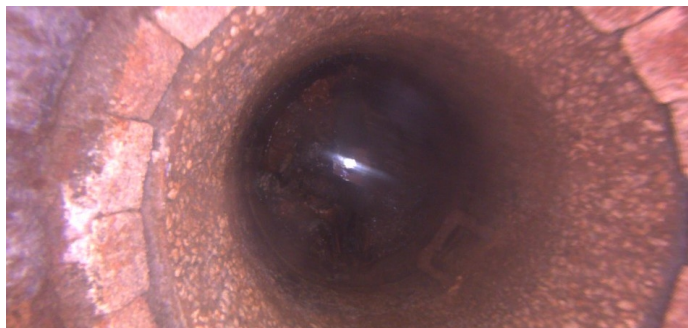
Code: **MGP**
Description: **General Photo**

Distance (ft): **.0**
Structural Grade: **0**
O&M Grade: **0**
Clock Start/From:
Clock To:
1st Value:
2nd Value:
Value Percent:
Step: **NO**
Remarks:

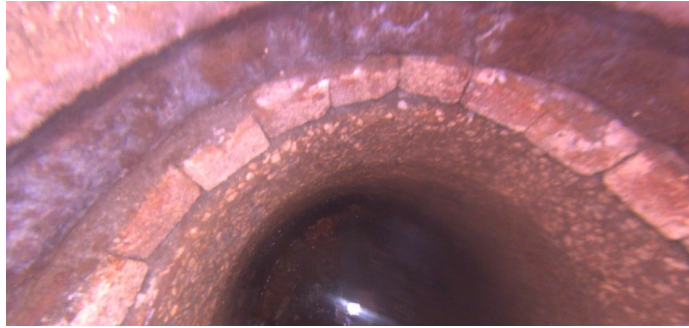
Code: **SAV**
Description: **Surface Aggregate Visible**

Distance (ft): **.0**
Structural Grade: **3**
O&M Grade: **0**
Clock Start/From: **12**
Clock To: **12**
1st Value:
2nd Value:
Value Percent:
Step: **NO**
Remarks:

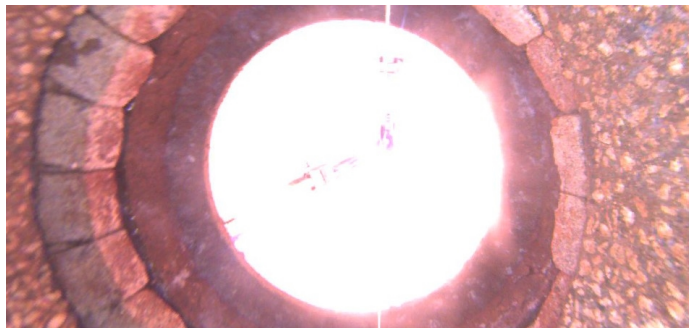
Code: **MGP**
Description: **General Photo**

Distance (ft): **2.0**
Structural Grade: **0**
O&M Grade: **0**
Clock Start/From:
Clock To:
1st Value:
2nd Value:
Value Percent:
Step: **NO**
Remarks:

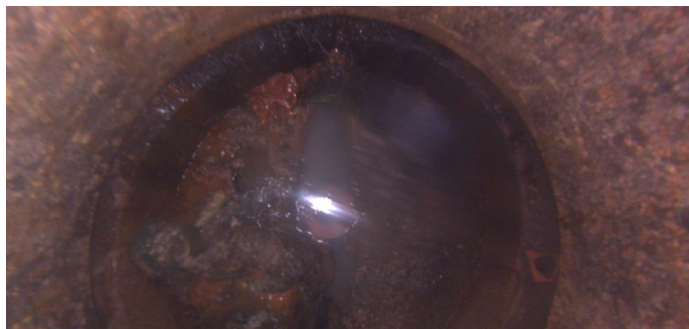
Code: **IS**
Description: **Infil Stain**

Distance (ft): **2.4**
Structural Grade: **0**
O&M Grade: **0**
Clock Start/From: **10**
Clock To: **3**
1st Value:
2nd Value:
Value Percent:
Step: **NO**
Remarks:

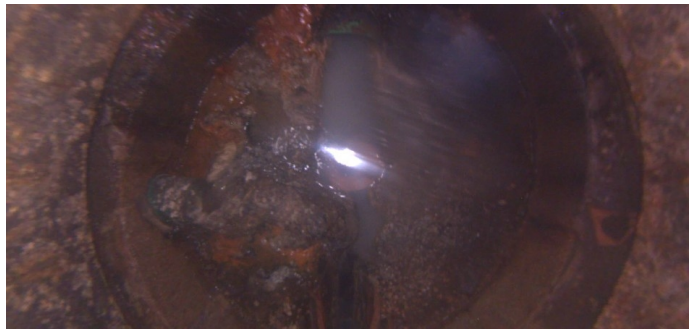
Code: **DAZ**
Description: **Deposits Attached Other**

Distance (ft): **2.8**
Structural Grade: **0**
O&M Grade: **3**
Clock Start/From: **12**
Clock To: **12**
1st Value:
2nd Value:
Value Percent: **15.000**
Step: **NO**
Remarks: **Mixed materials**

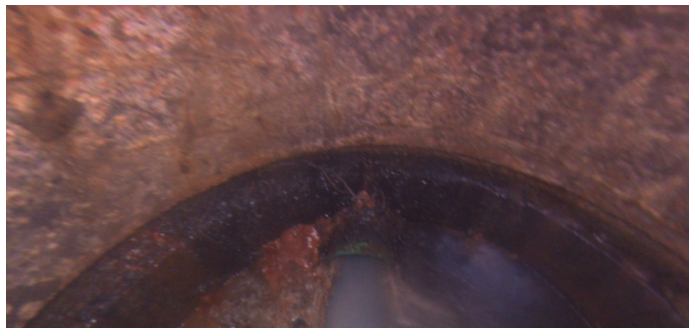
Code: **SAV**
Description: **Surface Aggregate Visible**

Distance (ft): **3.3**
Structural Grade: **3**
O&M Grade: **0**
Clock Start/From: **12**
Clock To: **12**
1st Value:
2nd Value:
Value Percent:
Step: **NO**
Remarks:

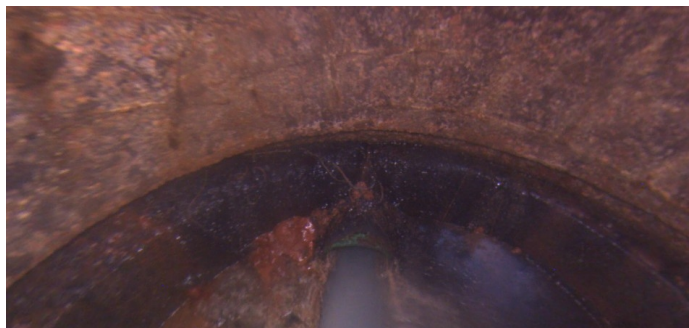
Code: **RFJ**
Description: **Roots Fine Joint**

Distance (ft): **3.5**
Structural Grade: **0**
O&M Grade: **1**
Clock Start/From: **11**
Clock To: **1**
1st Value:
2nd Value:
Value Percent:
Step: **NO**
Remarks:

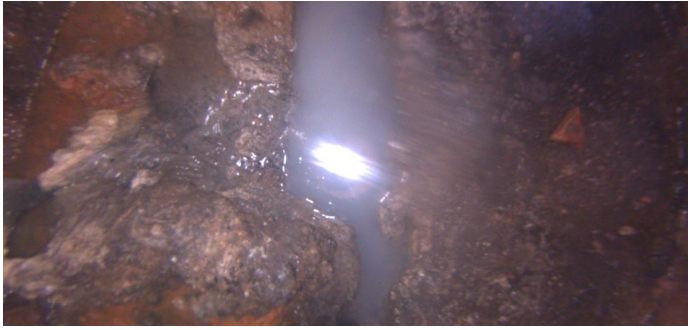
Code:	MGO
Description:	General Observation
Distance (ft):	4.3
Structural Grade:	0
O&M Grade:	0
Clock Start/From:	
Clock To:	
1st Value:	
2nd Value:	
Value Percent:	
Step:	NO
Remarks:	Ins. Comp.
