# Manhole Inspection Report

Date:	<b>03/30/2018</b>	Weather:		Coding:	<b>RZMACP</b>
MH#:	<b>M-503-070</b>	Owner:	<b>NA</b>	Len. Surveyed:	<b>1.6</b>
P.O.#:		Surveyor:	<b>John Kuglmaier</b>	Rim to Invert:	<b>3.5</b>
Customer:		Cert. #:	<b>U-1215-07002349</b>	Wall Material:	<b>Concrete (reinforced)</b>

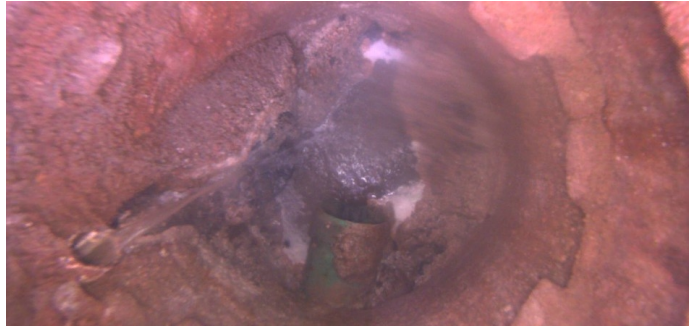
Code: **MGP**  
Description: **General Photo**

Distance (ft): **.0**  
Structural Grade: **0**  
O&M Grade: **0**  
Clock Start/From:  
Clock To:  
1st Value:  
2nd Value:  
Value Percent:  
Step: **NO**  
Remarks:

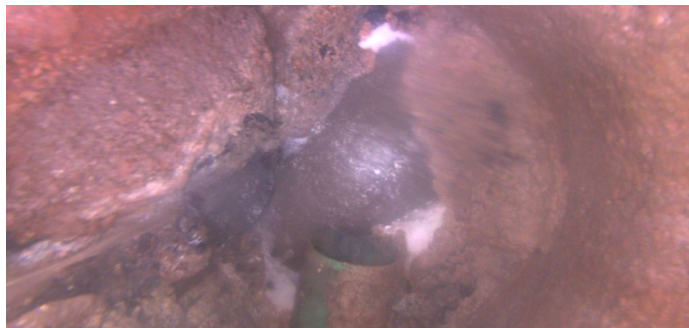
Code: **DAZ**  
Description: **Deposits Attached Other**

Distance (ft): **.8**  
Structural Grade: **0**  
O&M Grade: **3**  
Clock Start/From: **12**  
Clock To: **12**  
1st Value:  
2nd Value:  
Value Percent: **15.000**  
Step: **NO**  
Remarks: **Mixed materials**

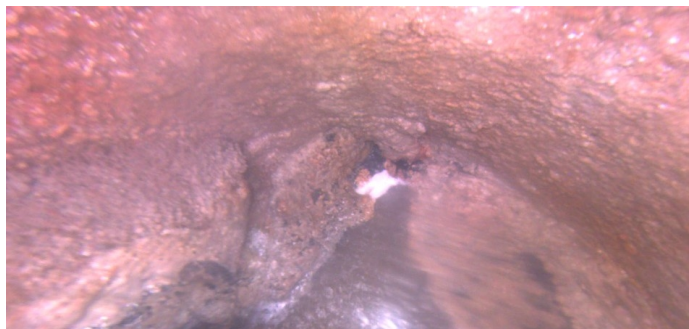
Code: **DAZ**  
Description: **Deposits Attached Other**

Distance (ft): **1.2**  
Structural Grade: **0**  
O&M Grade: **2**  
Clock Start/From: **12**  
Clock To: **12**  
1st Value:  
2nd Value:  
Value Percent: **5.000**  
Step: **NO**  
Remarks: **Mixed materials**

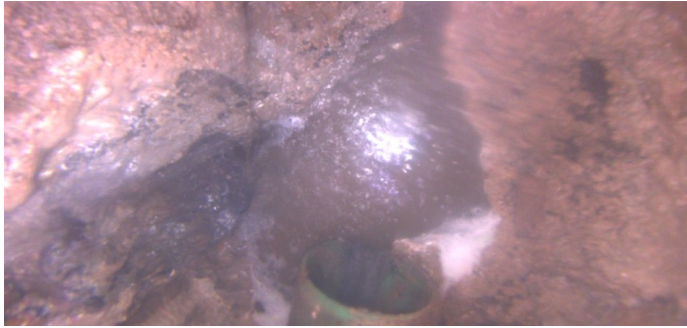
Code:	<b>MGO</b>
Description:	<b>General Observation</b>
Distance (ft):	<b>1.3</b>
Structural Grade:	<b>0</b>
O&M Grade:	<b>0</b>
Clock Start/From:	
Clock To:	
1st Value:	
2nd Value:	
Value Percent:	
Step:	<b>NO</b>
Remarks:	<b>Ins. Comp.</b>
