Manhole Inspection Report

Date:	03/30/2018	Weather:		Coding:	RZMACP
MH#:	M-503-072.1	Owner:	NA	Len. Surveyed:	7.1
P.O.#:		Surveyor:	John Kuglmaier	Rim to Invert:	8.2
Customer:		Cert. #:	U-1215-07002349	Wall Material:	Concrete (reinforced)

Street:	77' East of Virginia St. 287' North of	Project:	Hobart, IN
City:	Hobart, IN	GPS Northing:	0.0
Location:		GPS Easting:	0.0
Drain Area:	Northwest	GPS Accuracy:	Nearest Meter
Cover Shape:	Circular	Evidence of Surcharge:	Yes
Cover Size:	23.0	Potential for Runoff:	None
Comments:

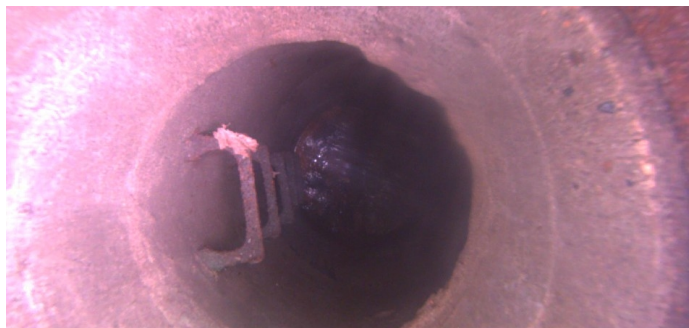
Code: **MGP**
Description: **General Photo**

Distance (ft): **.0**
Structural Grade: **0**
O&M Grade: **0**
Clock Start/From:
Clock To:
1st Value:
2nd Value:
Value Percent:
Step: **NO**
Remarks:

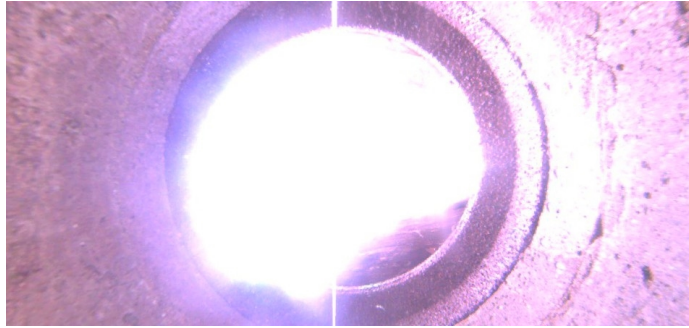
Code: **MGP**
Description: **General Photo**

Distance (ft): **2.3**
Structural Grade: **0**
O&M Grade: **0**
Clock Start/From:
Clock To:
1st Value:
2nd Value:
Value Percent:
Step: **NO**
Remarks:

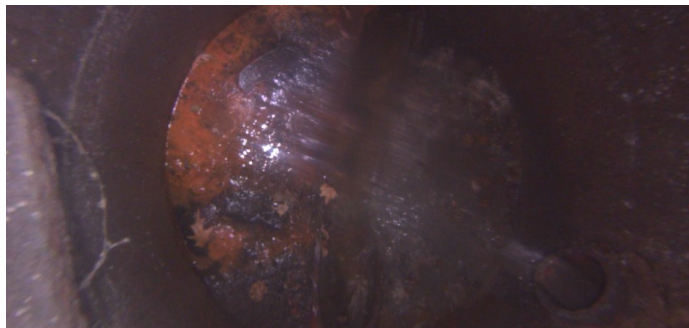
Code: **DAZ**
Description: **Deposits Attached Other**

Distance (ft): **5.0**
Structural Grade: **0**
O&M Grade: **2**
Clock Start/From: **12**
Clock To: **12**
1st Value:
2nd Value:
Value Percent: **5.000**
Step: **NO**
Remarks: **Mixed materials**

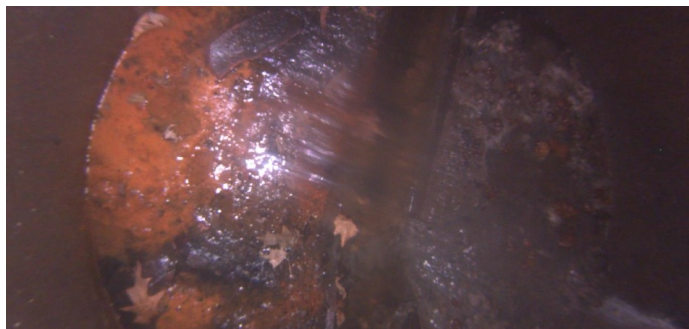
Code: **MGO**
Description: **General Observation**

Distance (ft): **6.2**
Structural Grade: **0**
O&M Grade: **0**
Clock Start/From:
Clock To:
1st Value:
2nd Value:
Value Percent:
Step: **NO**
Remarks: **Ins. Comp.**
