Manhole Inspection Report

Date:	03/30/2018	Weather:		Coding:	RZMACP
MH#:	M-503-072	Owner:	NA	Len. Surveyed:	13.0
P.O.#:		Surveyor:	John Kuglmaier	Rim to Invert:	15.0
Customer:		Cert. #:	U-1215-07002349	Wall Material:	Concrete (reinforced)

Street:	38th Ave. 66' East of Virginia St.	Project:	Hobart, IN
City:	Hobart, IN	GPS Northing:	0.0
Location:		GPS Easting:	0.0
Drain Area:	Northwest	GPS Accuracy:	Nearest Meter
Cover Shape:	Circular	Evidence of Surcharge:	Yes
Cover Size:	23.0	Potential for Runoff:	None
Comments:

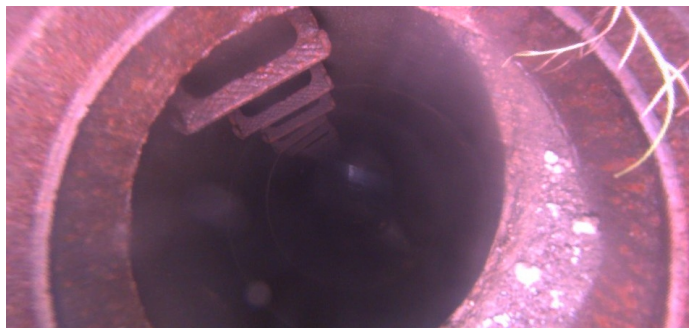
Code: **MGP**
Description: **General Photo**

Distance (ft): **.0**
Structural Grade: **0**
O&M Grade: **0**
Clock Start/From:
Clock To:
1st Value:
2nd Value:
Value Percent:
Step: **NO**
Remarks:

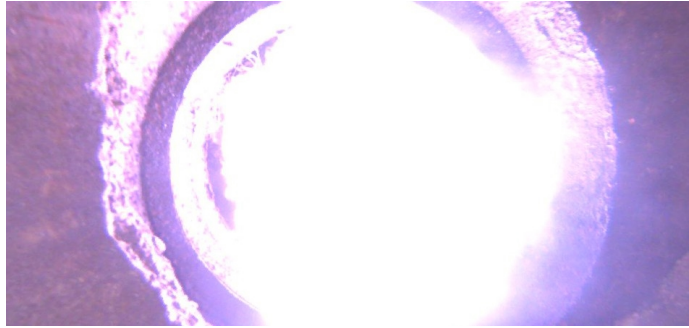
Code:	MGP
Description:	General Photo
Distance (ft):	2.2
Structural Grade:	0
O&M Grade:	0
Clock Start/From:	
Clock To:	
1st Value:	
2nd Value:	
Value Percent:	
Step:	NO
Remarks:

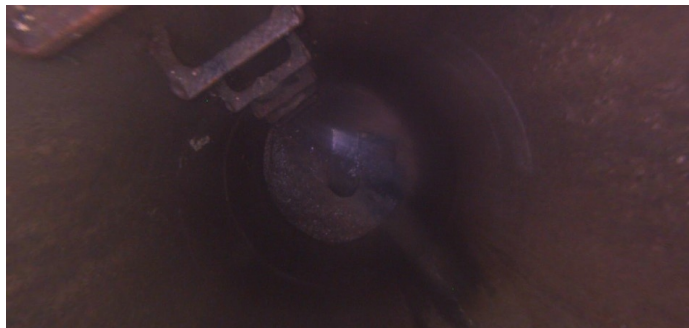
Code:	IS
Description:	Infil Stain
Distance (ft):	6.5
Structural Grade:	0
O&M Grade:	0
Clock Start/From:	12
Clock To:	12
1st Value:	
2nd Value:	
Value Percent:	
Step:	NO
Remarks:

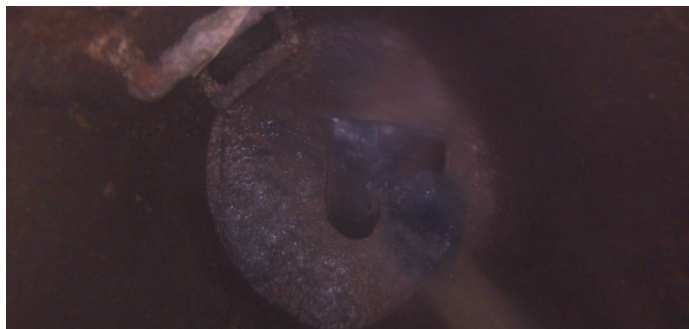
Code:	DSF
Description:	Deposits Settled Fine
Distance (ft):	9.8
Structural Grade:	0
O&M Grade:	2
Clock Start/From:	12
Clock To:	12
1st Value:	
2nd Value:	
Value Percent:	10.000
Step:	NO
Remarks:

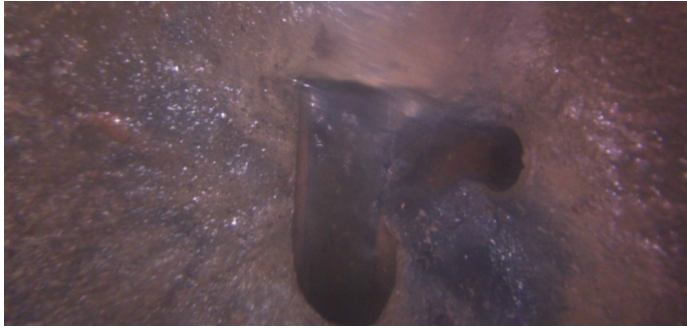
Code:	MGO
Description:	General Observation
Distance (ft):	11.9
Structural Grade:	0
O&M Grade:	0
Clock Start/From:	
Clock To:	
1st Value:	
2nd Value:	
Value Percent:	
Step:	NO
Remarks:	Ins. Comp.
