Manhole Inspection Report

Date:	03/30/2018	Weather:		Coding:	RZMACP
MH#:	M-503-073	Owner:	NA	Len. Surveyed:	13.9
P.O.#:		Surveyor:	John Kuglmaier	Rim to Invert:	16.4
Customer:		Cert. #:	U-1215-07002349	Wall Material:	Concrete (reinforced)

Street:	38th Ave. 260' West of Virginia St.	Project:	Hobart, IN
City:	Hobart, IN	GPS Northing:	0.0
Location:		GPS Easting:	0.0
Drain Area:	Northwest	GPS Accuracy:	Nearest Meter
Cover Shape:	Circular	Evidence of Surcharge:	Yes
Cover Size:	23.0	Potential for Runoff:	None
Comments:

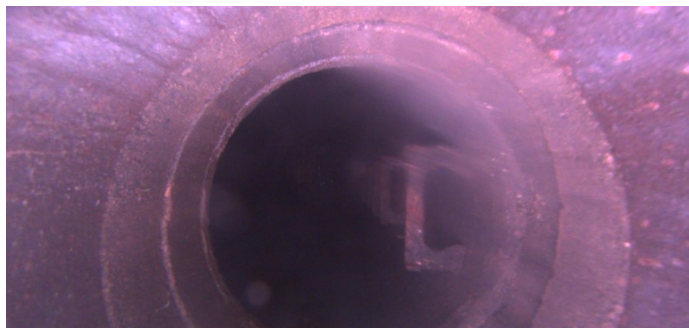
Code: **MGP**
Description: **General Photo**

Distance (ft): **.0**
Structural Grade: **0**
O&M Grade: **0**
Clock Start/From:
Clock To:
1st Value:
2nd Value:
Value Percent:
Step: **NO**
Remarks:

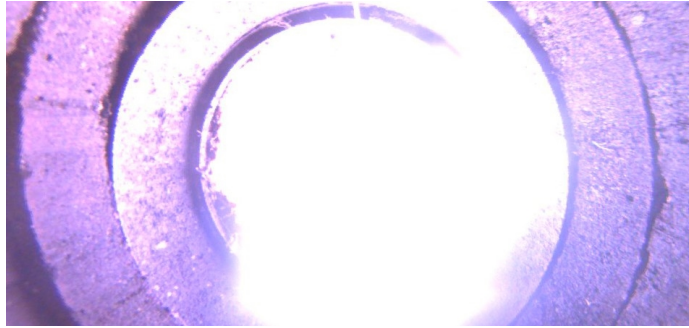
Code: **MGP**
Description: **General Photo**

Distance (ft): **2.2**
Structural Grade: **0**
O&M Grade: **0**
Clock Start/From:
Clock To:
1st Value:
2nd Value:
Value Percent:
Step: **NO**
Remarks:

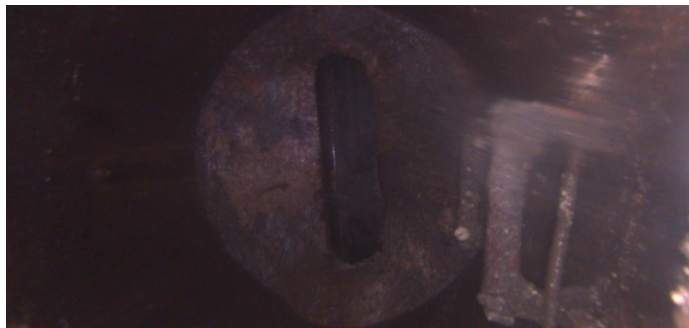
Code: **DSF**
Description: **Deposits Settled Fine**

Distance (ft): **11.6**
Structural Grade: **0**
O&M Grade: **3**
Clock Start/From: **12**
Clock To: **12**
1st Value:
2nd Value:
Value Percent: **15.000**
Step: **NO**
Remarks:

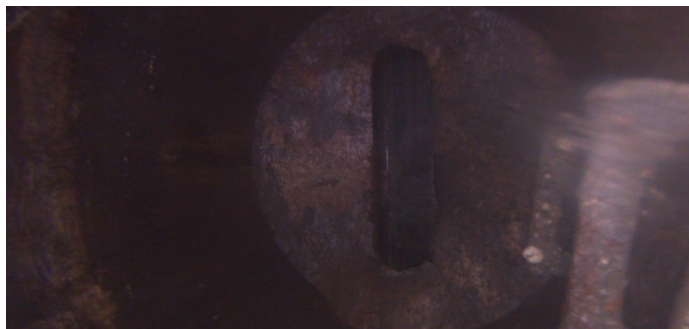
Code: **IS**
Description: **Infil Stain**

Distance (ft): **11.9**
Structural Grade: **0**
O&M Grade: **0**
Clock Start/From: **9**
Clock To:
1st Value:
2nd Value:
Value Percent:
Step: **NO**
Remarks:

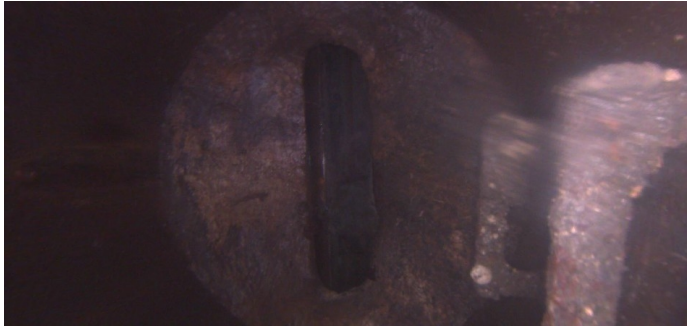
Code:	MGO
Description:	General Observation
Distance (ft):	12.2
Structural Grade:	0
O&M Grade:	0
Clock Start/From:	
Clock To:	
1st Value:	
2nd Value:	
Value Percent:	
Step:	NO
Remarks:	Ins. Comp.
