Manhole Inspection Report

Date:	03/30/2018	Weather:		Coding:	RZMACP
MH#:	M-503-075	Owner:	NA	Len. Surveyed:	9.9
P.O.#:		Surveyor:	John Kuglmaier	Rim to Invert:	11.0
Customer:		Cert. #:	U-1215-07002349	Wall Material:	Concrete (reinforced)

Street:	Colorado St. 166' North of 38th Ave.	Project:	Hobart, IN
City:	Hobart, IN	GPS Northing:	0.0
Location:		GPS Easting:	0.0
Drain Area:	Northwest	GPS Accuracy:	Nearest Meter
Cover Shape:	Circular	Evidence of Surcharge:	Yes
Cover Size:	23.0	Potential for Runoff:	None
Comments:

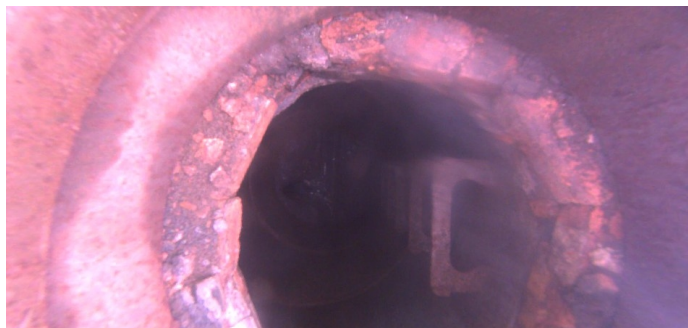
Code: **MGP**
Description: **General Photo**

Distance (ft): **.0**
Structural Grade: **0**
O&M Grade: **0**
Clock Start/From:
Clock To:
1st Value:
2nd Value:
Value Percent:
Step: **NO**
Remarks:

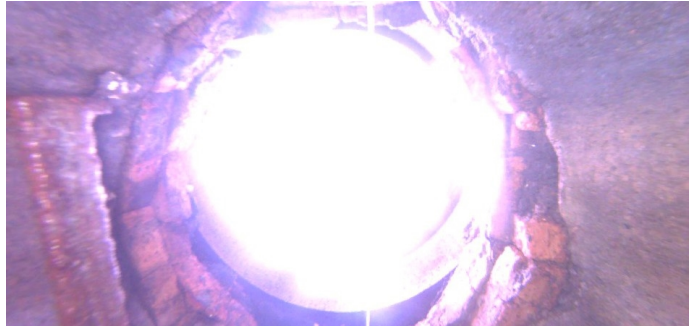
Code: **MGP**
Description: **General Photo**

Distance (ft): **2.9**
Structural Grade: **0**
O&M Grade: **0**
Clock Start/From:
Clock To:
1st Value:
2nd Value:
Value Percent:
Step: **NO**
Remarks:

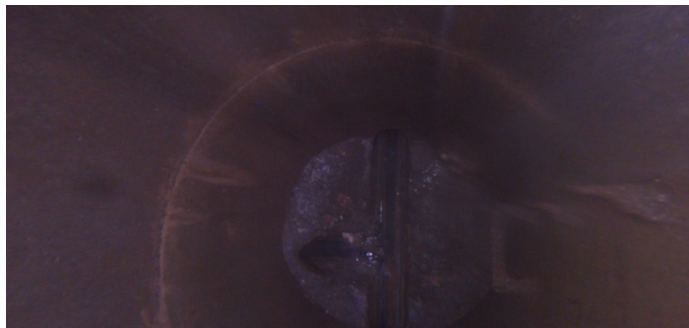
Code: **IS**
Description: **Infil Stain**

Distance (ft): **5.4**
Structural Grade: **0**
O&M Grade: **0**
Clock Start/From: **10**
Clock To:
1st Value:
2nd Value:
Value Percent:
Step: **NO**
Remarks:

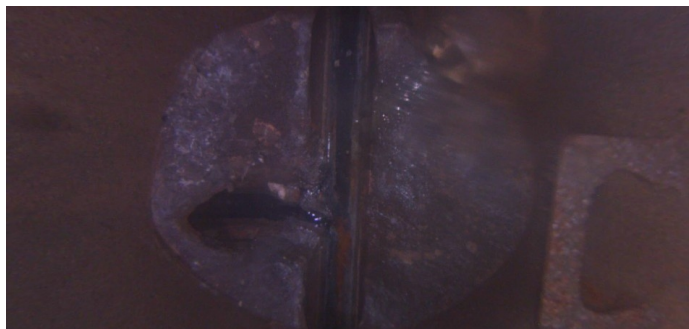
Code: **DAZ**
Description: **Deposits Attached Other**

Distance (ft): **7.8**
Structural Grade: **0**
O&M Grade: **3**
Clock Start/From: **12**
Clock To: **12**
1st Value:
2nd Value:
Value Percent: **15.000**
Step: **NO**
Remarks: **Mixed materials**

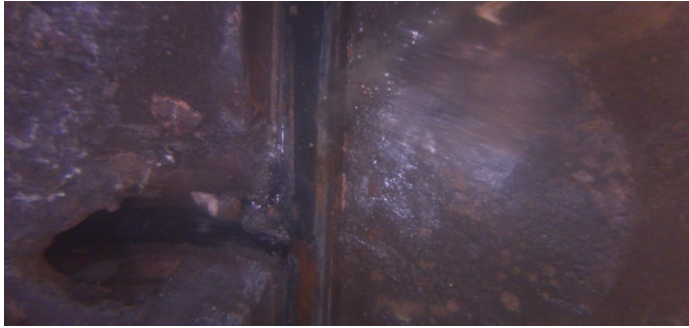
Code:	MGO
Description:	General Observation
Distance (ft):	8.9
Structural Grade:	0
O&M Grade:	0
Clock Start/From:	
Clock To:	
1st Value:	
2nd Value:	
Value Percent:	
Step:	NO
Remarks:	Ins. Comp.
