Manhole Inspection Report

Date:	03/30/2018	Weather:		Coding:	RZMACP
MH#:	M-503-078	Owner:	NA	Len. Surveyed:	7.1
P.O.#:		Surveyor:	John Kuglmaier	Rim to Invert:	8.7
Customer:		Cert. #:	U-1215-07002349	Wall Material:	Concrete (reinforced)

Street:	Colorado St. 165' North of 37th PL.	Project:	Hobart, IN
City:	Hobart, IN	GPS Northing:	0.0
Location:		GPS Easting:	0.0
Drain Area:	Northwest	GPS Accuracy:	Nearest Meter
Cover Shape:	Circular	Evidence of Surcharge:	Yes
Cover Size:	23.0	Potential for Runoff:	None
Comments:

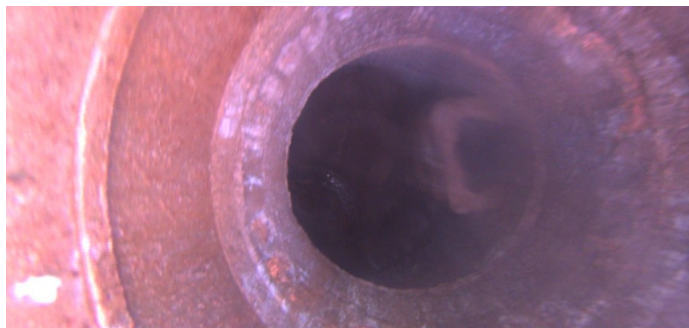
Code: **MGP**
Description: **General Photo**

Distance (ft): **.0**
Structural Grade: **0**
O&M Grade: **0**
Clock Start/From:
Clock To:
1st Value:
2nd Value:
Value Percent:
Step: **NO**
Remarks:

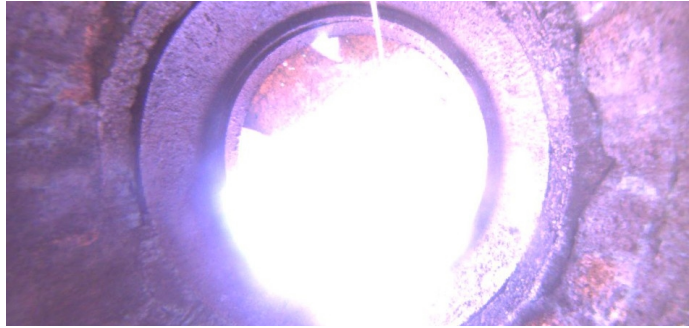
Code: **MGP**
Description: **General Photo**

Distance (ft): **2.3**
Structural Grade: **0**
O&M Grade: **0**
Clock Start/From:
Clock To:
1st Value:
2nd Value:
Value Percent:
Step: **NO**
Remarks:

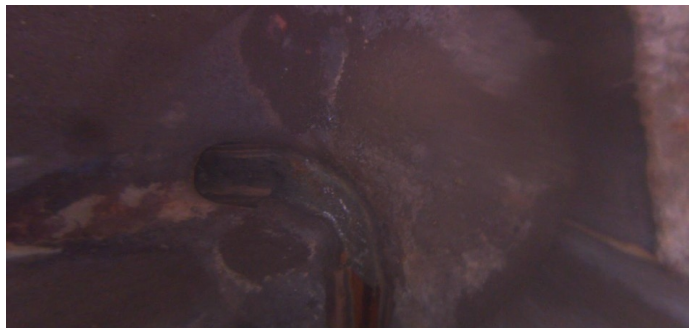
Code: **DSF**
Description: **Deposits Settled Fine**

Distance (ft): **5.4**
Structural Grade: **0**
O&M Grade: **2**
Clock Start/From: **12**
Clock To: **12**
1st Value:
2nd Value:
Value Percent: **5.000**
Step: **NO**
Remarks:

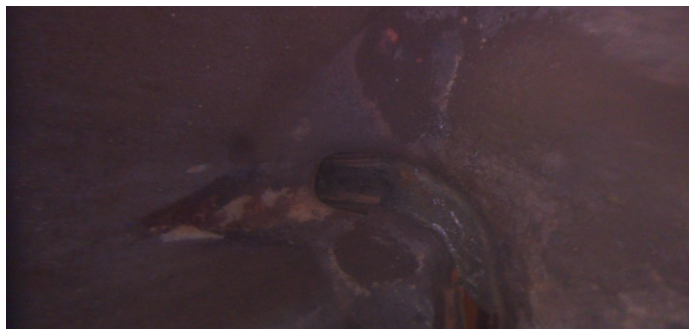
Code: **IS**
Description: **Infil Stain**

Distance (ft): **5.4**
Structural Grade: **0**
O&M Grade: **0**
Clock Start/From: **9**
Clock To:
1st Value:
2nd Value:
Value Percent:
Step: **NO**
Remarks:

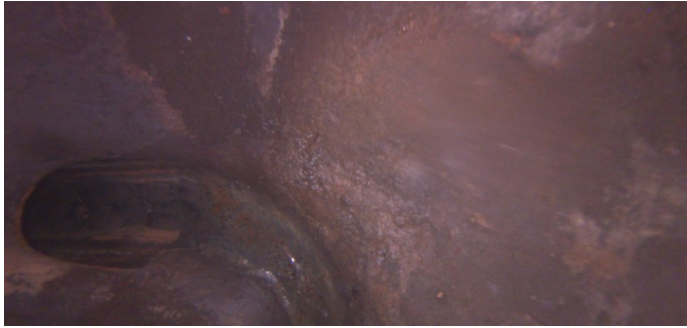
Code:	MGO
Description:	General Observation
Distance (ft):	6.6
Structural Grade:	0
O&M Grade:	0
Clock Start/From:	
Clock To:	
1st Value:	
2nd Value:	
Value Percent:	
Step:	NO
Remarks:	Ins. Comp.
