Manhole Inspection Report

Date:	03/30/2018	Weather:		Coding:	RZMACP
MH#:	M-503-087	Owner:	NA	Len. Surveyed:	6.2
P.O.#:		Surveyor:	John Kuglmaier	Rim to Invert:	8.1
Customer:		Cert. #:	U-1215-07002349	Wall Material:	Concrete (reinforced)

Street:	167' South of 37th Ave. 55' East of	Project:	Hobart, IN
City:	Hobart, IN	GPS Northing:	0.0
Location:		GPS Easting:	0.0
Drain Area:	Northwest	GPS Accuracy:	Nearest Meter
Cover Shape:	Circular	Evidence of Surcharge:	No
Cover Size:	23.0	Potential for Runoff:	None
Comments:

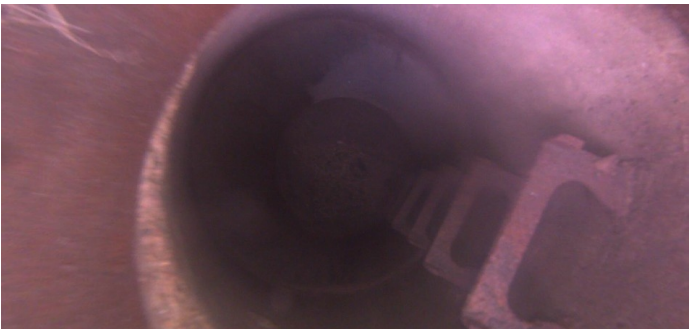
Code: **MGP**
 Description: **General Photo**

Distance (ft): **.0**
 Structural Grade: **0**
 O&M Grade: **0**
 Clock Start/From:
 Clock To:
 1st Value:
 2nd Value:
 Value Percent:
 Step: **NO**
 Remarks:

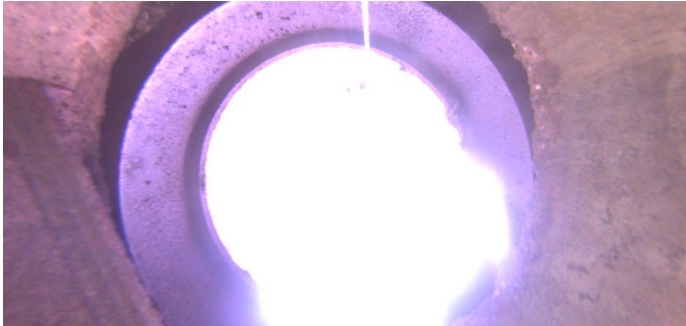
Code: **MGP**
Description: **General Photo**

Distance (ft): **2.2**
Structural Grade: **0**
O&M Grade: **0**
Clock Start/From:
Clock To:
1st Value:
2nd Value:
Value Percent:
Step: **NO**
Remarks:

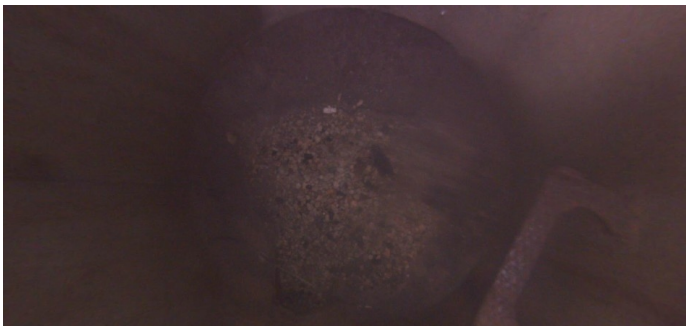
Code: **DAZ**
Description: **Deposits Attached Other**

Distance (ft): **4.7**
Structural Grade: **0**
O&M Grade: **3**
Clock Start/From: **12**
Clock To: **12**
1st Value:
2nd Value:
Value Percent: **15.000**
Step: **NO**
Remarks: **Mixed materials**

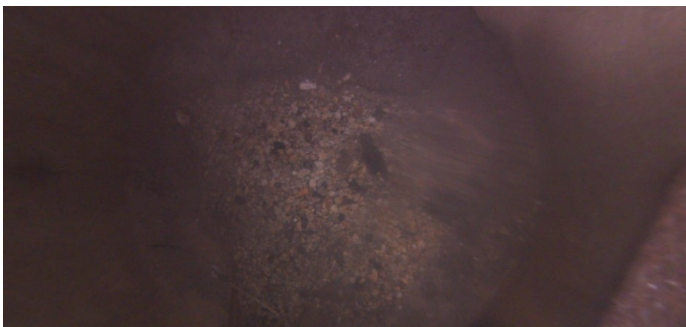
Code: **MGO**
Description: **General Observation**

Distance (ft): **5.6**
Structural Grade: **0**
O&M Grade: **0**
Clock Start/From:
Clock To:
1st Value:
2nd Value:
Value Percent:
Step: **NO**
Remarks: **Ins. Comp.**
