Manhole Inspection Report

Date:	04/10/2018	Weather:		Coding:	RZMACP
MH#:	M-503-090	Owner:	NA	Len. Surveyed:	4.3
P.O.#:		Surveyor:	John Kuglmaier	Rim to Invert:	5.5
Customer:		Cert. #:	U-1215-07002349	Wall Material:	Concrete (reinforced)

Street:	172' East of Wilson St. 107' North of	Project:	Hobart, IN
City:	Hobart, IN	GPS Northing:	0.0
Location:		GPS Easting:	0.0
Drain Area:	Northwest	GPS Accuracy:	Nearest Meter
Cover Shape:	Circular	Evidence of Surcharge:	Yes
Cover Size:	23.0	Potential for Runoff:	None
Comments:

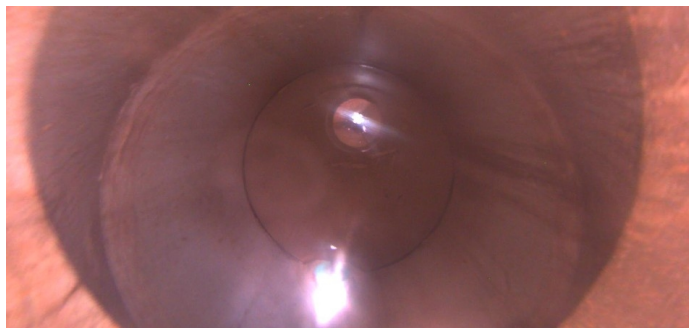
Code: **MGP**
Description: **General Photo**

Distance (ft): **.0**
Structural Grade: **0**
O&M Grade: **0**
Clock Start/From:
Clock To:
1st Value:
2nd Value:
Value Percent:
Step: **NO**
Remarks:

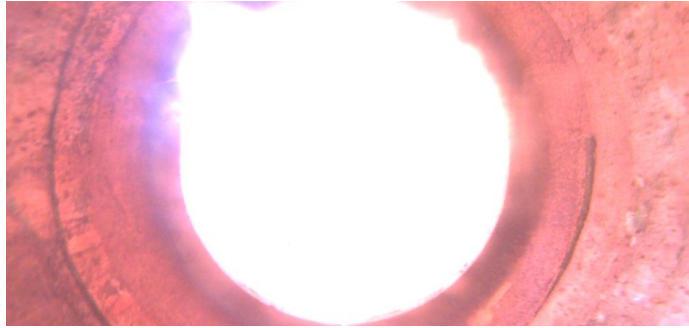
Code: **MGP**
Description: **General Photo**

Distance (ft): **1.5**
Structural Grade: **0**
O&M Grade: **0**
Clock Start/From:
Clock To:
1st Value:
2nd Value:
Value Percent:
Step: **NO**
Remarks:

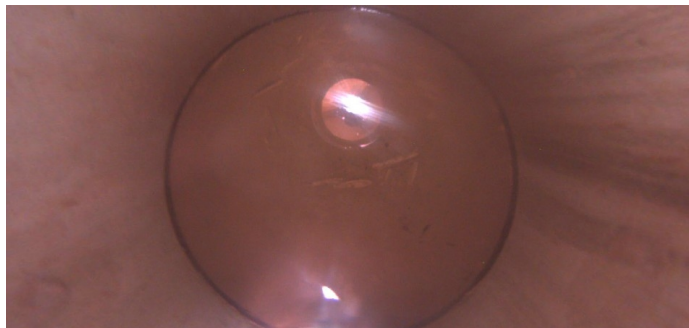
Code: **MGO**
Description: **General Observation**

Distance (ft): **2.0**
Structural Grade: **0**
O&M Grade: **0**
Clock Start/From:
Clock To:
1st Value:
2nd Value:
Value Percent:
Step: **NO**
Remarks: **Surcharge**

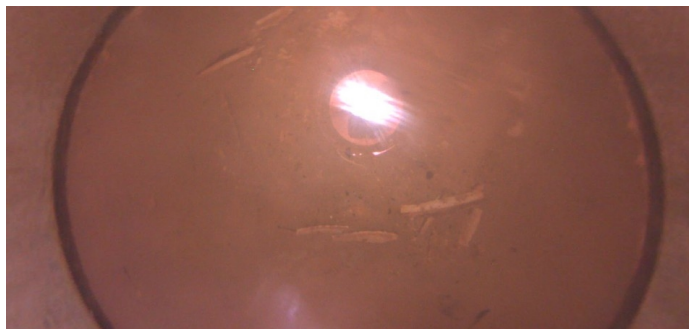
Code: **MGO**
Description: **General Observation**

Distance (ft): **3.4**
Structural Grade: **0**
O&M Grade: **0**
Clock Start/From:
Clock To:
1st Value:
2nd Value:
Value Percent:
Step: **NO**
Remarks: **Ins. Comp.**
