Manhole Inspection Report

Date:	04/10/2018	Weather:		Coding:	RZMACP
MH#:	M-503-090	Owner:	NA	Len. Surveyed:	11.3
P.O.#:		Surveyor:	John Kuglmaier	Rim to Invert:	12.0
Customer:		Cert. #:	U-1215-07002349	Wall Material:	Concrete (reinforced)

Street:	172' East of Wilson St. 107' North of	Project:	Hobart, IN
City:	Hobart, IN	GPS Northing:	0.0
Location:		GPS Easting:	0.0
Drain Area:	Northwest	GPS Accuracy:	Nearest Meter
Cover Shape:	Circular	Evidence of Surcharge:	No
Cover Size:	23.0	Potential for Runoff:	None
Comments:

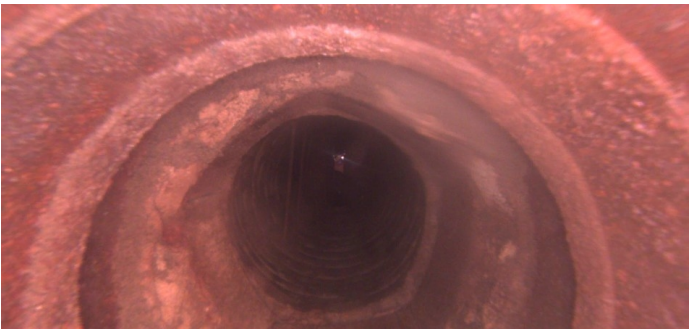
Code: **MGP**
 Description: **General Photo**

Distance (ft): **.0**
 Structural Grade: **0**
 O&M Grade: **0**
 Clock Start/From:
 Clock To:
 1st Value:
 2nd Value:
 Value Percent:
 Step: **NO**
 Remarks:

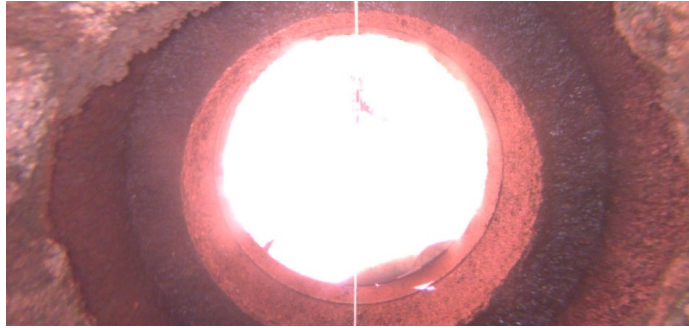
Code: **MGP**
Description: **General Photo**

Distance (ft): **2.2**
Structural Grade: **0**
O&M Grade: **0**
Clock Start/From:
Clock To:
1st Value:
2nd Value:
Value Percent:
Step: **NO**
Remarks:

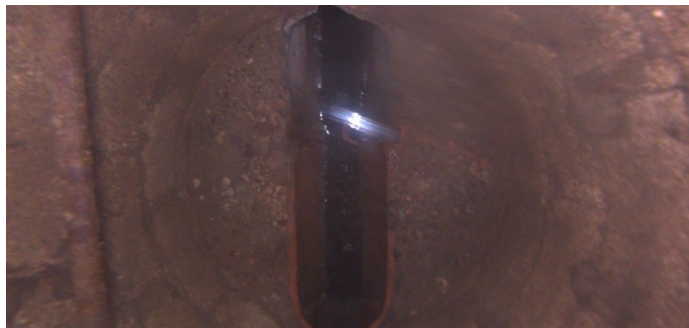
Code: **DAZ**
Description: **Deposits Attached Other**

Distance (ft): **8.7**
Structural Grade: **0**
O&M Grade: **2**
Clock Start/From: **12**
Clock To: **12**
1st Value:
2nd Value:
Value Percent: **10.000**
Step: **NO**
Remarks: **Mixed materials**

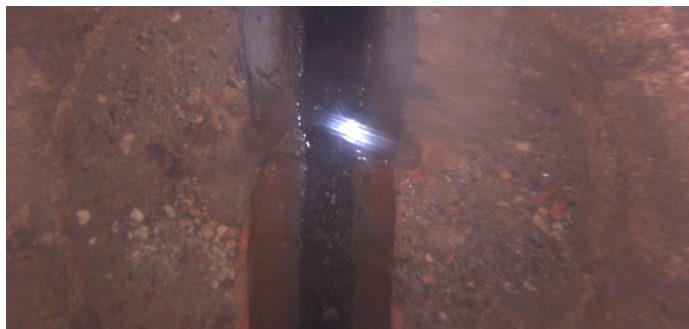
Code: **MGO**
Description: **General Observation**

Distance (ft): **9.8**
Structural Grade: **0**
O&M Grade: **0**
Clock Start/From:
Clock To:
1st Value:
2nd Value:
Value Percent:
Step: **NO**
Remarks: **Ins. Comp.**
