Manhole Inspection Report

Date:	03/30/2018	Weather:		Coding:	RZMACP
MH#:	M-503-091	Owner:	NA	Len. Surveyed:	4.0
P.O.#:		Surveyor:	John Kuglmaier	Rim to Invert:	5.0
Customer:		Cert. #:	U-1215-07002349	Wall Material:	Concrete (reinforced)

Street:	221' North of 38th St. and 199' East	Project:	Hobart, IN
City:	Hobart, IN	GPS Northing:	0.0
Location:		GPS Easting:	0.0
Drain Area:	Northwest	GPS Accuracy:	Nearest Meter
Cover Shape:	Circular	Evidence of Surcharge:	Yes
Cover Size:	23.0	Potential for Runoff:	None
Comments:

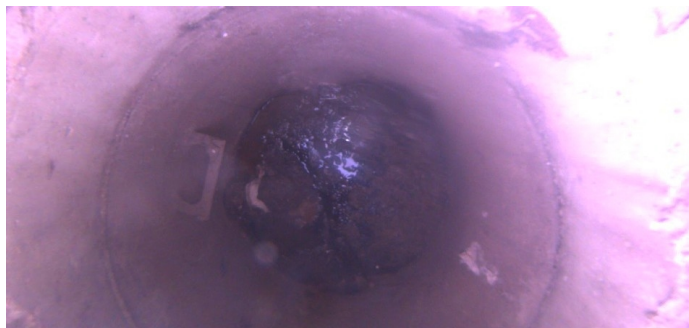
Code: **MGP**
Description: **General Photo**

Distance (ft): **.0**
Structural Grade: **0**
O&M Grade: **0**
Clock Start/From:
Clock To:
1st Value:
2nd Value:
Value Percent:
Step: **NO**
Remarks:

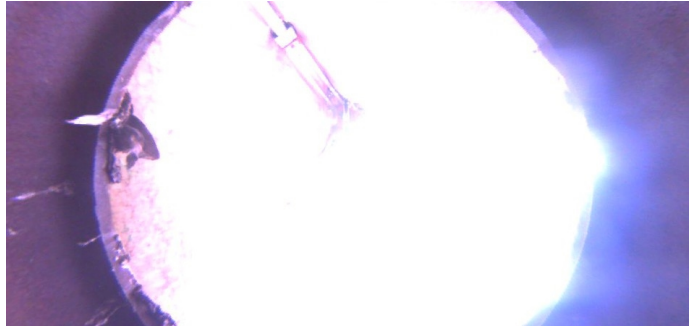
Code: **MGP**
Description: **General Photo**

Distance (ft): **1.7**
Structural Grade: **0**
O&M Grade: **0**
Clock Start/From:
Clock To:
1st Value:
2nd Value:
Value Percent:
Step: **NO**
Remarks:

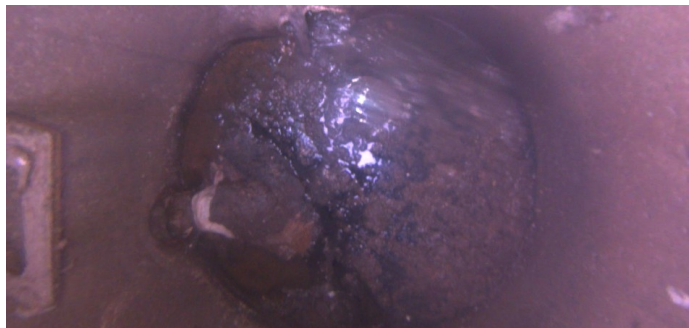
Code: **DAZ**
Description: **Deposits Attached Other**

Distance (ft): **2.3**
Structural Grade: **0**
O&M Grade: **2**
Clock Start/From: **12**
Clock To: **12**
1st Value:
2nd Value:
Value Percent: **10.000**
Step: **NO**
Remarks: **Mixed materials**

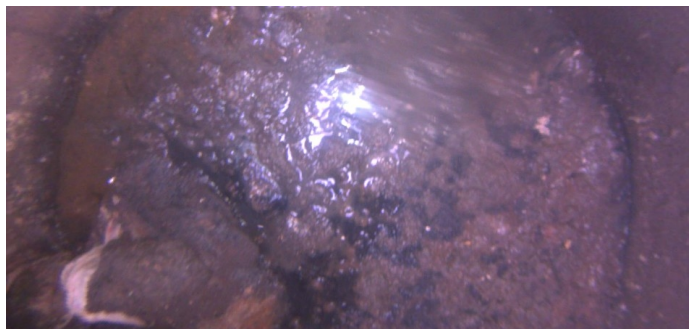
Code: **MGO**
Description: **General Observation**

Distance (ft): **3.4**
Structural Grade: **0**
O&M Grade: **0**
Clock Start/From:
Clock To:
1st Value:
2nd Value:
Value Percent:
Step: **NO**
Remarks: **Ins. Comp.**
