# Manhole Inspection Report

| MH#: | <b>M-504-003</b> | Owner: | <b>NA</b> | Len. Surveyed: | <b>10.6</b> |

| Street: | <b>Wisconsin St. and Home Ave. 1 to th</b> | Project: | <b>Hobart, IN</b> |

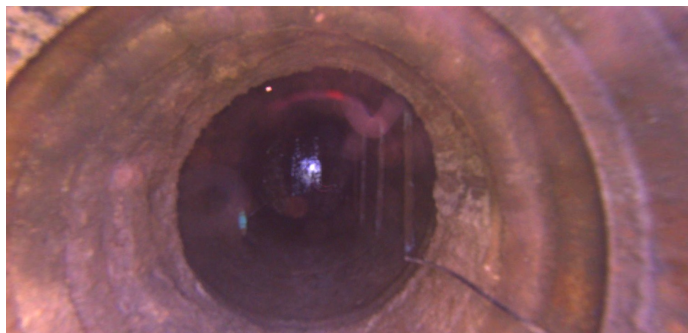
Code: **MGO**  
Description: **General Observation**

Distance (ft): **.0**  
Structural Grade: **0**  
O&M Grade: **0**  
Clock Start/From:  
Clock To:  
1st Value:  
2nd Value:  
Value Percent:  
Step: **NO**  
Remarks: **ACCESS Mh**

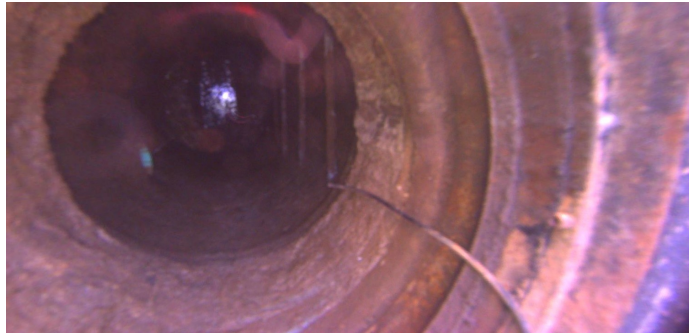
| | Position | Code | Observation | Video (sec) | Grade |
|--|---|---|---|---|---|
| | .0 | RFJ | Roots Fine Joint | 22 | M 1 |

Code: **RFJ**  
Description: **Roots Fine Joint**

Distance (ft): **.0**  
Structural Grade: **0**  
O&M Grade: **1**  
Clock Start/From: **4**  
Clock To:  
1st Value:  
2nd Value:  
Value Percent:  
Step: **NO**  
Remarks:

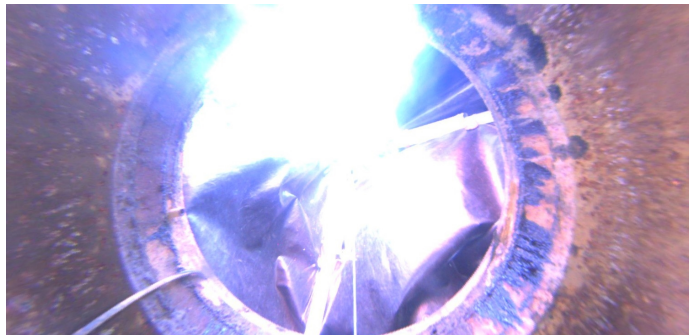
Code: **MGO**  
Description: **General Observation**

Distance (ft): **1.4**  
Structural Grade: **0**  
O&M Grade: **0**  
Clock Start/From:  
Clock To:  
1st Value:  
2nd Value:  
Value Percent:  
Step: **NO**  
Remarks: **underside of frame**

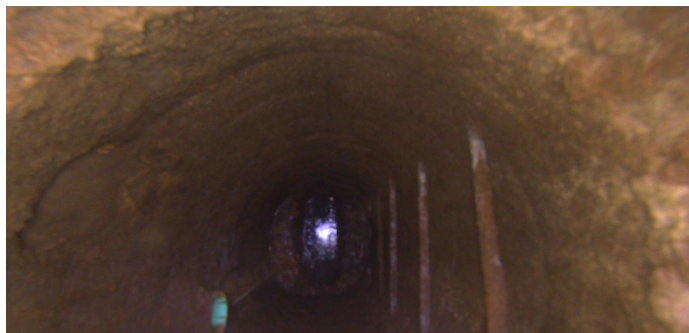
| | Position | Code | Observation | Video (sec) | Grade |
|--|---|---|---|---|---|
| | 1.4 | DAE | Deposits Attached Encrustation | 51 | M 2 |

Code: **DAE**  
Description: **Deposits Attached Encrustation**

Distance (ft): **1.4**  
Structural Grade: **0**  
O&M Grade: **2**  
Clock Start/From: **12**  
Clock To: **12**  
1st Value:  
2nd Value:  
Value Percent: **5.000**  
Step: **NO**  
Remarks:

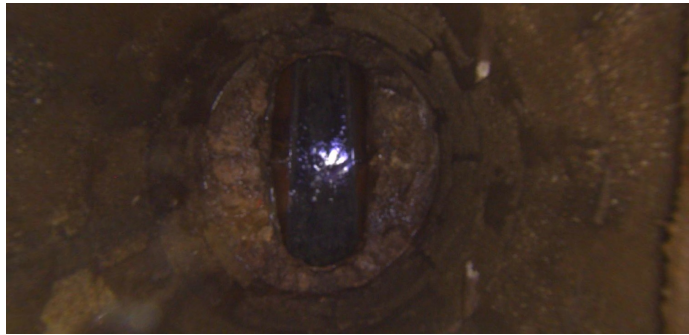
| | Position | Code | Observation | Video (sec) | Grade |
|--|---|---|---|---|---|
| | 6.5 | IS | Infil Stain | 72 | NA |

Code: **IS**  
Description: **Infil Stain**

Distance (ft): **6.5**  
Structural Grade: **0**  
O&M Grade: **0**  
Clock Start/From: **12**  
Clock To: **12**  
1st Value:  
2nd Value:  
Value Percent:  
Step: **NO**  
Remarks:

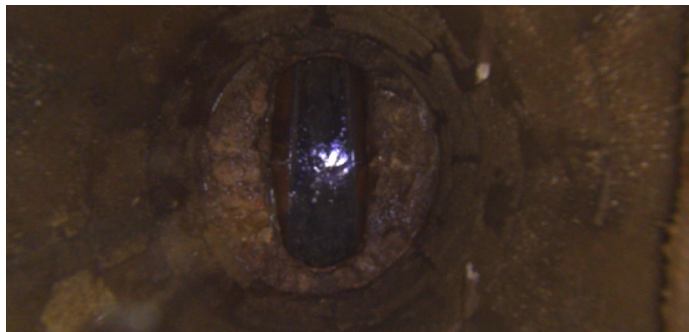
Code: **MGO**  
Description: **General Observation**

Distance (ft): **6.5**  
Structural Grade: **0**  
O&M Grade: **0**  
Clock Start/From:  
Clock To:  
1st Value:  
2nd Value:  
Value Percent:  
Step: **NO**  
Remarks: **broken step**

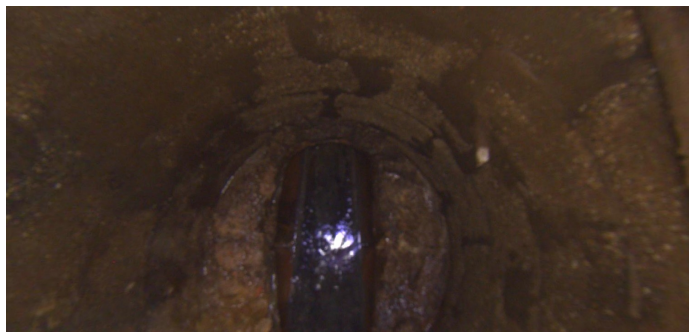
| | Position | Code | Observation | Video (sec) | Grade |
|--|---|---|---|---|---|
| | 6.5 | SAV | Surface Aggregate Visible | 95 | S 3 |

Code: **SAV**  
Description: **Surface Aggregate Visible**

Distance (ft): **6.5**  
Structural Grade: **3**  
O&M Grade: **0**  
Clock Start/From: **12**  
Clock To: **12**  
1st Value:  
2nd Value:  
Value Percent:  
Step: **NO**  
Remarks:

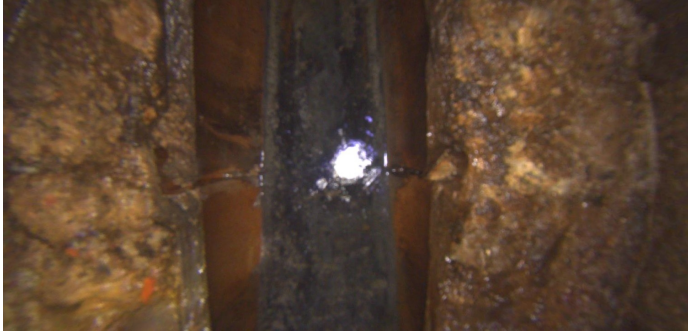
| | Position | Code | Observation | Video (sec) | Grade |
|--|---|---|---|---|---|
| | 9.0 | DSC | Deposits Settled Compacted | 111 | M 2 |

Code: **DSC**  
Description: **Deposits Settled Compacted**

Distance (ft): **9.0**  
Structural Grade: **0**  
O&M Grade: **2**  
Clock Start/From: **12**  
Clock To: **12**  
1st Value:  
2nd Value:  
Value Percent: **10.000**  
Step: **NO**  
Remarks:

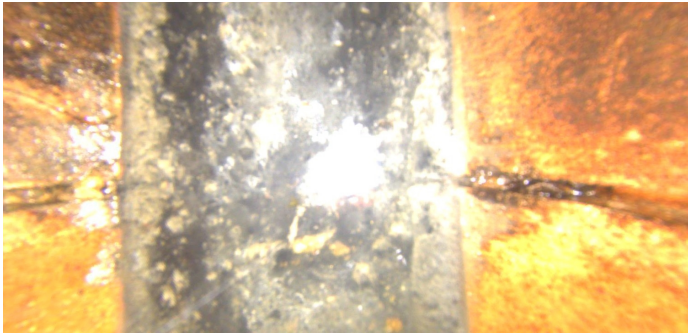
Code: **MGO**  
Description: **General Observation**

Distance (ft): **10.6**  
Structural Grade: **0**  
O&M Grade: **0**  
Clock Start/From:  
Clock To:  
1st Value:  
2nd Value:  
Value Percent:  
Step: **NO**  
Remarks: **end survey**
