Manhole Inspection Report

Date:	04/30/2018	Weather:		Coding:	RZMACP
MH#:	M-504-005	Owner:	NA	Len. Surveyed:	9.0
P.O.#:		Surveyor:	Jen Costello	Rim to Invert:	9.4
Customer:		Cert. #:	U-907-5518	Wall Material:	Brick

Street:	44th Ave. 171' West of Wisconsin St.	Project:	Hobart, IN
City:	Hobart, IN	GPS Northing:	2901644.12
Location:		GPS Easting:	2901644.12
Drain Area:	West	GPS Accuracy:	Sub-Meter
Cover Shape:	Circular	Evidence of Surcharge:	No
Cover Size:	22.5	Potential for Runoff:	None
Comments:

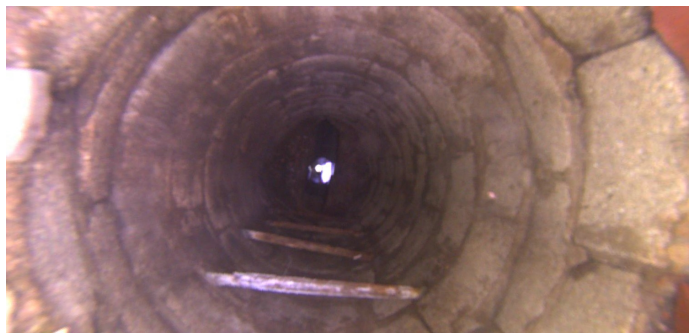
Code: **MGP**
Description: **General Photo**

Distance (ft): **.0**
Structural Grade: **0**
O&M Grade: **0**
Clock Start/From:
Clock To:
1st Value:
2nd Value:
Value Percent:
Step: **NO**
Remarks: **ACCESS MH**

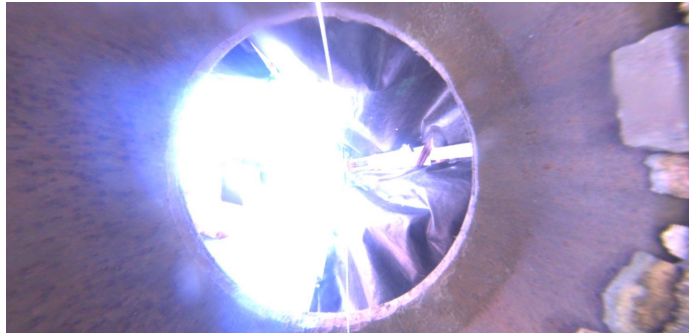
Code: **MGO**
Description: **General Observation**

Distance (ft): **1.4**
Structural Grade: **0**
O&M Grade: **0**
Clock Start/From:
Clock To:
1st Value:
2nd Value:
Value Percent:
Step: **NO**
Remarks: **UNDERSIDE OF FRAME**

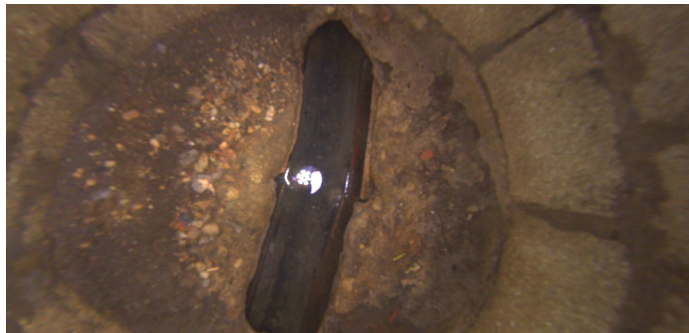
Code: **DSGV**
Description: **Deposits Settled Gravel**

Distance (ft): **7.2**
Structural Grade: **0**
O&M Grade: **2**
Clock Start/From: **12**
Clock To: **12**
1st Value:
2nd Value:
Value Percent: **5.000**
Step: **NO**
Remarks:

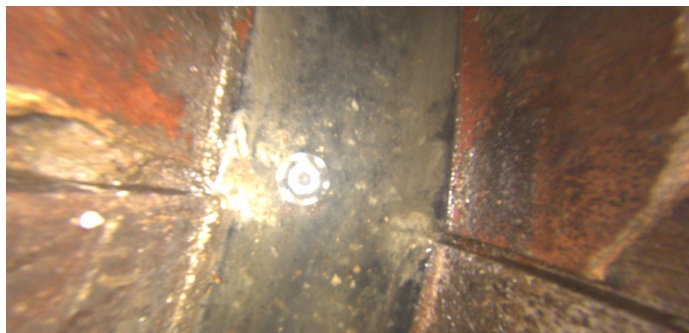
Code: **MGO**
Description: **General Observation**

Distance (ft): **9.0**
Structural Grade: **0**
O&M Grade: **0**
Clock Start/From:
Clock To:
1st Value:
2nd Value:
Value Percent:
Step: **NO**
Remarks: **END SURVEY**
