Manhole Inspection Report

Date:	05/03/2018	Weather:		Coding:	RZMACP
MH#:	M-504-006	Owner:	NA	Len. Surveyed:	9.5
P.O.#:		Surveyor:	Jen Costello	Rim to Invert:	9.9
Customer:		Cert. #:	U-907-5518	Wall Material:	Brick

Street:	Intersection of 44th Ave. and Califor	Project:	Hobart, IN
City:	Hobart, IN	GPS Northing:	41.53830338
Location:		GPS Easting:	-87.27062225
Drain Area:	West	GPS Accuracy:	Nearest Meter
Cover Shape:	Circular	Evidence of Surcharge:	No
Cover Size:	22.5	Potential for Runoff:	None
Comments:

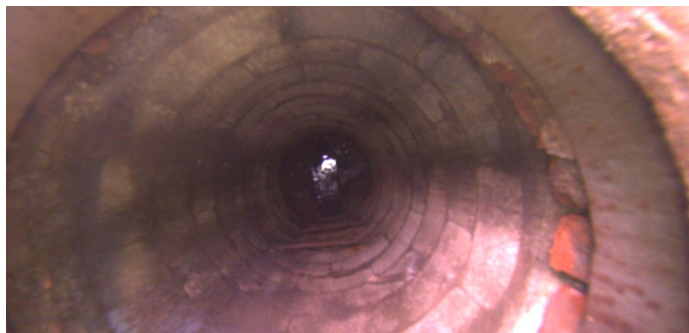
Code: **MGO**
Description: **General Observation**

Distance (ft): **.0**
Structural Grade: **0**
O&M Grade: **0**
Clock Start/From:
Clock To:
1st Value:
2nd Value:
Value Percent:
Step: **NO**
Remarks: **END SURVEY**

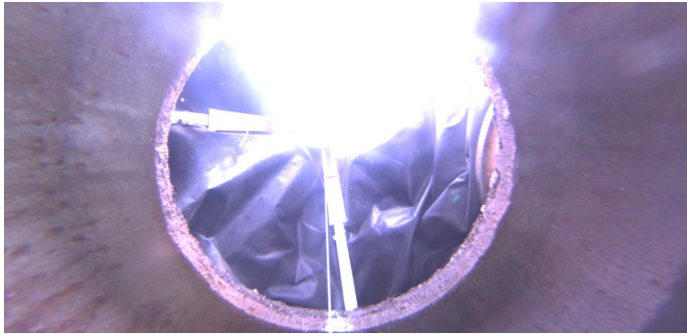
Code:	MGO
Description:	General Observation
Distance (ft):	1.5
Structural Grade:	0
O&M Grade:	0
Clock Start/From:	
Clock To:	
1st Value:	
2nd Value:	
Value Percent:	
Step:	NO
Remarks:	UNDERSIDE OF FRAME

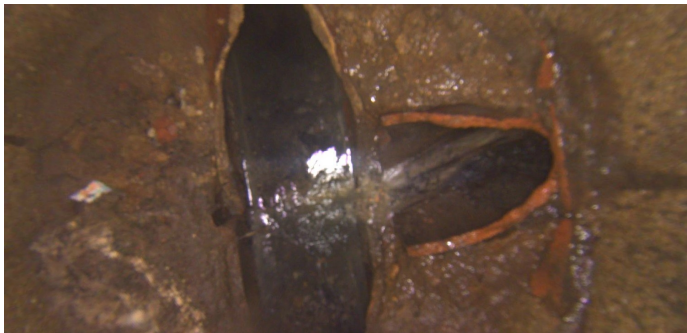
Code:	DSF
Description:	Deposits Settled Fine
Distance (ft):	8.2
Structural Grade:	0
O&M Grade:	2
Clock Start/From:	12
Clock To:	12
1st Value:	
2nd Value:	
Value Percent:	5.000
Step:	NO
Remarks:

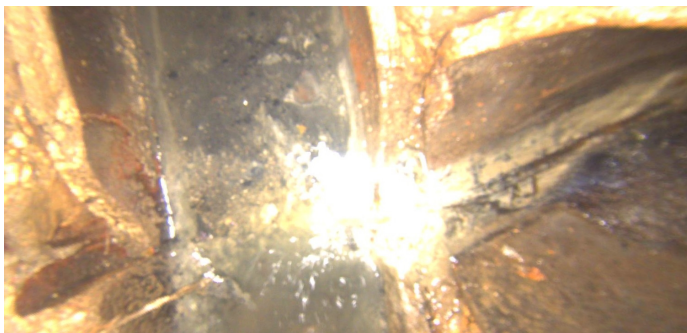
Code:	MGO
Description:	General Observation
Distance (ft):	9.5
Structural Grade:	0
O&M Grade:	0
Clock Start/From:	
Clock To:	
1st Value:	
2nd Value:	
Value Percent:	
Step:	NO
Remarks:	END SURVEY
