Manhole Inspection Report

Date:	05/14/2018	Weather:		Coding:	RZMACP
MH#:	M-504-011	Owner:	NA	Len. Surveyed:	8.7
P.O.#:		Surveyor:	Jen Costello	Rim to Invert:	9.2
Customer:		Cert. #:	U-907-5518	Wall Material:	Brick

Street:	44th Ave. 318' East of Delaware St.	Project:	Hobart, IN
City:	Hobart, IN	GPS Northing:	41.53824615
Location:		GPS Easting:	-87.27183533
Drain Area:	West	GPS Accuracy:	Nearest Meter
Cover Shape:	Circular	Evidence of Surcharge:	No
Cover Size:	22.5	Potential for Runoff:	None
Comments:

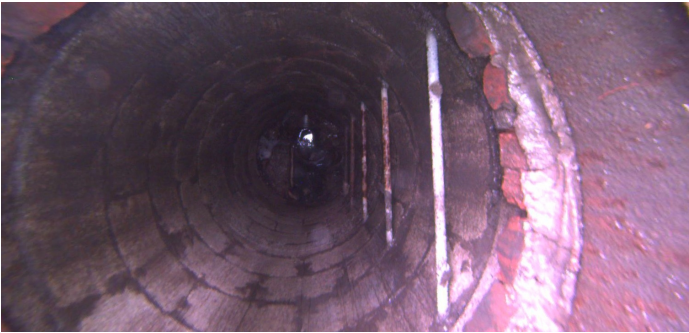
Code: **MGO**
Description: **General Observation**

Distance (ft): **.0**
Structural Grade: **0**
O&M Grade: **0**
Clock Start/From:
Clock To:
1st Value:
2nd Value:
Value Percent:
Step: **NO**
Remarks: **ACCESS MH**

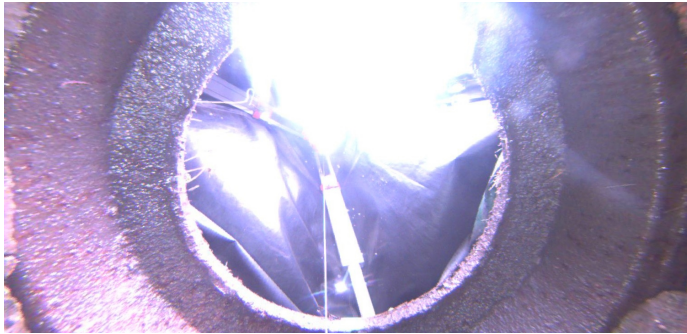
Code:	MGO
Description:	General Observation
Distance (ft):	1.8
Structural Grade:	0
O&M Grade:	0
Clock Start/From:	
Clock To:	
1st Value:	
2nd Value:	
Value Percent:	
Step:	NO
Remarks:	UNDERSIDE OF FRAME

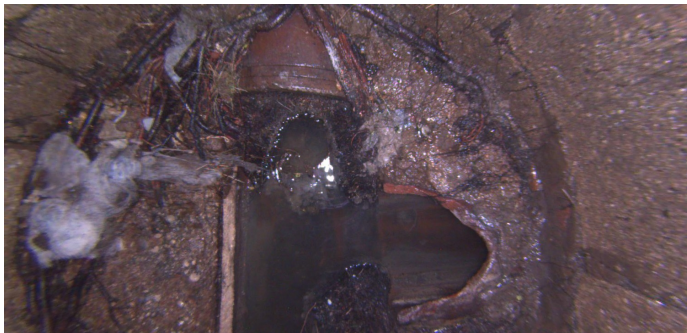
Code:	OBZ
Description:	Obstacle Other
Distance (ft):	7.5
Structural Grade:	0
O&M Grade:	2
Clock Start/From:	8
Clock To:	2
1st Value:	
2nd Value:	
Value Percent:	5.000
Step:	NO
Remarks:	STICKS

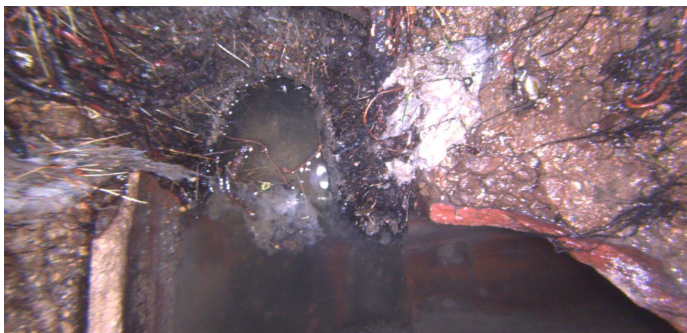
Code:	MGO
Description:	General Observation
Distance (ft):	8.7
Structural Grade:	0
O&M Grade:	0
Clock Start/From:	
Clock To:	
1st Value:	
2nd Value:	
Value Percent:	
Step:	NO
Remarks:	END SURVEY
