Manhole Inspection Report

Date:	05/14/2018	Weather:		Coding:	RZMACP
MH#:	M-504-012	Owner:	NA	Len. Surveyed:	9.8
P.O.#:		Surveyor:	Jen Costello	Rim to Invert:	10.0
Customer:		Cert. #:	U-907-5518	Wall Material:	Brick

Street:	162' North of 44th Ave. East of Dela	Project:	Hobart, IN
City:	Hobart, IN	GPS Northing:	41.53862762
Location:		GPS Easting:	-87.27186584
Drain Area:	West	GPS Accuracy:	Nearest Meter
Cover Shape:	Circular	Evidence of Surcharge:	No
Cover Size:	22.5	Potential for Runoff:	None
Comments:

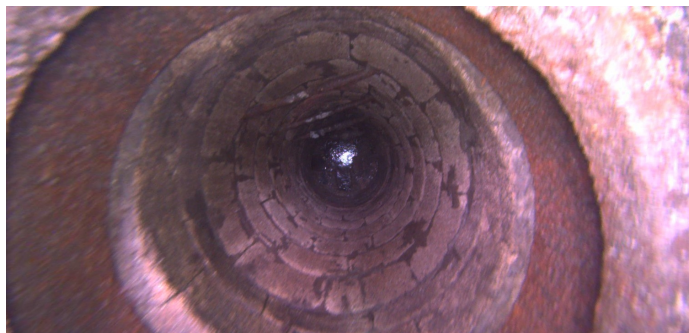
Code: **MGO**
Description: **General Observation**

Distance (ft): **.0**
Structural Grade: **0**
O&M Grade: **0**
Clock Start/From:
Clock To:
1st Value:
2nd Value:
Value Percent:
Step: **NO**
Remarks: **ACCESS MH**

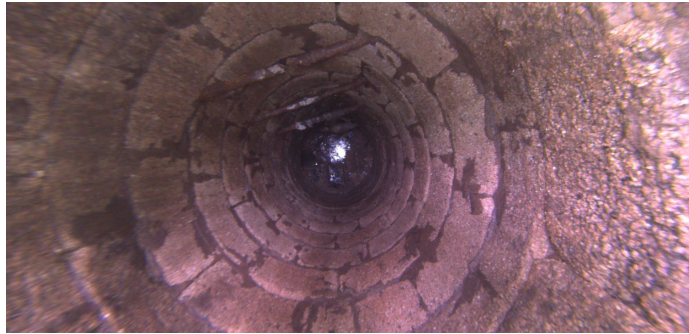
Code: **SAV**
Description: **Surface Aggregate Visible**

Distance (ft): **.7**
Structural Grade: **3**
O&M Grade: **0**
Clock Start/From: **12**
Clock To: **12**
1st Value:
2nd Value:
Value Percent:
Step: **NO**
Remarks:

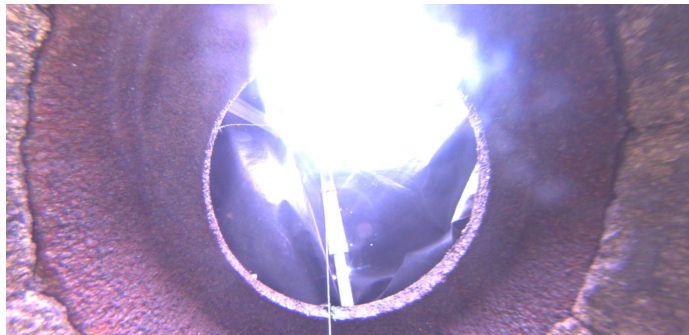
Code: **MGO**
Description: **General Observation**

Distance (ft): **1.8**
Structural Grade: **0**
O&M Grade: **0**
Clock Start/From:
Clock To:
1st Value:
2nd Value:
Value Percent:
Step: **NO**
Remarks: **UNDERSIDE OF FRAME**

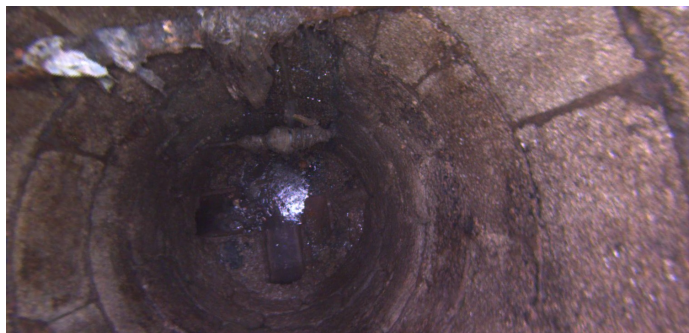
Code: **DAR**
Description: **Deposits Attached Ragging**

Distance (ft): **4.5**
Structural Grade: **0**
O&M Grade: **2**
Clock Start/From: **12**
Clock To:
1st Value:
2nd Value:
Value Percent: **5.000**
Step: **YES**
Remarks:

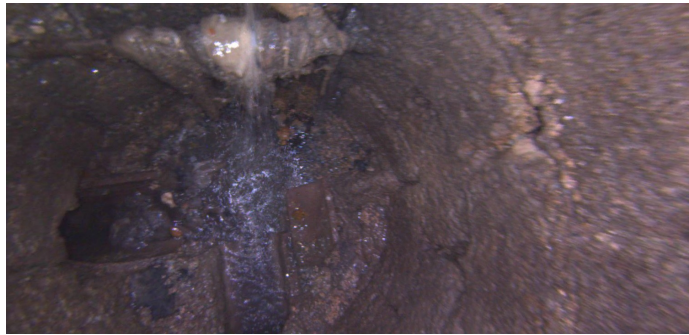
Code: **DAR**
Description: **Deposits Attached Ragging**

Distance (ft): **6.9**
Structural Grade: **0**
O&M Grade: **2**
Clock Start/From: **11**
Clock To: **1**
1st Value:
2nd Value:
Value Percent: **5.000**
Step: **YES**
Remarks:

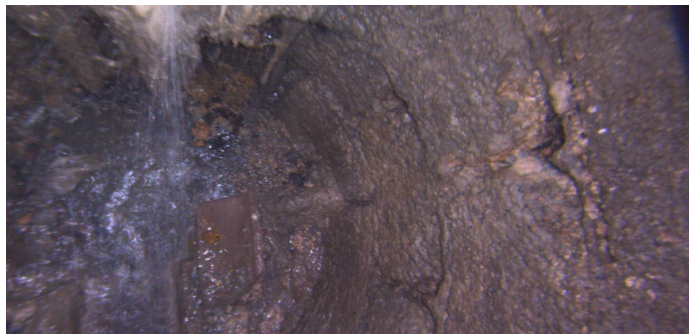
Code: **HVV**
Description: **Hole Void Visible**

Distance (ft): **7.5**
Structural Grade: **5**
O&M Grade: **0**
Clock Start/From: **3**
Clock To:
1st Value:
2nd Value:
Value Percent:
Step: **NO**
Remarks:

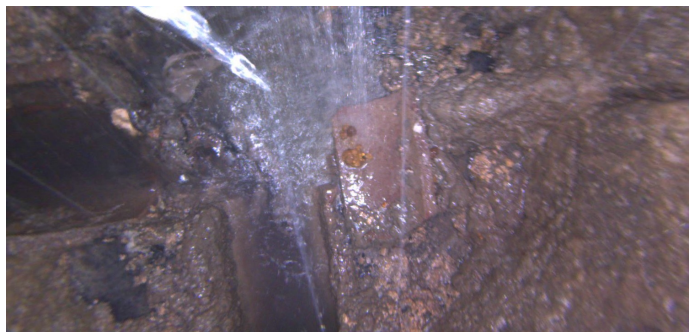
Code: **OBM**
Description: **Obstacle Pipe Material**

Distance (ft): **8.9**
Structural Grade: **0**
O&M Grade: **2**
Clock Start/From: **3**
Clock To: **4**
1st Value:
2nd Value:
Value Percent: **10.000**
Step: **NO**
Remarks:

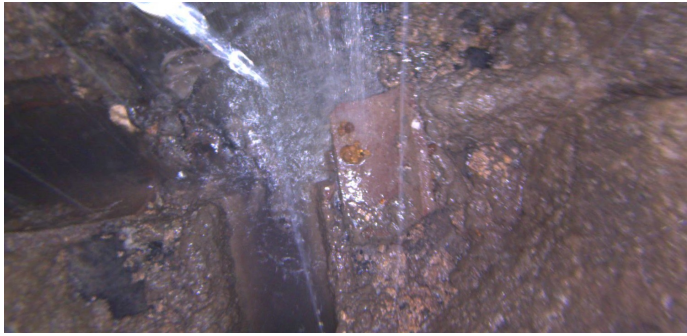
Code: **DAGS**
Description: **Deposits Attached Grease**

Distance (ft): **8.9**
Structural Grade: **0**
O&M Grade: **2**
Clock Start/From: **12**
Clock To: **12**
1st Value:
2nd Value:
Value Percent: **5.000**
Step: **NO**
Remarks:

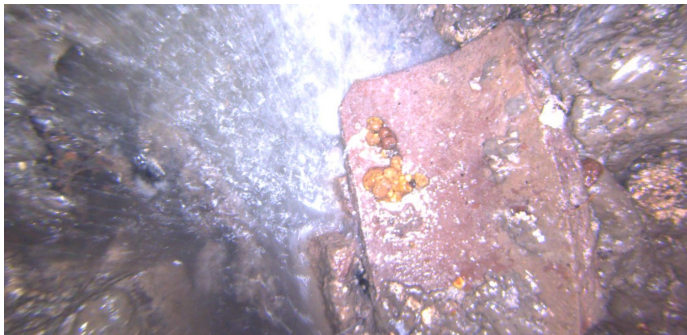
Code: **MGO**
Description: **General Observation**

Distance (ft): **9.8**
Structural Grade: **0**
O&M Grade: **0**
Clock Start/From:
Clock To:
1st Value:
2nd Value:
Value Percent:
Step: **NO**
Remarks: **END SURVEY**

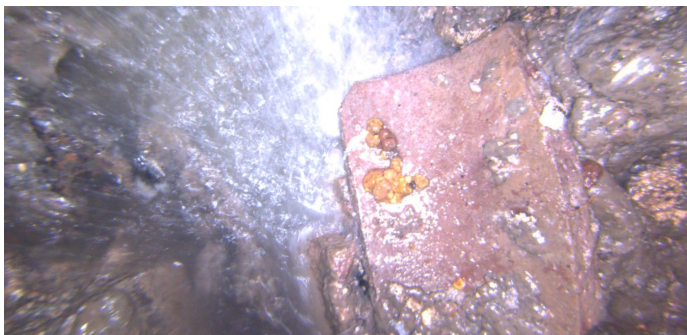
Code: **SAV**
Description: **Surface Aggregate Visible**

Distance (ft): **9.8**
Structural Grade: **3**
O&M Grade: **0**
Clock Start/From: **12**
Clock To: **12**
1st Value:
2nd Value:
Value Percent:
Step: **NO**
Remarks:
