Manhole Inspection Report

Date:	05/13/2018	Weather:		Coding:	RZMACP
MH#:	M-504-019	Owner:	NA	Len. Surveyed:	10.4
P.O.#:		Surveyor:	Jen Costello	Rim to Invert:	11.2
Customer:		Cert. #:	U-907-5518	Wall Material:	Brick

Street:	Wisconsin St. and Home Ave. to the	Project:	Hobart, IN
City:	Hobart, IN	GPS Northing:	2901802.495
Location:		GPS Easting:	2901802.495
Drain Area:	West	GPS Accuracy:	Sub-Meter
Cover Shape:	Circular	Evidence of Surcharge:	No
Cover Size:	22.5	Potential for Runoff:	None
Comments:

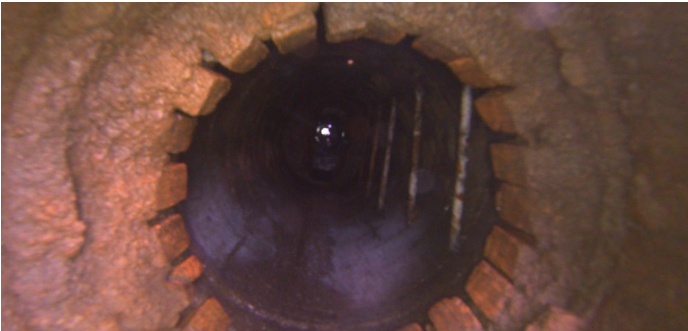
MGP

General Photo

ACCESS MH

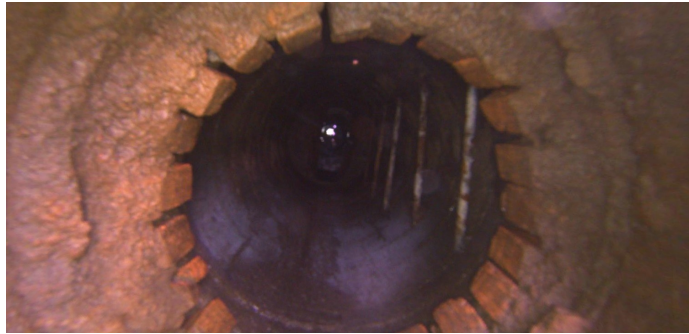
Code: **DAZ**
Description: **Deposits Attached Other**

Distance (ft): **.0**
Structural Grade: **0**
O&M Grade: **2**
Clock Start/From: **12**
Clock To: **12**
1st Value:
2nd Value:
Value Percent: **5.000**
Step: **NO**
Remarks:

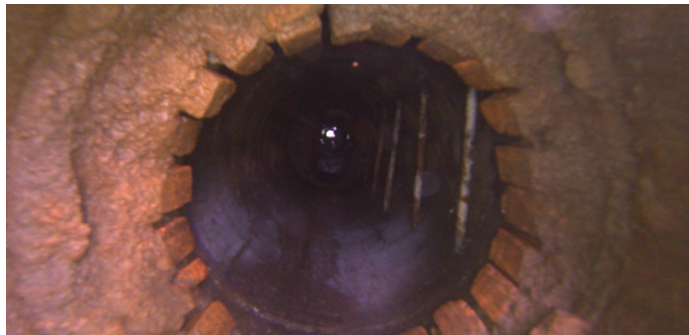
Code: **MMM**
Description: **Mortar Missing Medium**

Distance (ft): **.0**
Structural Grade: **3**
O&M Grade: **0**
Clock Start/From: **12**
Clock To: **12**
1st Value:
2nd Value:
Value Percent:
Step: **NO**
Remarks:

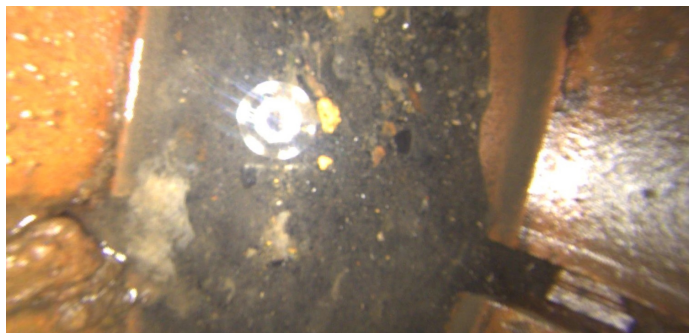
Code: **MGO**
Description: **General Observation**

Distance (ft): **10.7**
Structural Grade: **0**
O&M Grade: **0**
Clock Start/From:
Clock To:
1st Value:
2nd Value:
Value Percent:
Step: **NO**
Remarks: **END SURVEY**
