Manhole Inspection Report

Date:	05/13/2018	Weather:		Coding:	RZMACP
MH#:	M-504-025	Owner:	NA	Len. Surveyed:	14.4
P.O.#:		Surveyor:	Jen Costello	Rim to Invert:	14.0
Customer:		Cert. #:	U-907-5518	Wall Material:	Concrete (reinforced)

Street:	45th Ave. 229' West of Colorado St.	Project:	Hobart, IN
City:	Hobart, IN	GPS Northing:	41.53644562
Location:		GPS Easting:	-87.27500153
Drain Area:	West	GPS Accuracy:	Nearest Meter
Cover Shape:	Circular	Evidence of Surcharge:	No
Cover Size:	22.5	Potential for Runoff:	None
Comments:

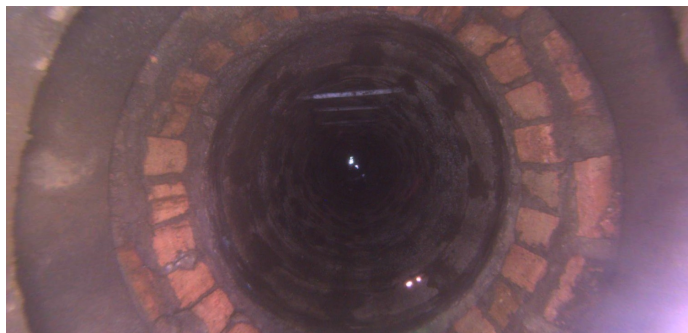
Code: **MGO**
Description: **General Observation**

Distance (ft): **.0**
Structural Grade: **0**
O&M Grade: **0**
Clock Start/From:
Clock To:
1st Value:
2nd Value:
Value Percent:
Step: **NO**
Remarks: **ACCESS MH**

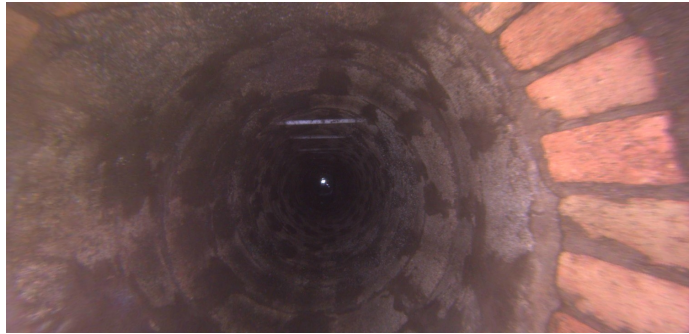
Code:	SAV
Description:	Surface Aggregate Visible
Distance (ft):	1.2
Structural Grade:	3
O&M Grade:	0
Clock Start/From:	12
Clock To:	12
1st Value:	
2nd Value:	
Value Percent:	
Step:	NO
Remarks:

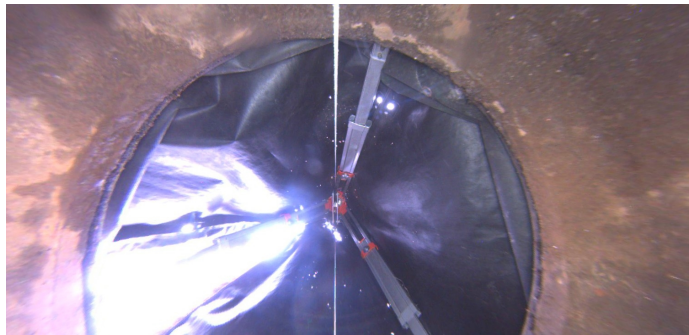
Code:	MGO
Description:	General Observation
Distance (ft):	1.5
Structural Grade:	0
O&M Grade:	0
Clock Start/From:	
Clock To:	
1st Value:	
2nd Value:	
Value Percent:	
Step:	NO
Remarks:	UNDERSIDE OF FRAME

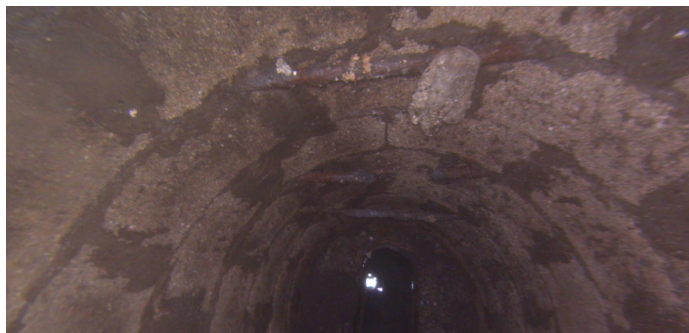
Code:	DAR
Description:	Deposits Attached Ragging
Distance (ft):	9.1
Structural Grade:	0
O&M Grade:	2
Clock Start/From:	12
Clock To:	
1st Value:	
2nd Value:	
Value Percent:	5.000
Step:	YES
Remarks:

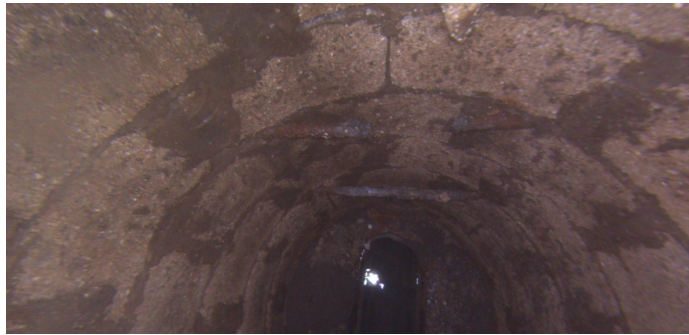
Code: **MGO**
Description: **General Observation**

Distance (ft): **9.8**
Structural Grade: **0**
O&M Grade: **0**
Clock Start/From:
Clock To:
1st Value:
2nd Value:
Value Percent:
Step: **YES**
Remarks: **BROKEN STEP**

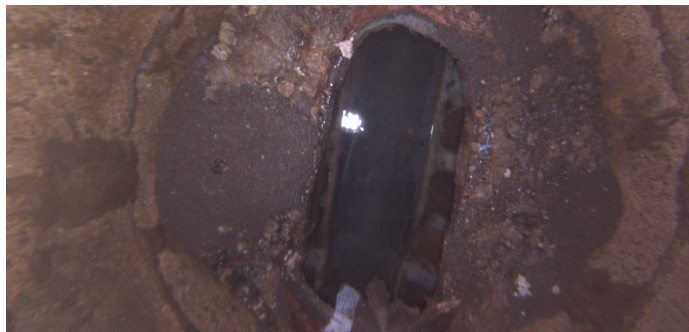
Code: **DSF**
Description: **Deposits Settled Fine**

Distance (ft): **12.7**
Structural Grade: **0**
O&M Grade: **2**
Clock Start/From: **12**
Clock To: **12**
1st Value:
2nd Value:
Value Percent: **5.000**
Step: **NO**
Remarks:

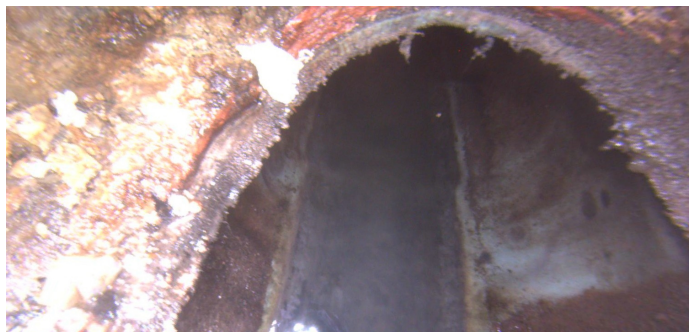
Code: **MGO**
Description: **General Observation**

Distance (ft): **14.4**
Structural Grade: **0**
O&M Grade: **0**
Clock Start/From:
Clock To:
1st Value:
2nd Value:
Value Percent:
Step: **NO**
Remarks: **END SURVEY**

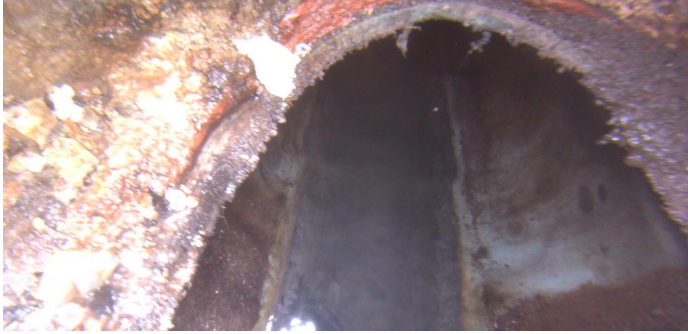
Code:	SAV
Description:	Surface Aggregate Visible
Distance (ft):	14.4
Structural Grade:	3
O&M Grade:	0
Clock Start/From:	12
Clock To:	12
1st Value:	
2nd Value:	
Value Percent:	
Step:	NO
Remarks:
