Manhole Inspection Report

Date:	10/14/2022	Weather:		Coding:	RZMACP
MH#:	M-504-031	Owner:	NA	Len. Surveyed:	11.9
P.O.#:		Surveyor:	Jen Costello	Rim to Invert:	13.3
Customer:		Cert. #:	U-907-5518	Wall Material:	Brick

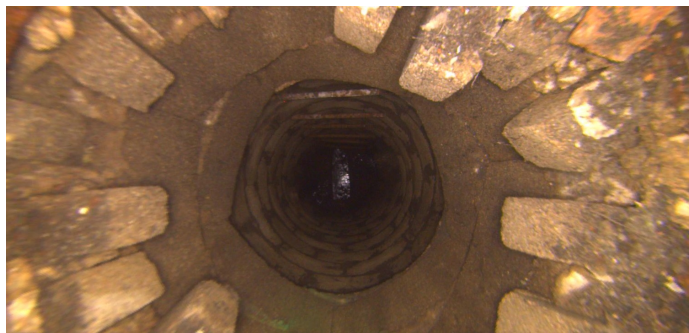
Code: **MGO**
Description: **General Observation**

Distance (ft): **.0**
Structural Grade: **0**
O&M Grade: **0**
Clock Start/From:
Clock To:
1st Value:
2nd Value:
Value Percent:
Step: **NO**
Remarks: **access mh**

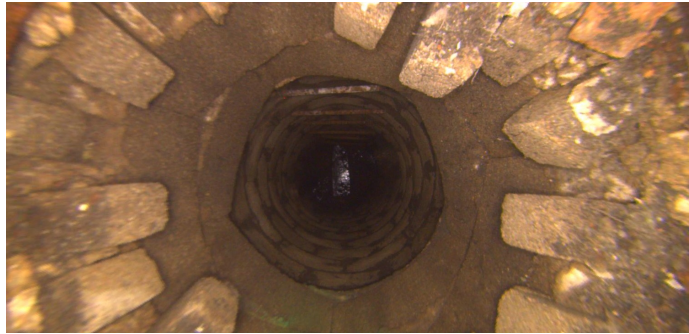
Code: **DB**
Description: **Displaced Brick**

Distance (ft): **.0**
Structural Grade: **3**
O&M Grade: **0**
Clock Start/From: **12**
Clock To: **12**
1st Value:
2nd Value:
Value Percent:
Step: **NO**
Remarks:

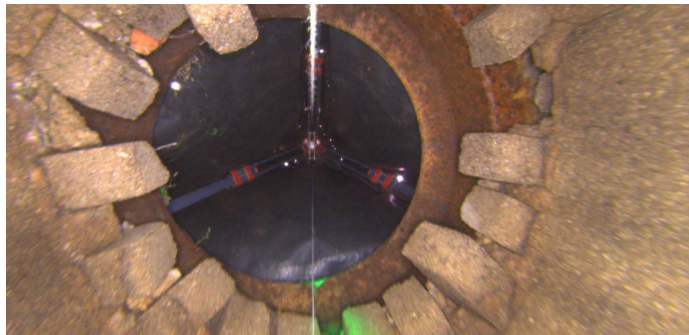
Code: **MGO**
Description: **General Observation**

Distance (ft): **2.2**
Structural Grade: **0**
O&M Grade: **0**
Clock Start/From:
Clock To:
1st Value:
2nd Value:
Value Percent:
Step: **NO**
Remarks: **underside of frame**

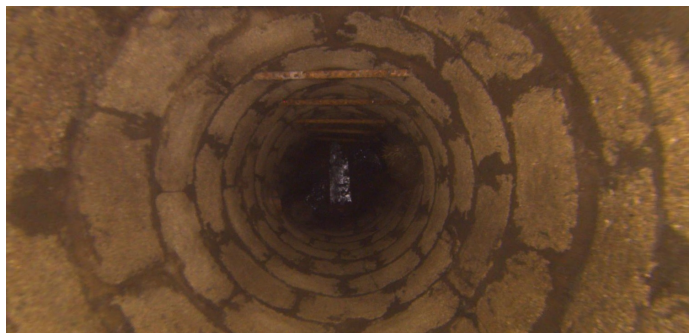
Code: **SAV**
Description: **Surface Aggregate Visible**

Distance (ft): **2.2**
Structural Grade: **3**
O&M Grade: **0**
Clock Start/From: **12**
Clock To: **12**
1st Value:
2nd Value:
Value Percent:
Step: **NO**
Remarks:

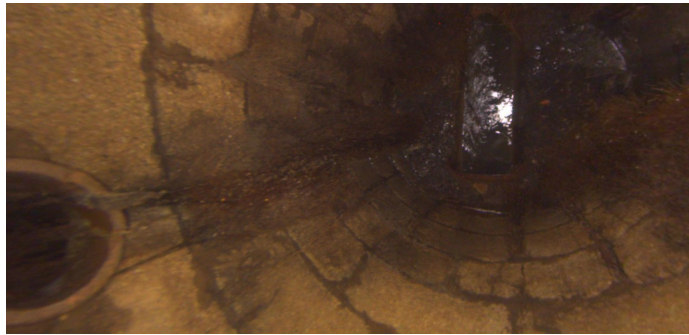
Code: **RFL**
Description: **Roots Fine Lateral**

Distance (ft): **7.6**
Structural Grade: **0**
O&M Grade: **1**
Clock Start/From: **8**
Clock To:
1st Value:
2nd Value:
Value Percent:
Step: **NO**
Remarks:

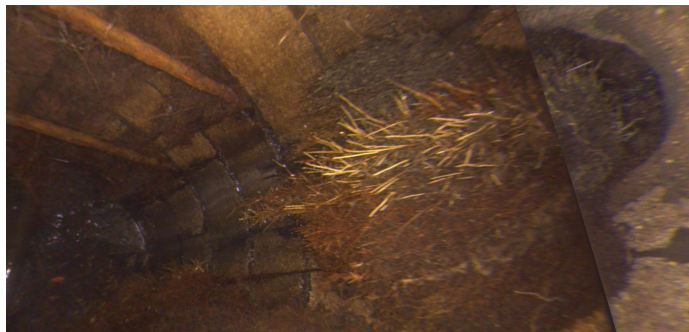
Code: **RML**
Description: **Roots Medium Lateral**

Distance (ft): **7.6**
Structural Grade: **0**
O&M Grade: **3**
Clock Start/From: **3**
Clock To:
1st Value:
2nd Value:
Value Percent: **10.000**
Step: **NO**
Remarks:

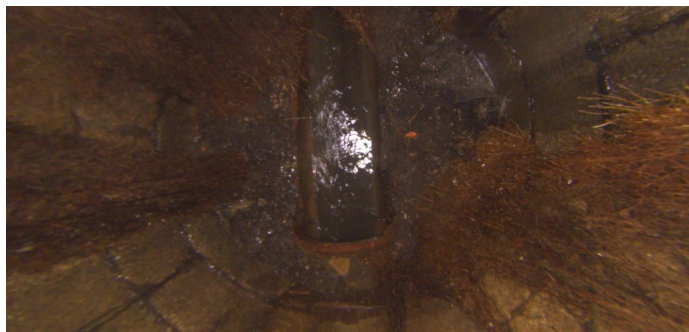
Code: **RMB**
Description: **Roots Medium Barrel**

Distance (ft): **9.6**
Structural Grade: **0**
O&M Grade: **4**
Clock Start/From: **12**
Clock To: **12**
1st Value:
2nd Value:
Value Percent: **10.000**
Step: **NO**
Remarks:

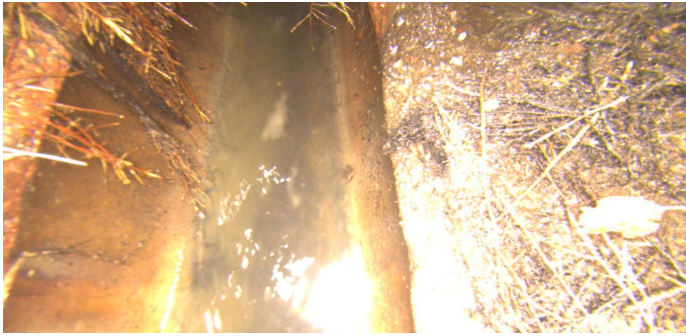
Code: **MGO**
Description: **General Observation**

Distance (ft): **11.9**
Structural Grade: **0**
O&M Grade: **0**
Clock Start/From:
Clock To:
1st Value:
2nd Value:
Value Percent:
Step: **NO**
Remarks: **end of survey**

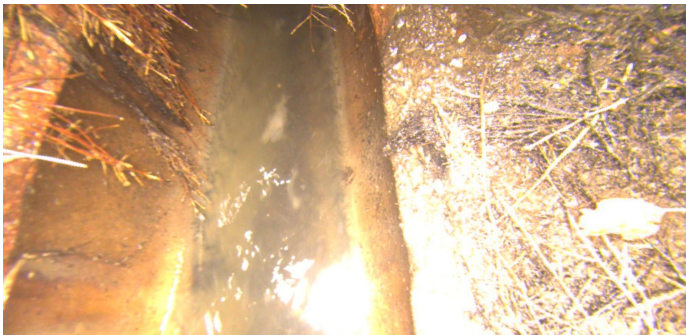
Code: **SAV**
Description: **Surface Aggregate Visible**

Distance (ft): **11.9**
Structural Grade: **3**
O&M Grade: **0**
Clock Start/From: **12**
Clock To: **12**
1st Value:
2nd Value:
Value Percent:
Step: **NO**
Remarks:
